**MULTIDISCIPLINARY FORENSIC
INVESTIGATION OF BUILDINGS IN FIRE: THE
CASE OF THE PLASCO TOWER**

Multidisciplinary Forensic Investigation of Buildings in Fire: The Case of the Plasco
Tower

A thesis submitted in partial fulfilment of the requirements for the degree of
Doctor of Philosophy
Aug 2024

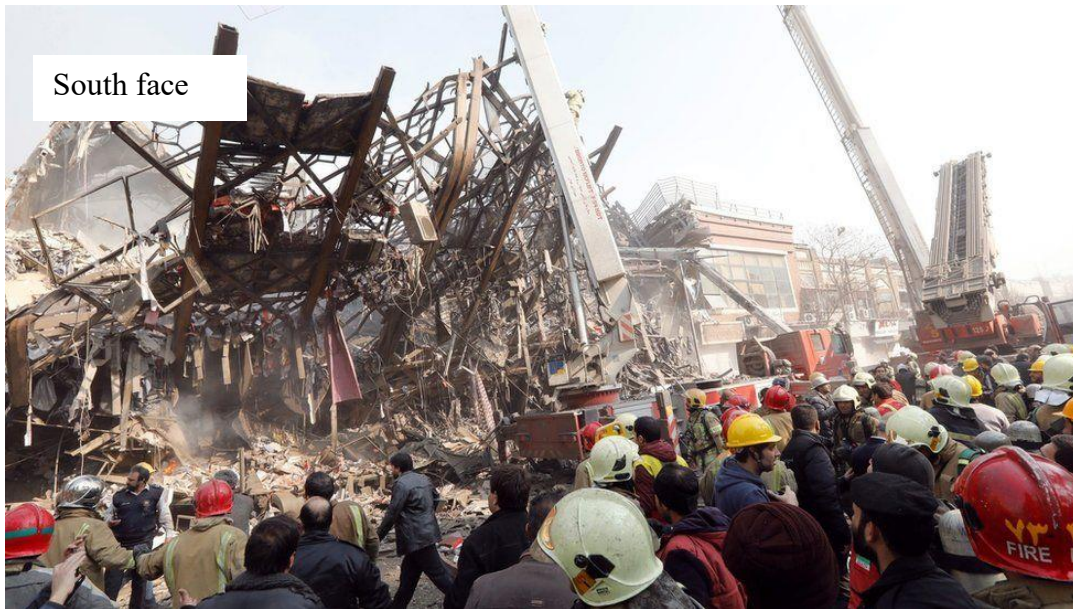
The building caught on fire and collapsed on 19 January 2017. The collapse of the tower (Figure 1.2) resulted in the loss of lives of over 20 firefighters. Approximately 200 firefighters worked tirelessly to combat the fire in the tower, which tragically collapsed in a brief period. Additionally, around 70 individuals sustained injuries, with 23 of them in critical condition after the rescue.

Figure 1.2 Post-collapse view of the tower (BBC (Middle East), 2017)

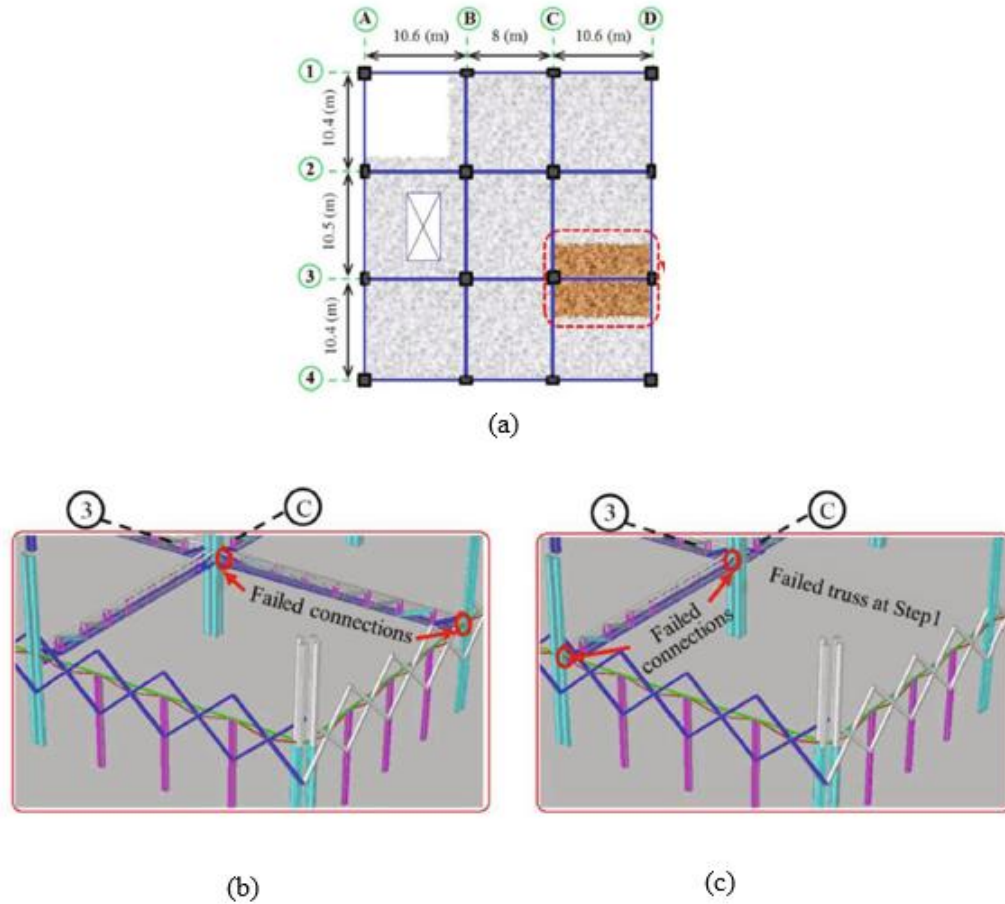
1. Failure of one of the columns
2. Failure of one of the main trusses
3. Failure of secondary trusses

Figure 2.5 (a) Location of Stage 3 collapse initiation; (b) and (c) show the failed connections and trusses in the Southeastern corner of the 9th and 10th ceiling, respectively.
Source: Shakib et al. (2020).

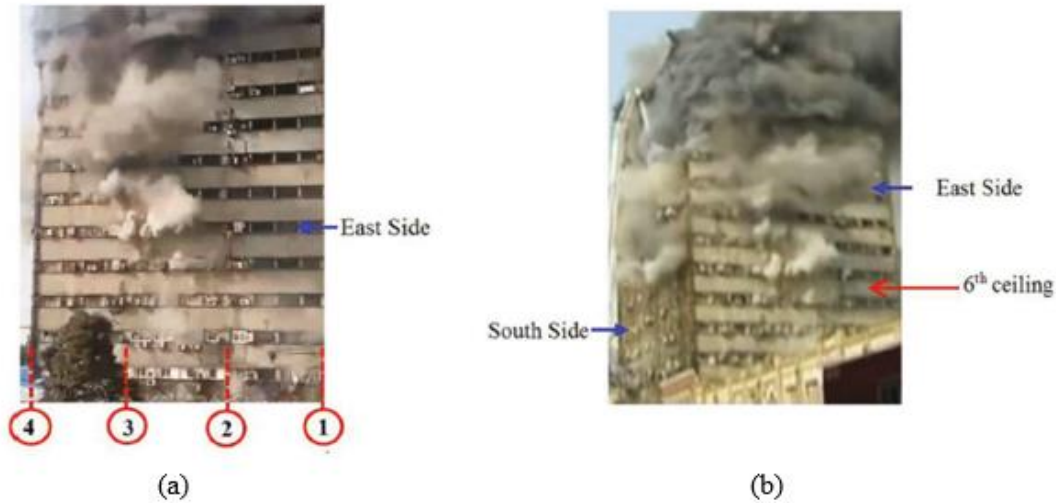
Figure 2.6 (a) Photo showing the inward slope of the South side perimeter columns; (b) dust clouds emerging from the South and East faces of the tower.

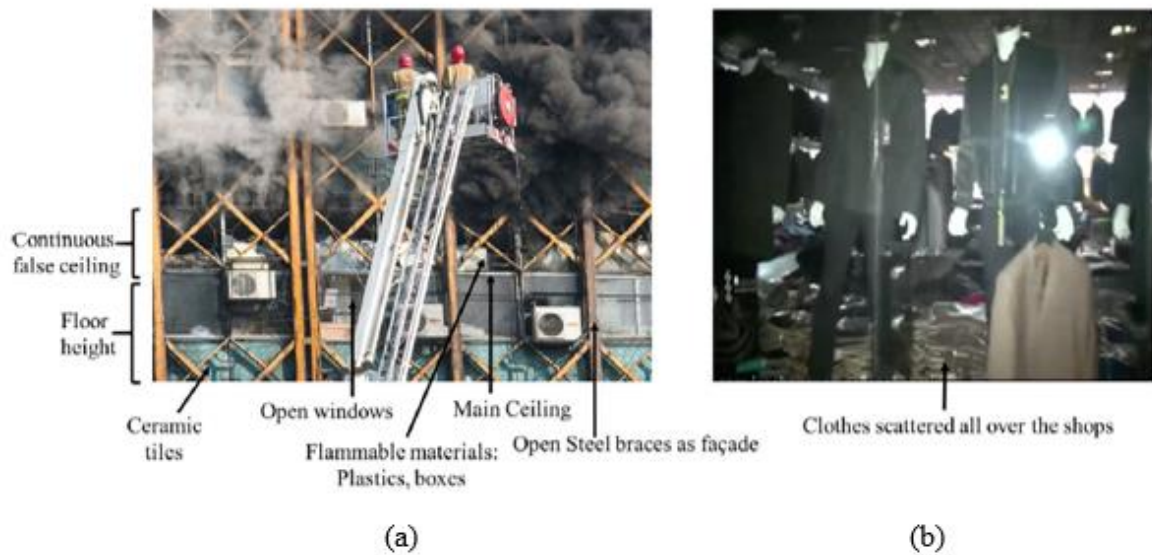
Figure 2.13 Photo showing (a) the ventilation conditions of the tower and (b) the interior of a shopping unit filled with fabrics.

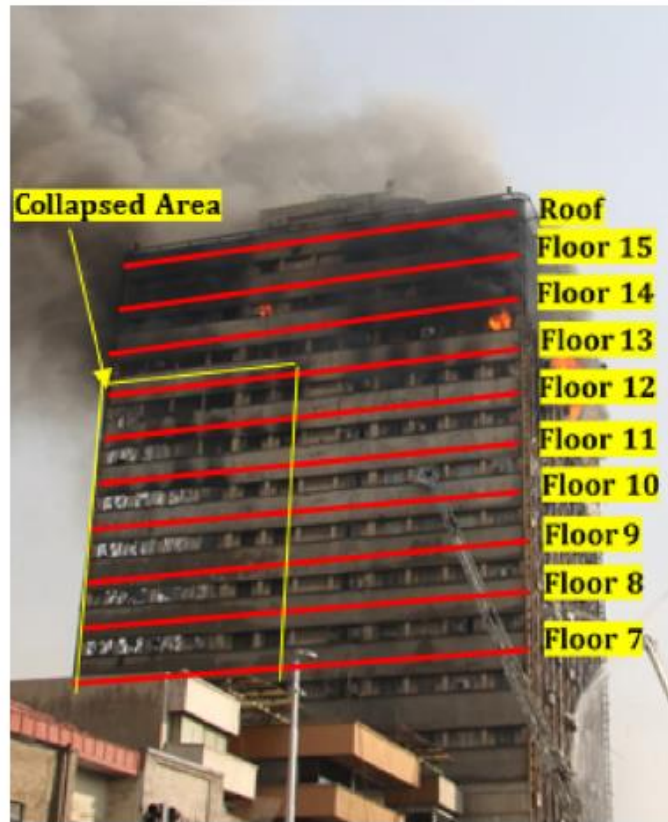
Meticulous analysis of the video evidence uncovered that two distinct floor collapses occurred in the Southeast corner of the building within a timeframe of 3 seconds; see Figure 2.16 and Figure 2.18. It was understood that those two collapses occurred on the 12th floor of the 11th floor first, followed by the 13th floor on the 11th. The structure collapsed after this incident.

Figure 2.17 The west view of the building shows the partial collapse (Second stage).

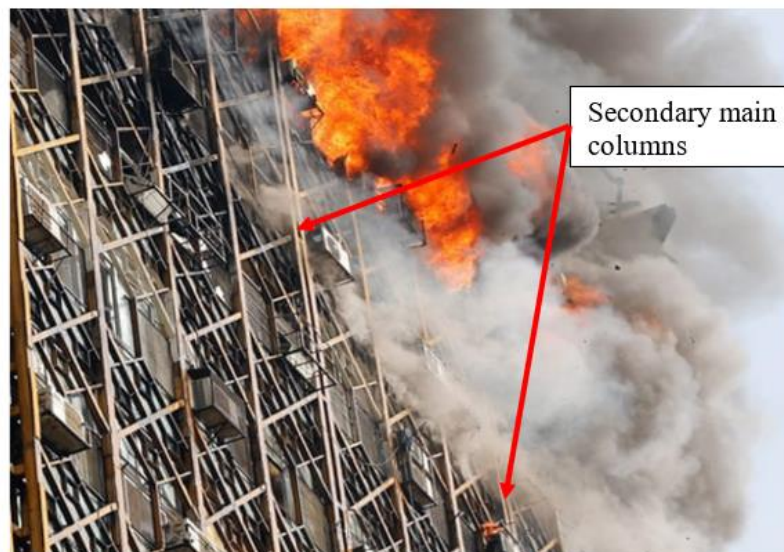
Figure 3.14 Photo of the tower showing fire possibly heating two primary beams simultaneously.

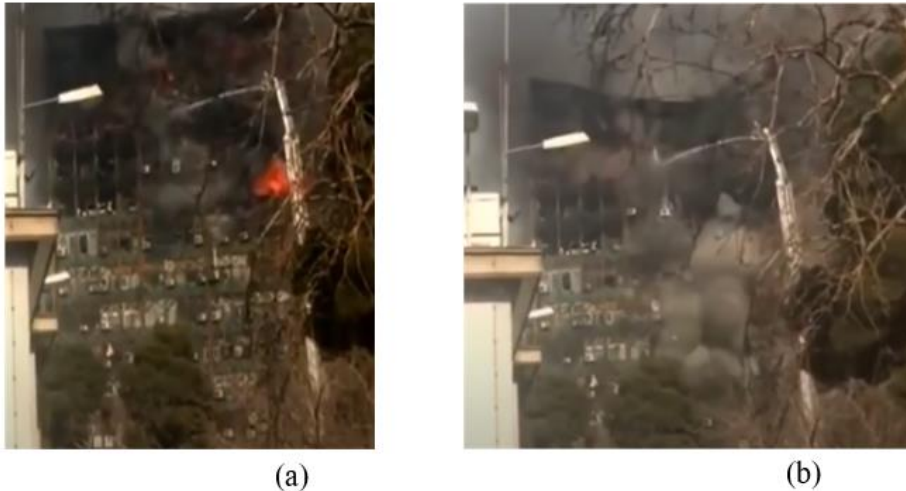
Figure 5.35 Screenshots (a) and (b) from video evidence show the South side peripheral column being pulled inwards seconds before the tower collapses.

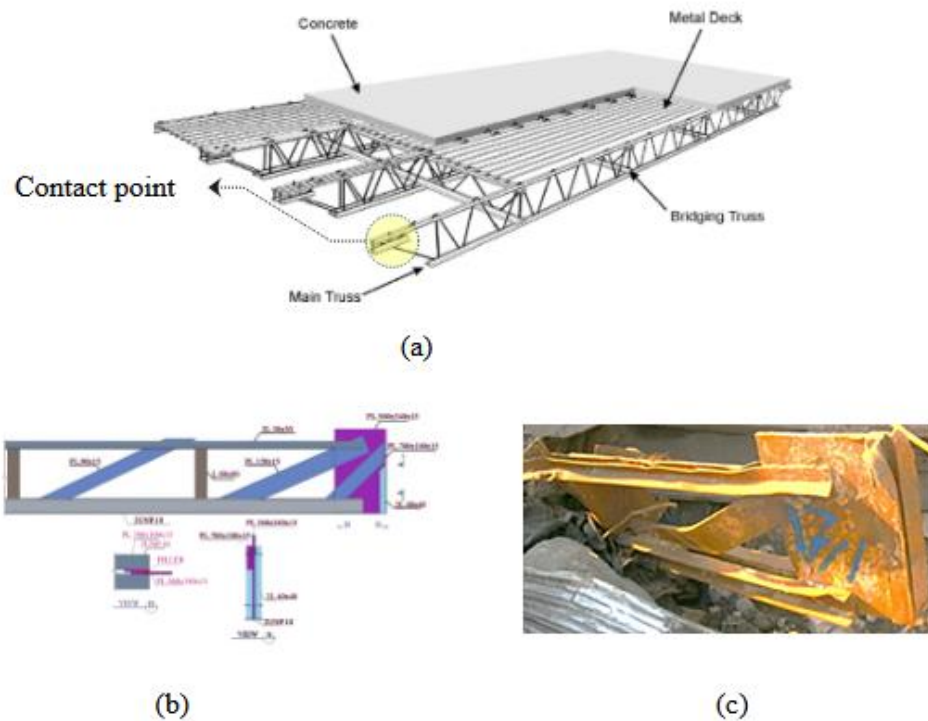
Figure 7.26 Connections of main trusses in (a) WTC (NIST (2005)) and (b) & (c) Plasco tower (Epackachi et al. (2022)).

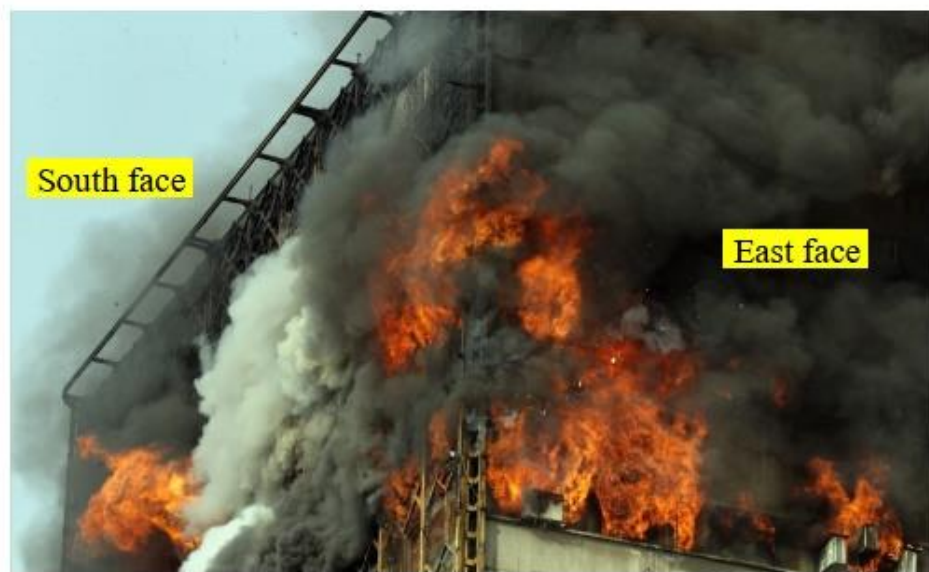
Figure 7.27 Intense fire near the SE corner on 13th and 14th floors

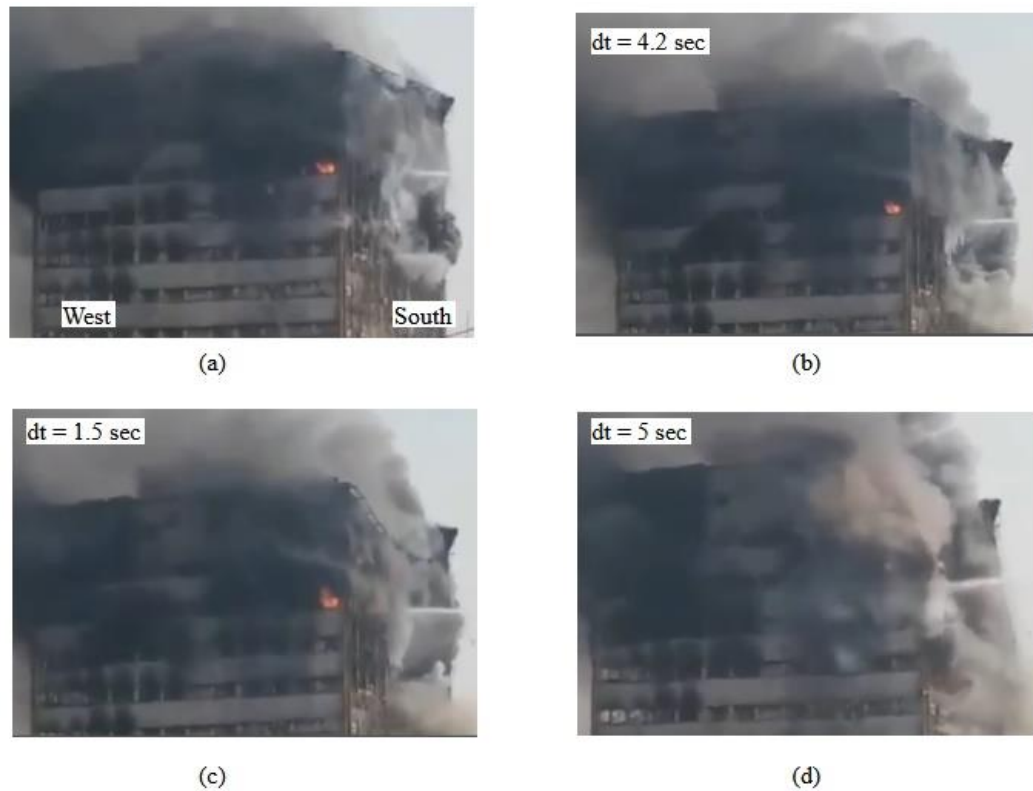
Figure 7.35 Collapse sequence observed in video evidence 1

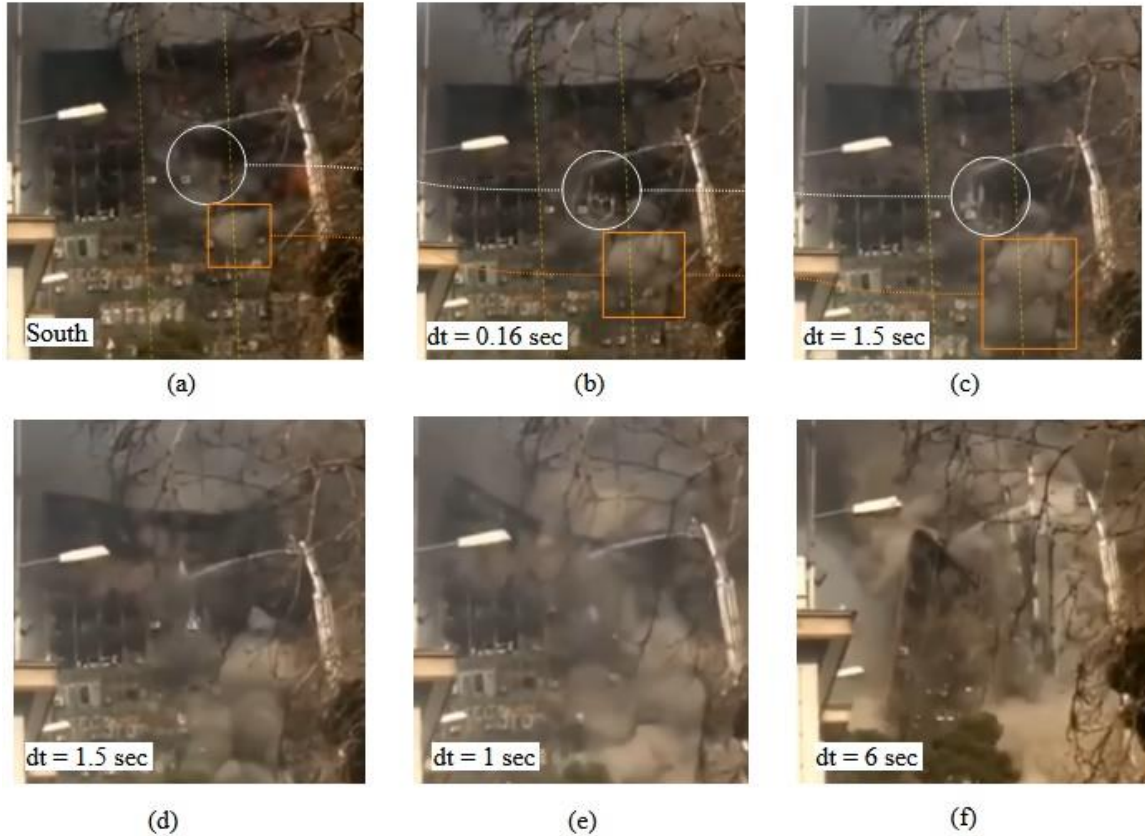
Figure 7.36 Collapse sequence observed in video evidence 2

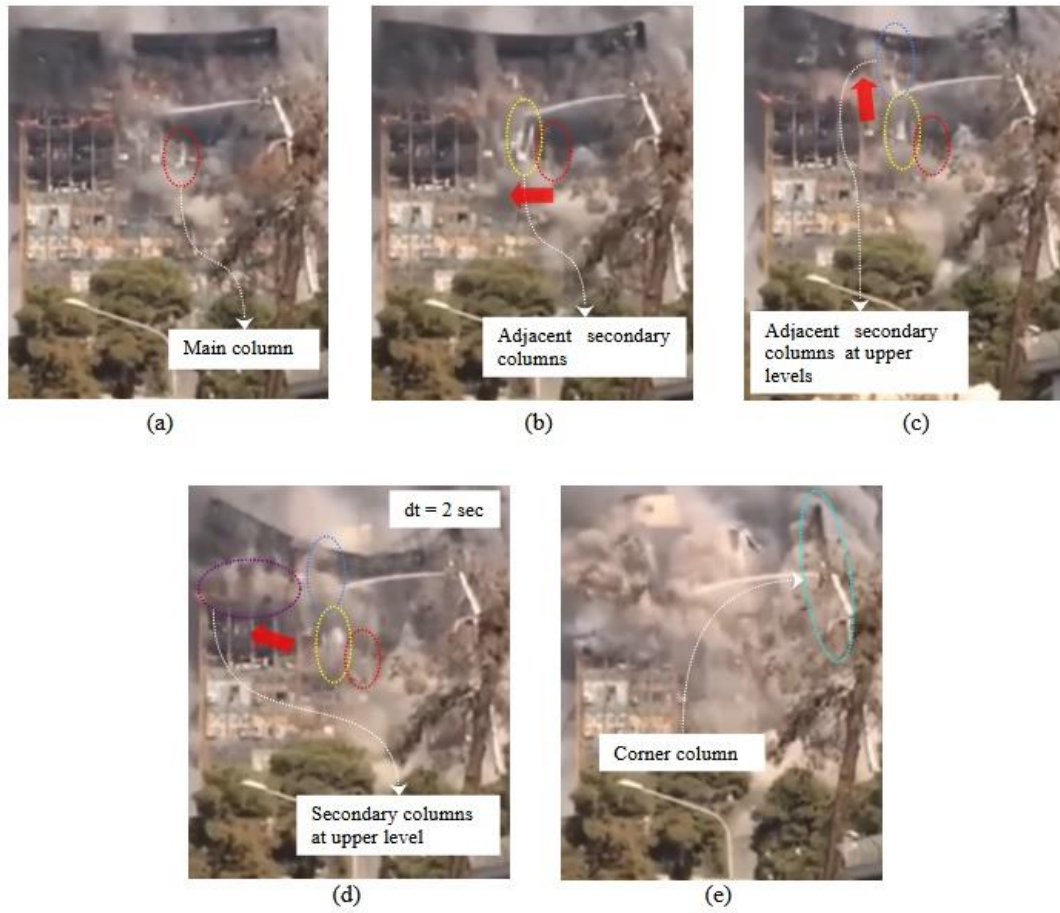
Figure 7.37 Collapse sequence observed in video evidence 3

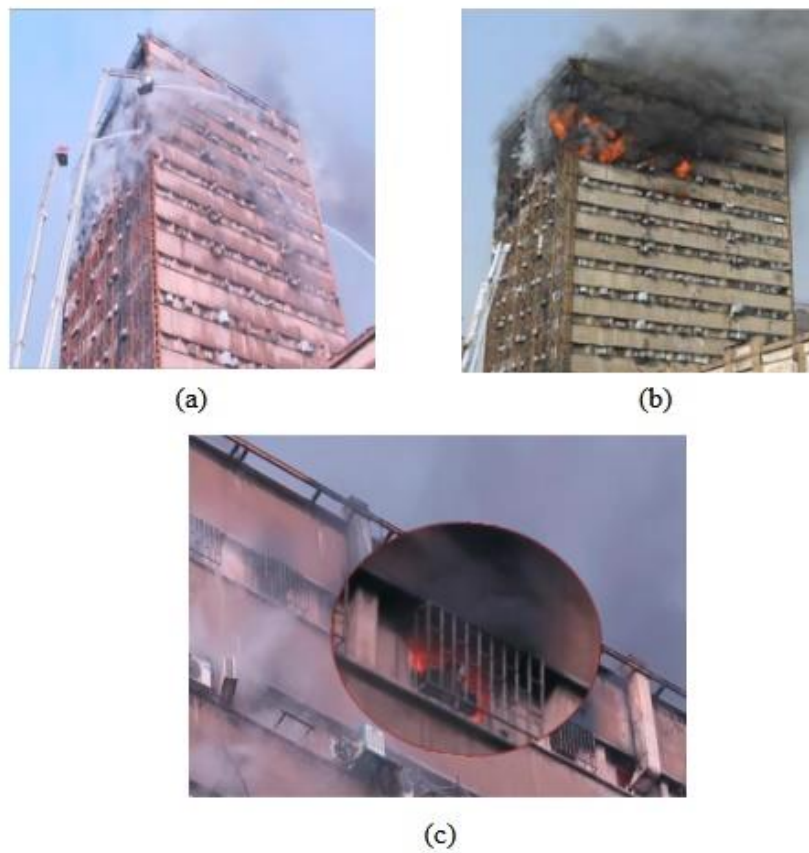
Figure 7.42 Western face of the tower in different instances
