**MULTIDISCIPLINARY FORENSIC
INVESTIGATION OF BUILDINGS IN FIRE: THE
CASE OF THE PLASCO TOWER**

Multidisciplinary Forensic Investigation of Buildings in Fire: The Case of the Plasco
Tower

A thesis submitted in partial fulfilment of the requirements for the degree of
Doctor of Philosophy
Aug 2024

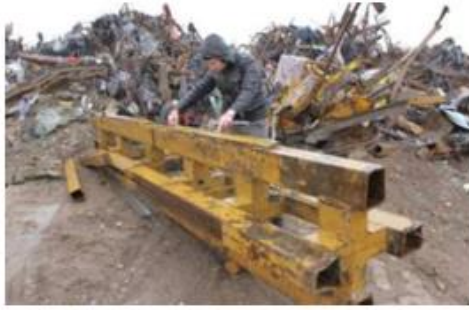
(a) Corner column

Figure 1.10 Photographs of column members found in debris (Govt. of Iran (2017)).

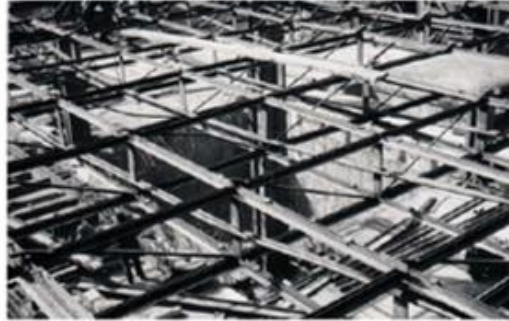
(a) Photo of the floor truss system taken during the construction stage.

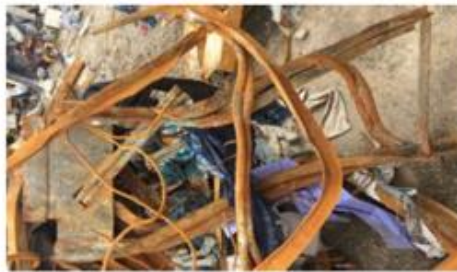
present, while in the EW direction, Vierendeel beams are present, and along the perimeter edge, truss beams are present connecting all columns along the boundary, including the cruciform-shaped corner columns, see Figure 1.13(c) and (d). Evidence of prestressing is found in Vierendeel beams as parabolic tubes are found in the debris; see Figure 1.12(b), (c) & (d).

(b) Parts of distorted Vierendeel beam parts found in the debris.

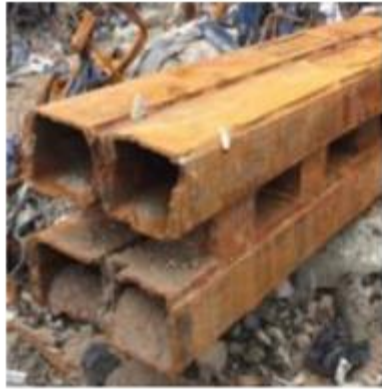
(a) Photo of collapsed core column

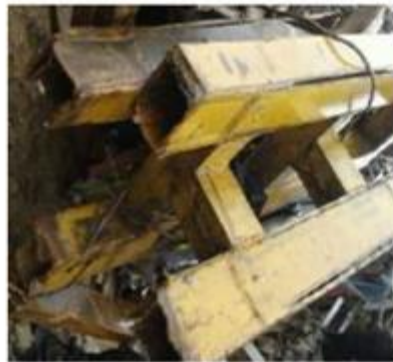
(c) Photo of collapsed corner column

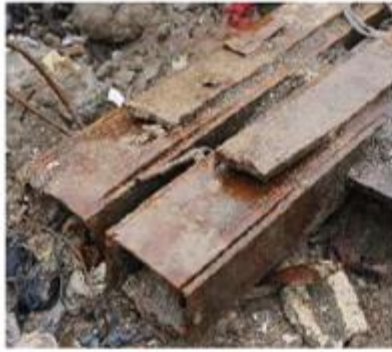
(a) Photo of collapsed main secondary column

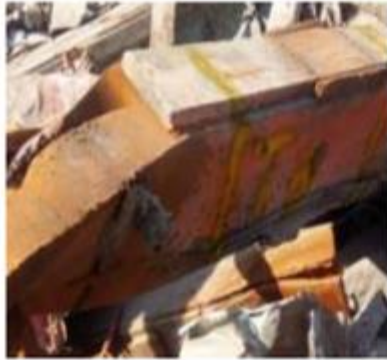
(c) Photo of collapsed minor secondary column

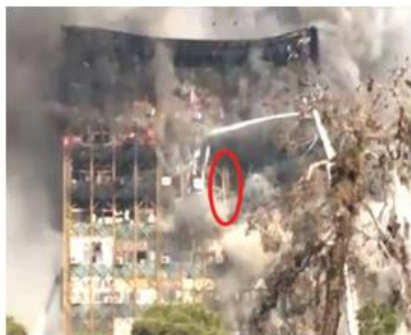
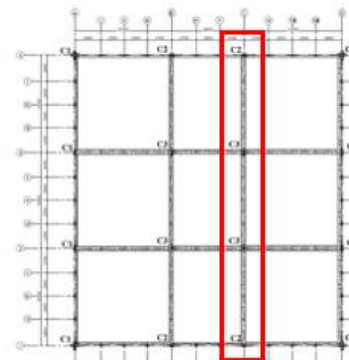
Thermo-mechanical analysis was conducted on a 16-storey model with fire load applied in three stages. The visual evidence from the Figure 2.3(a) showed that the collapse was initiated in the frame located on the third axis (Figure 2.3(b)), Hence, it was chosen to carry out this study. In stage one, fire load was applied only on the 10th floor, representing the fire initiation, and in the next stage, fire load was applied over the 11th floor with a 29-minute delay. In the final stage, floors 12-14 were subjected to concurrent fire load, implying minimal time lag (<10min) in fire reaching these floors.

Figure 2.3 (a) South tower elevation with external column collapsing inwards; (b) location of the frame chosen for the study.

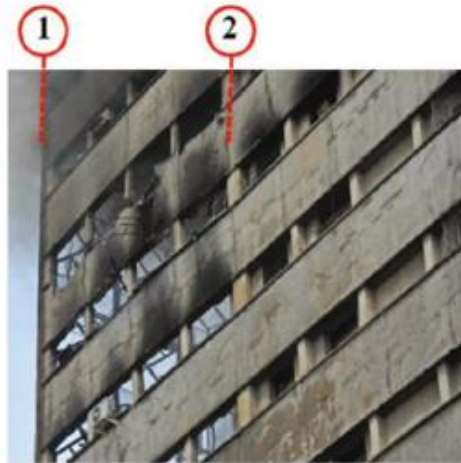
In the second stage, the collapse of all floors in the NW corner of the tower took place. Due to the overloading caused by the fallen 10th and 11th ceilings on the 9th, the connections failed. This led to a sequence of sandwich-style failures of one floor over the other. This left the perimeter columns in the corner freely standing, supported only by the edge beams; this was

supported by the visual evidence, where a few floors were seen missing from the view, see Figure 2.4. Even though considerable damage occurred in the structure, the building was stable for a 31-minute period.

Figure 2.4 The west side view of the corner shows the multiple collapsed ceilings.

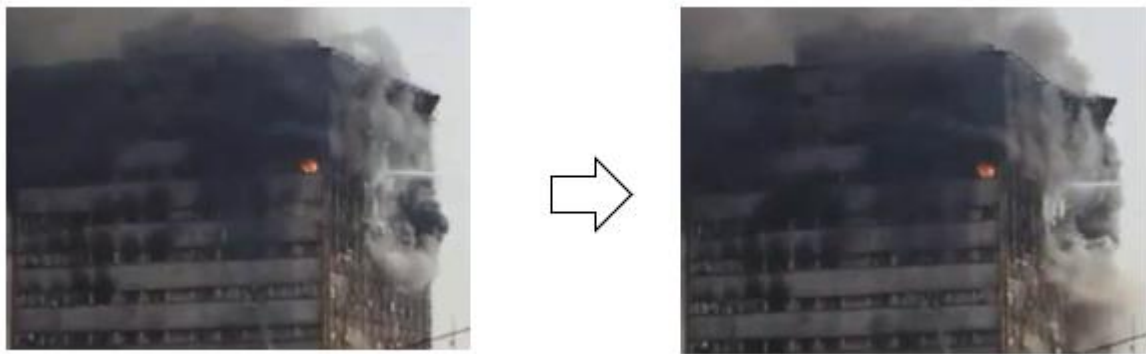
Figure 2.7 Before and after photos showing the downward displacement of the roof near the South face.

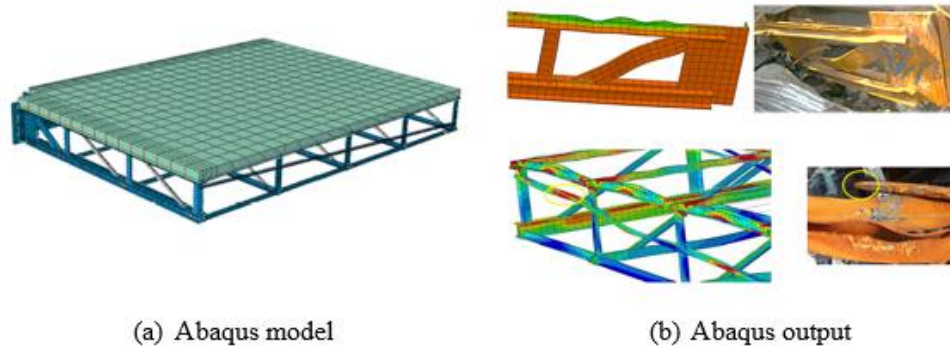
Figure 2.8 A quarter model of the NW corner of the tower (Aghakouchak et al. (2021)).

Figure 2.8(b) shows the plastic deformation and buckling of the top and bottom chords of the truss, which match closely with the deformed truss members found in the debris. The study concludes that the floor failure was caused by the connection failure of the main trusses, caused by the out-of-plane deformation of gusset plates.

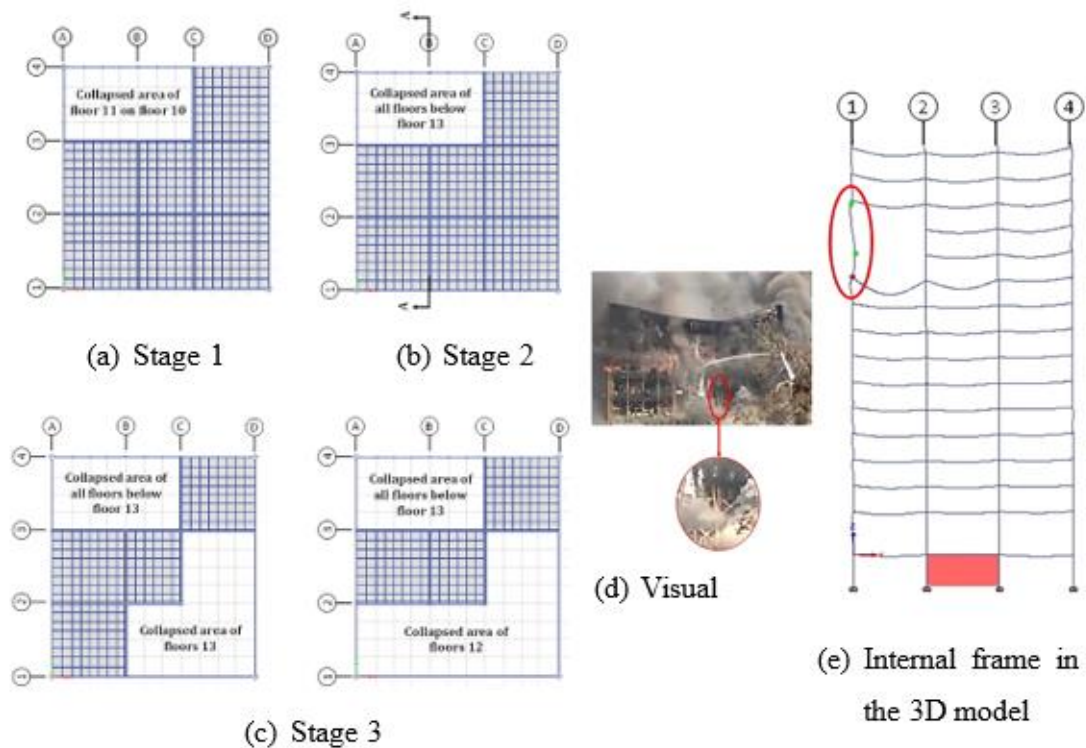
Stage 2 showed the formation of plastic hinges in the columns adjacent to the removed parts. However, the still global collapse was not predicted because of the safe redistribution of loads. Damaged Model Stage 3, the final model with large areas of structure removed, showed the formation of plastic hinges in the perimeter columns on the south and east sides of the structure (Figure 2.10(e)), indicating a collapse pattern similar to what was predicted previously in the 2D OpenSees model.

In conclusion, the authors argue that the connection failure was the reason for the floor collapse in the NW corner and other areas of the building. Due to the loss of floors through partial collapses, the perimeter columns on the NW and SE corners lost lateral bracing support. Since the extent of the flood damage in the NW corner was less than in the SE corner, the columns near the NW did not buckle while the columns on the SE corner buckled, eventually leading to the global failure of the tower. The study, however, relied on unrealistic linearly rising thermal loading.

Figure 2.10 Damages states considered in the ETABS model & response of the external column before the global collapse.

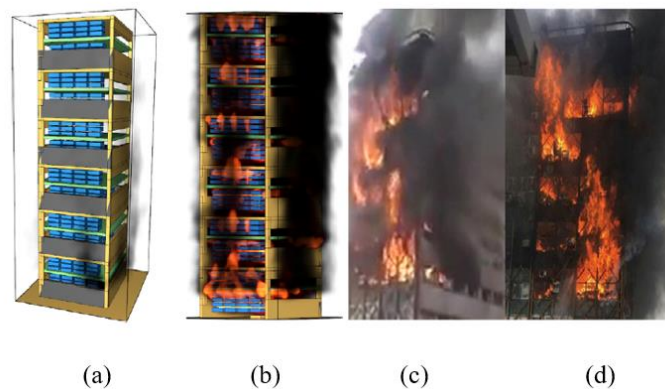
Figure 2.14 (a) CFD model, (b) simulation of the corner fire observed in the initial stages of the incident, (c) & (d) visual evidence from the North and South faces.

In the analysis of Case 1, the vertical fire travel simulation indicated that it took 25-30 minutes for the fire to grow and spread to the other floor vertically; this fire spread simulation fits well with the available video evidence, accident and personal testimonies of onlookers and firefighters. In the simulation of horizontal fire travel, it was assumed that the partitions at the ceiling level failed, thereby facilitating the rapid spread of fire across the floors. To simulate the accurate initial stage fire, the authors have created another 7-floor model representing the Northwest corner of the building. The temperature data from this analysis is used for the structural analysis of the building in the later chapter of the thesis.

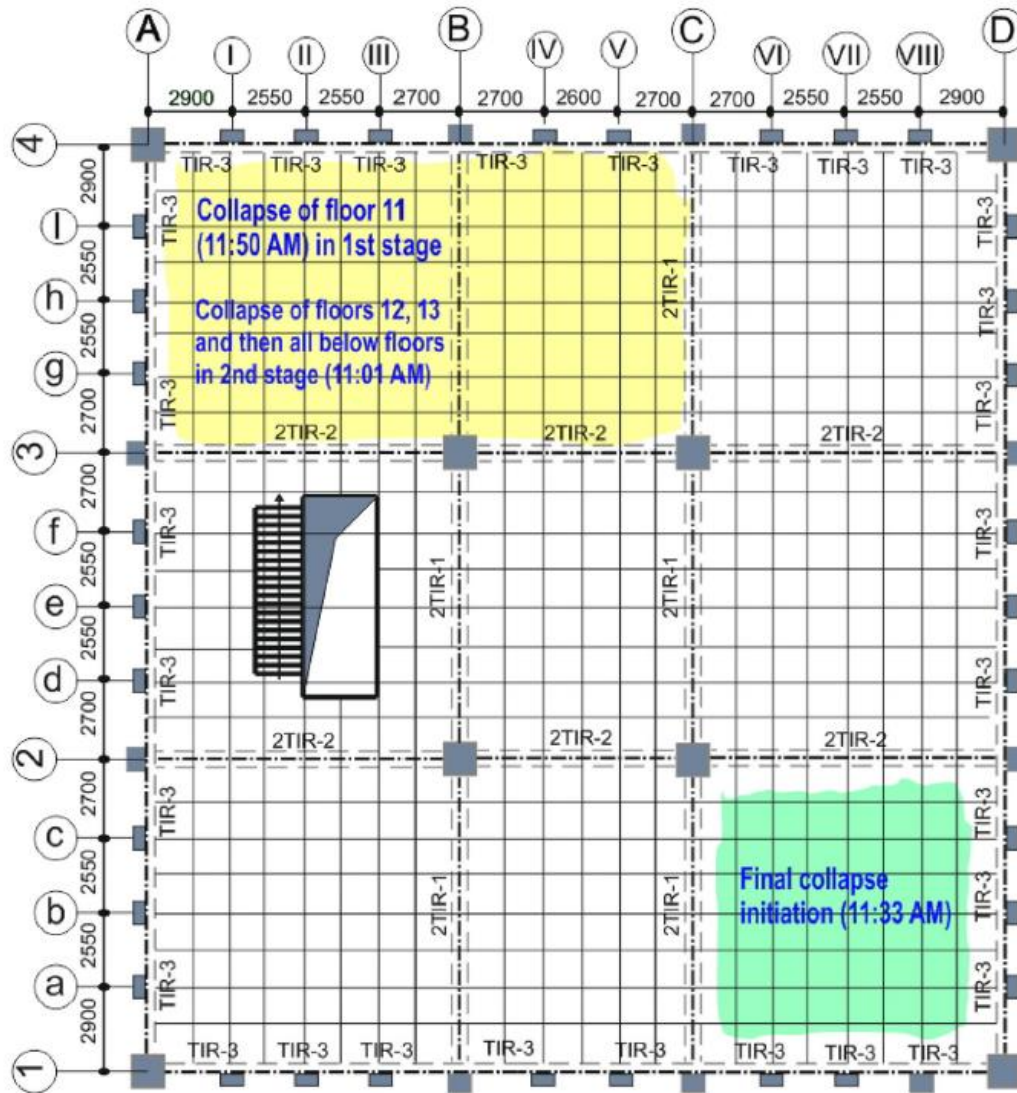
Figure 2.16 The floor plan of the tower indicates the stages of damage on different floors.

Meticulous analysis of the video evidence uncovered that two distinct floor collapses occurred in the Southeast corner of the building within a timeframe of 3 seconds; see Figure 2.16 and Figure 2.18. It was understood that those two collapses occurred on the 12th floor of the 11th floor first, followed by the 13th floor on the 11th. The structure collapsed after this incident.

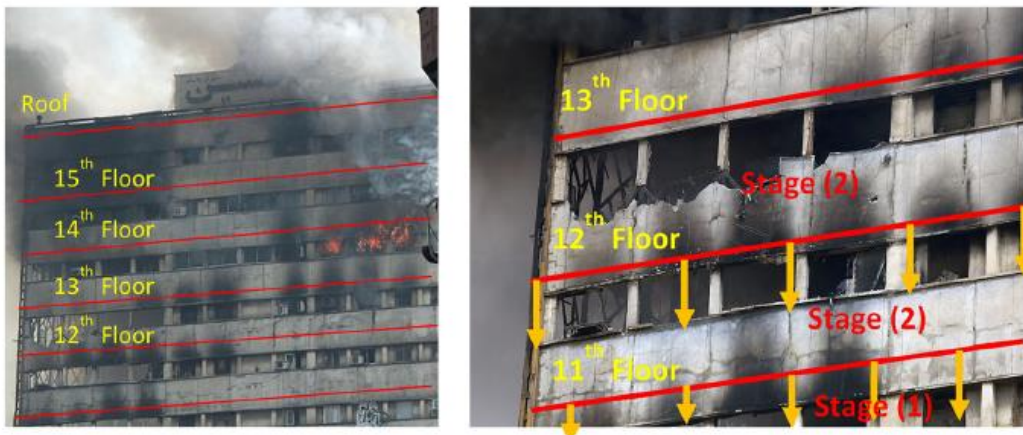
Figure 2.18 Closer view of the West elevation of the building showing the two stages of the partial collapse in the Northwestern corner.

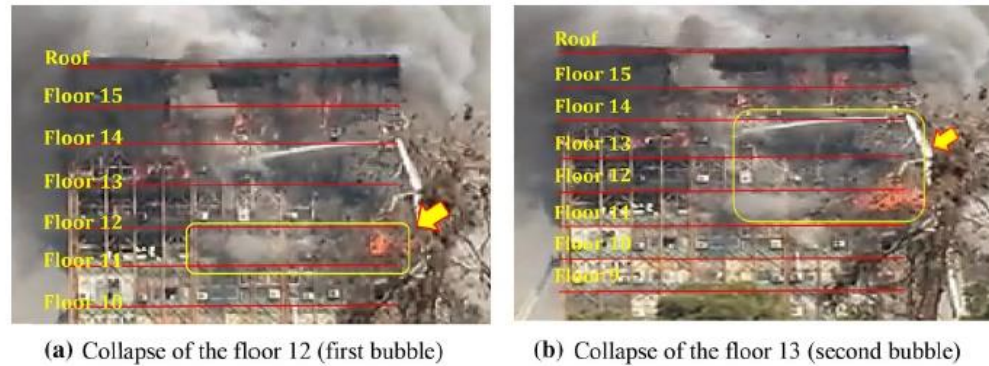
Figure 2.19 Southern elevation of the building moments before the final collapse.

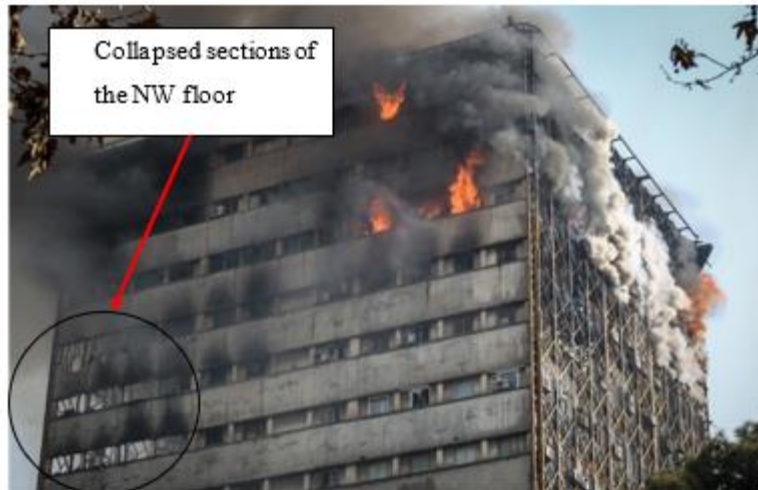
In the case of the Plasco tower incident, the structure withstood the initial structural damage caused by the fire for at least 30 minutes (Behnam (2019) & Ahmadi et al. (2020)). The researcher observed that the connection failure of the floor system in the Northwest corner of the tower caused the failure of the 11th and 12th floors of the tower, in terms of falling freely onto the lower floors. The impact caused by the falling floors caused further damage to the lower floors locally. Nevertheless, the damage did not impact the vertical load-carrying members of the structure, see Figure 3.1. The failure of connections was the main reason for the spread of damage in the structure horizontally. In the Plasco tower, core columns, secondary main columns and primary beams form the major load transfer system of the tower. The four core columns form the vertical spine of the building by carrying nearly half of the total gravity load. The truss, Vierendeel, and edge beams form the secondary load transfer system. The stability and resilience of the structure, even after the multiple floor failures in the NW corner, proves that key structural components of the building were unaffected by the accidental consequence of the NW compartment fire.

Figure 3.1 Photo showing the partially collapsed floors in the NW corner of the tower (West elevation)

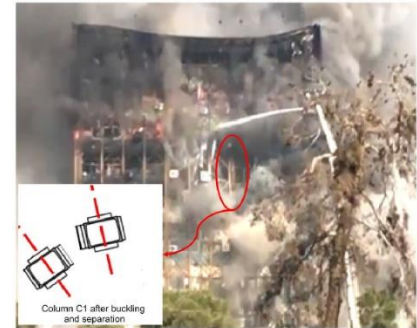
<p>The secondary main column, built using 4xUNP200 sections, was seen rupturing into two pairs of boxed columns moments before the collapse. This may have played a significant role in the collapse but reduced the buckling strength of the column (Ahmadi et al. (2020)).</p>

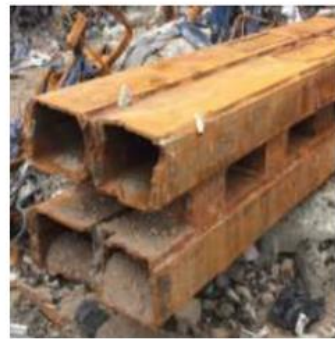
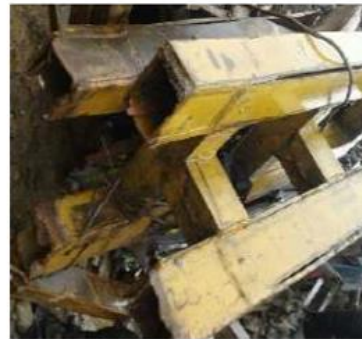
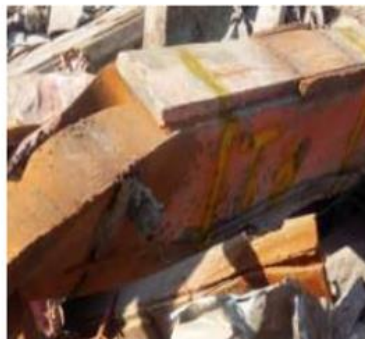
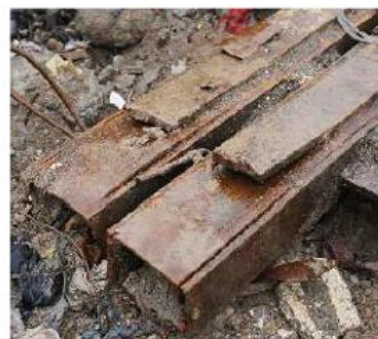
Figure 3.6 Photos of built-up column sections taken after the collapse.

The columns in their study were not fire-protected and were heated over their entire length on all sides. In partially penetrated welded columns, the mode of failure under fire occurred through cracking of welds. The authors hypothesised that a partial weld penetration

could leave a crack-like gap between the connected plates. This thin line of gap was the likely cause for failure at lower thermal loads and temperatures of 500 °C. In addition, in local floor collapses, i.e., in the case of the initial partial collapse of the NW corner, the effective length of the column increases due to the loss of lateral support. In such cases, the load ratio on the column increases significantly because of reduced buckling strength. As steel columns would be under a service load state before being subjected to thermal loads, the magnitude of the service load is a crucial factor affecting the fire performance of steel columns. Therefore, this study calculated the loading on the columns based on the state the Plasco tower was in before the accident. The likelihood of reduced performance of column sections due to aged, welded connections (see Figure 3.6) in the case of the Plasco tower is an important factor, but it is not considered in this study. By not modelling the connections, it is possible to study whether the structure could sustain the applied thermal load irrespective of connection failures.

the calculated values if the effect of welds in the built-up column section is considered. It should be noted that the core column comprised eight sections of UNP 160 type steel members; see Figure 3.6(a). In a real fire scenario, the performance of welding cannot be taken for granted. Due to the lack of data on the welding and age of the structure, the welded sections of the columns are likely to fail at reasonably lower temperatures than properly welded sections/single cold-formed sections of the same strength.

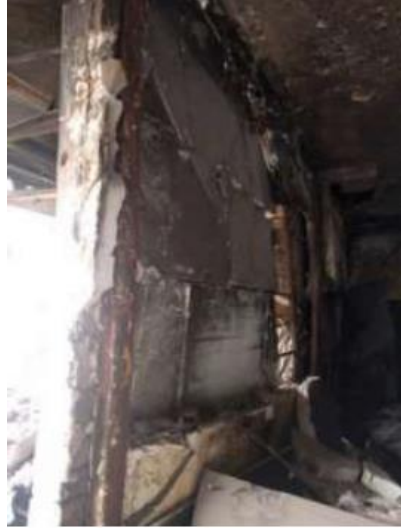
Realistically, between the core columns, there was masonry present till the false ceiling level. This results in a potential exposure of only 400mm length of steel columns to extremely high temperatures. Some evidence shows that only a tiny portion of the wall comprised of masonry was present; the rest of the height was provided with thin partition boards, as seen in the Figure 3.8. If masonry protected a significant portion of columns, then high section temperatures are not likely. However, a considerable length of core columns can be exposed to severe temperatures when masonry walls are destroyed due to collapse debris.

Figure 3.8 Interior view of the surviving 5-storey building beside the Plasco tower.

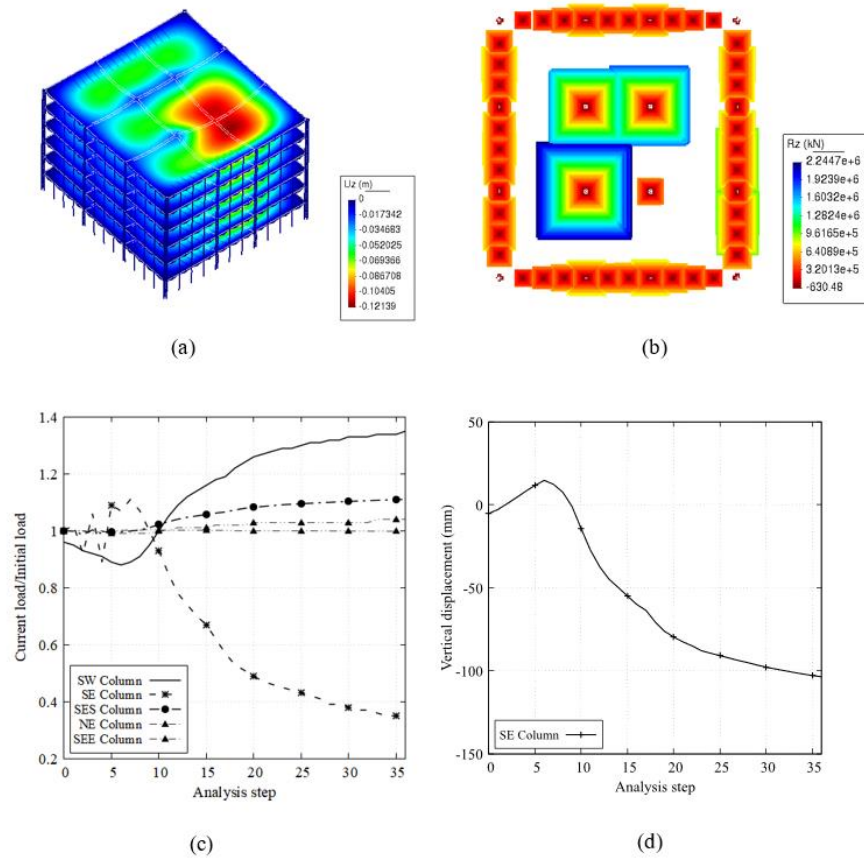
As a result of the failed SE core column, the load on the adjacent columns increased by varying proportions. The adjacent SW core column received a higher redistributed load than the NE core column. It can be seen in Figure 3.9(c) that the SW core column received 35% of the additional load while the NE core column received only 4-5% of the additional load with respect to the loads they were under during the service state. The aspect ratio of the floor segment in the core area can explain this disproportionate distribution of load transfer. In the case of the Plasco tower, the distance between the SE and NE core columns was 10.5m, while the distance between the SE and SW columns was 8m. When a column supporting a square-shaped floor fails, an even redistribution of loads to the neighbouring columns is expected. Similar failures due to uneven load redistribution were observed in the progressive collapse analysis studies of composite steel frames by J. Jiang & Li (2017). The graph depicted in

Figure 3.9(c) shows that the reaction forces in the SE column rise during the initial phase of fire due to restricted thermal expansion. Consequently, the ground reaction in the SW core column decreases by 10% compared to its initial value. However, the reaction forces in the other adjacent columns mostly remain unchanged during this period. At a later stage, once the gas temperatures exceed 550 °C, the ground reaction in the SE core column begins to decrease. The findings indicate that the secondary columns located around the edges did not undergo a noteworthy rise in the ground reaction forces. Hence, in a fire affecting a core column, the outward redistribution of load is nearly even over the columns along the edges, see

Figure 3.9(b). The plot shows that the main secondary columns – SES and SEE received additional redistributed loads of 5-10% of their initial magnitudes.

Figure 3.9 (a) Global response of the structure under localised fire load on the Southeastern core column; (b) contour plot showing the ground reaction forces of columns; (c) evolution of ground reaction forces; and (d) vertical displacement of the SE column.

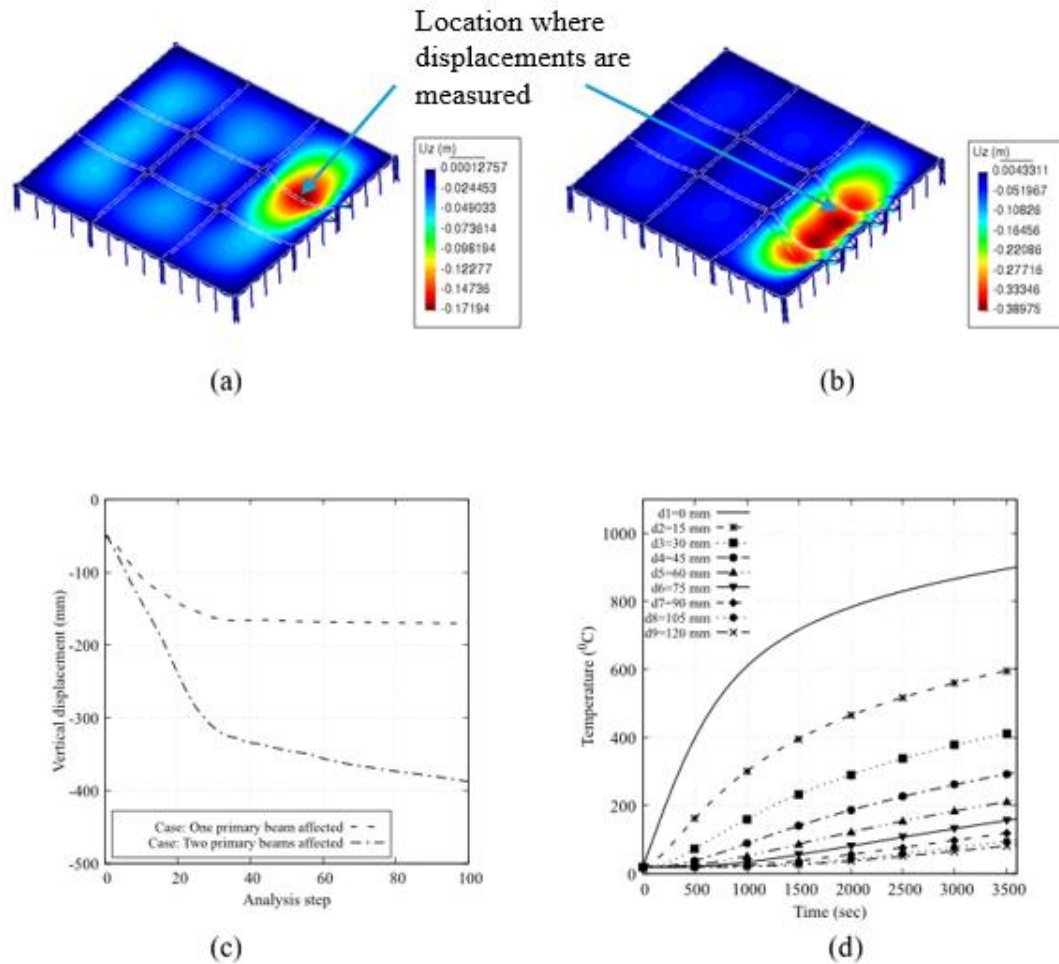
The results from the simulated structural response showed large floor deformations near the Southeastern portion of the floor slab. The importance of the primary beam can be understood from the fact that an intense localised fire near any primary beam can cause displacement closer to 150-200mm in large portions of the floor (Figure 3.12(c)). In the current study, nearly 200 m² of the floor was affected by the localised fire case scenario. Figure 3.12(a)

shows simulation results, which show that displacements in a large portion of the slab are higher than 100mm.

Figure 3.12 Response of the floor when (a) only one primary beam is heated, (b) two primary beams are heated, (c) comparison & (d) slab temperature profile.

The simulation results showed large floor displacements in the region with a maximum value of 340mm, which is nearly thrice the value (Figure 3.12(a)) observed in the previous case, where only a single primary beam (near SE zone) was heated in the same region.

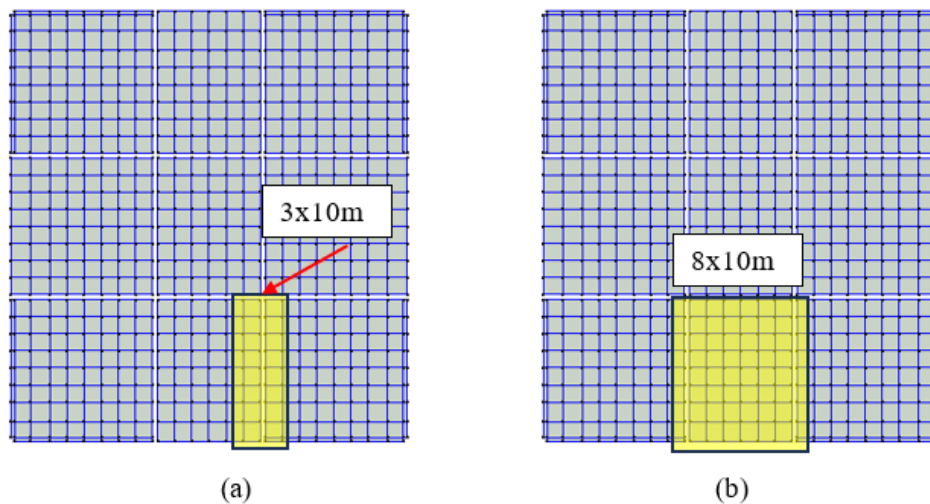
Figure 3.13 Zones in the edge compartment considered for applying the fire load.

If fire affects a portion of the floor such that it involves at least one primary beam, then the adjacent floor segment loses support over the edge along the primary beam. In the study case of fire spread over an area of 8 x 10m zone (Figure 3.13(b)) engulfing two primary beams on the same floor, which was a probable scenario during the Plasco tower fire incident, see Figure 3.14. Then, the floor segments might behave like slabs whose aspect ratio is equivalent to 3. To simulate the response of the floor when two primary beams are affected, both primary

beams near the south side are subjected to thermal load. The results showed large vertical floor displacements in three-floor segments near the south face. The magnitude of displacements when two primary beams are heated (Figure 3.13(b)) is nearly 3 times higher than the case where only a single primary beam (Figure 3.13(a)) was heated. Figure 3.12(c) compares the maximum vertical displacement obtained in both cases. It can be seen in the contour map of Figure 3.12(b) that in the event of two primary beams under severe fire, a one-way single curvature floor deformation is unavoidable.

In such cases, the catenary action of the floor might pull the external columns inwards, leading to a collapse scenario. If the floors collapse due to failure of connections, like in the Northwestern corner of the tower, then a partial collapse can be expected.

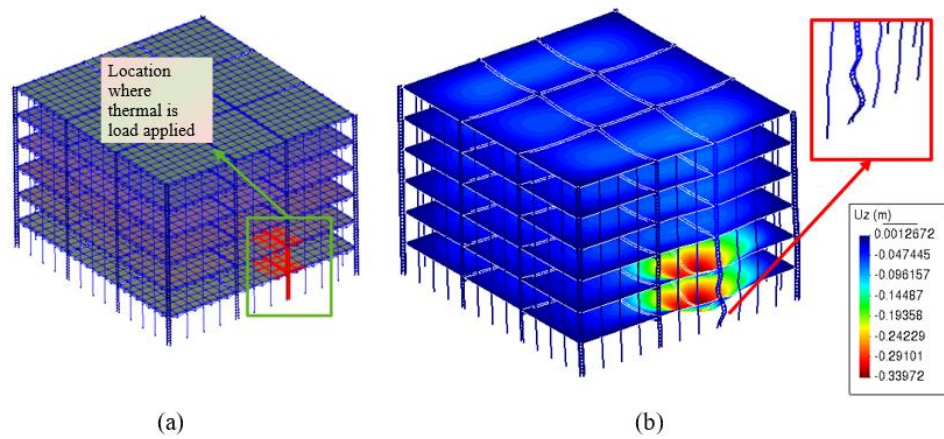
Figure 3.15 Simulation of the tower with primary beams and secondary main columns subjected to fire.

After the core columns and primary beams, secondary columns play an important role in the global stability of the structure. In the final study, a secondary main column of two storeys in height and the connecting primary beams are subject to elevated temperatures. Initially, the study was limited to single-storey, and it was realised that the load shed by the heated columns was successfully redistributed to the adjacent columns. Therefore, the thermal load is extended to two storeys, as seen in the Figure 3.15(a) to study the response of the structure.

The secondary main column buckled at analysis step 23 corresponding to column temperature of 500 °C. At this point, the global stability of the structure was not affected unless connections failed. If connections fail, then progressive collapse of floors can be expected due to the action of dynamic loads. However, if connections sustain temperature-induced forces, then redistribution of loads towards the adjacent columns can be expected.

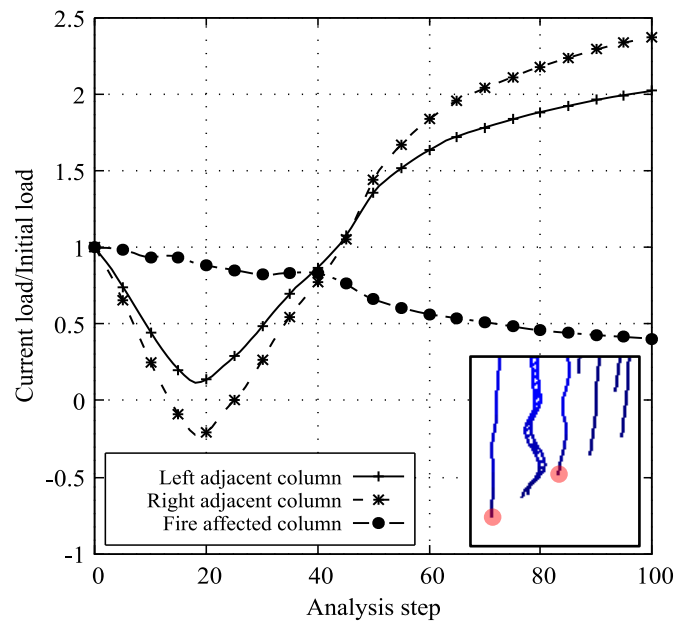
Figure 3.16 Plot showing the increased load due to the load shedding of the fire-affected column.

The plot in Figure 3.16 shows the pattern of load redistribution in the adjacent columns. The x-axis shows the analysis step values, and the y-axis shows the non-dimensional load in the form of $P_{current}/P_{initial}$. The load shedding caused by the heated columns induced an additional load of more than 100% in the adjacent secondary columns. The plot shows that the column reactions in the left and right adjacent columns increased by a factor of 2.0 and 2.37, respectively.

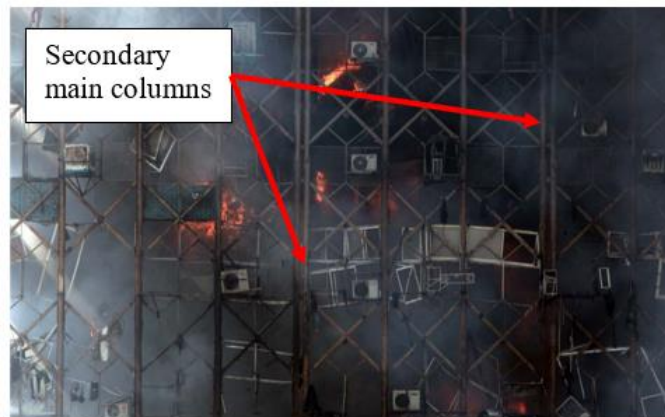
Figure 3.17 Photo showing the Northern elevation of the tower under a fully grown fire over multiple floor levels.

In a different scenario representing the fire condition, as shown in Figure 3.17, the fire load was applied across multiple floors, impacting the compartments at the edges. Temperature load was not applied to the edge beams as masonry was present along the periphery. As anticipated, the simulation outcome from this analysis showed significant displacement in the slabs of all three-floor segments. Figure 3.18(a) shows the buckled secondary main columns and the secondary columns across multiple floors. These failed columns account for not more than 10% of the total gravity load of the structure. The deformation observed is of a magnitude of 520mm in the centre of the edge bay floor slab segment; see Figure 3.18. In reality, catenary deformations exert substantial forces on the connections, increasing the likelihood of partial floor collapse. It should be noted that connections were not modelled as the focus of the study was to look for the load redistribution patterns and collapse mechanisms that can lead to global or partial floor collapses. The load shed by the buckled columns was transferred to the other secondary columns on the same plane as the edge frame. It can be seen in Figure 3.18(b) that the contour plot shows the thickness of line elements proportioned to the axial forces the columns are experiencing. The ground reactions of the secondary columns adjacent to the buckled secondary main columns are 2.72 times their initial value. Therefore, there is a possibility of a progressive collapse of the columns in the periphery where load shedding and load redistribution happen along the edge, leading to an inward collapse of the structure. Or suppose lateral propagation of failure of buckling did not take place. In that case, the structure will achieve a temporary stable condition where edge beams and corner columns resist the inward pull forces caused by the catenary action of trusses, as depicted in Figure 3.19. The overloaded adjacent columns did not show buckling as lateral support was present from colder parts of the structure. In a real scenario, under partial collapse, a lack of lateral support for the columns can be detrimental to the stability of the structure.

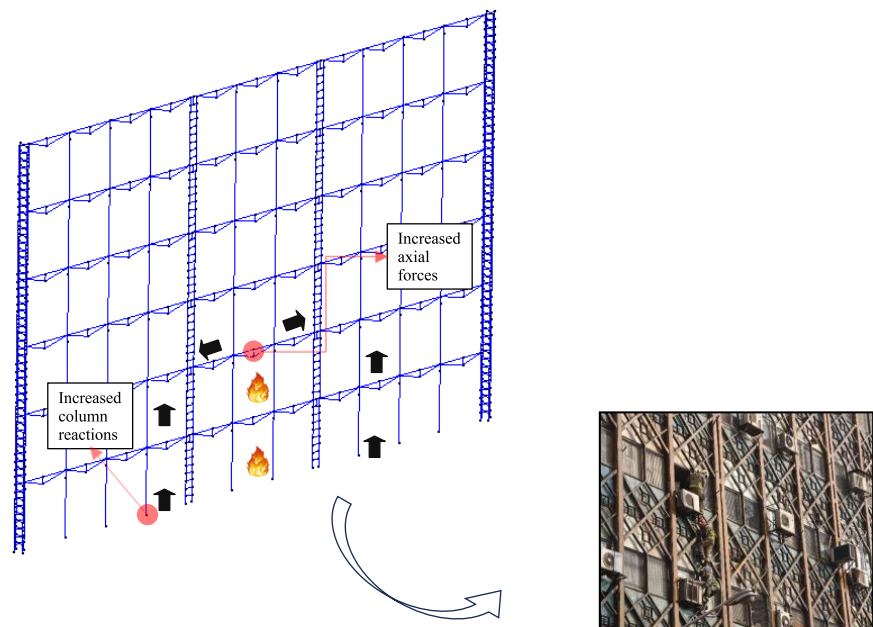
Figure 3.19 Load redistribution in the edge frame due to the fire in multiple edge compartments.

structural elements in the western and southwestern (SW) regions of the building, as depicted in Figure 7.21. Load redistribution before the global collapse was successful because of the intact peripheral beam. Stability mechanism during this phase is akin to what was described in section 3.5.3, refer to Figure 3.19.

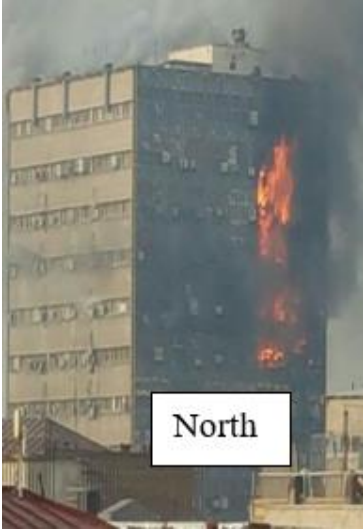
<p>The fire was visible on the 10th and the floors above near the northwest side.</p>

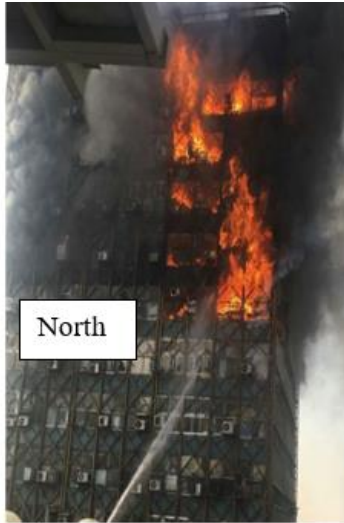
8:25 AM - 9:40 AM	5	<p>The fire was growing at the 10th, 11th, and upper floors. One hour elapsed with fire on 10th and 11th floors.</p>
9:40 AM – 10:00 AM	6	<p>Temporary fire suppression on the 10th and 11th floors in the northwestern corner.</p>

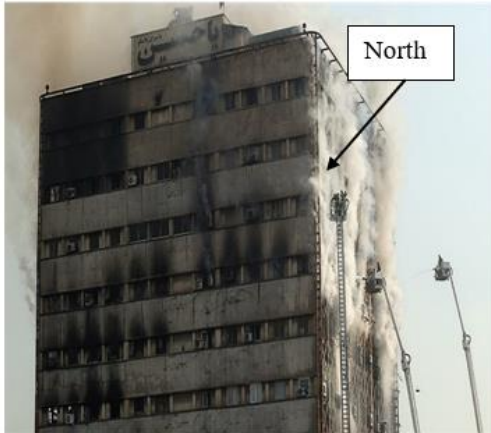
10:00AM – 10:50 AM	7	<p>Re-ignition of fire in the areas where it was suppressed. Fire observed in the western and eastern side of the building on the 12th and above floors.</p>

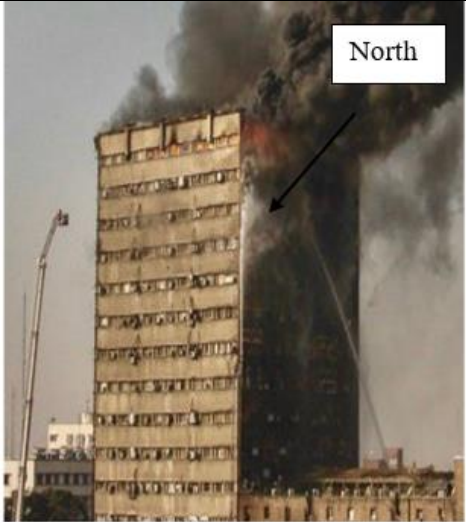
Collapse events		
10:50 AM – 11:02 AM	8 (First partial collapse)	A notable section of the 11th floor collapsed onto the 10th floor on the northern side of the building. The fire extended up to the 15th floor and spread across multiple floors on the southern side of the tower.
11:02 AM – 11:32 AM	9 (Second partial collapse)	Nearly all the floors below the 13th on the northern side experienced collapse. The fire expanded in two directions, advancing towards the southwest and southeast, eventually meeting at the southeast corner.

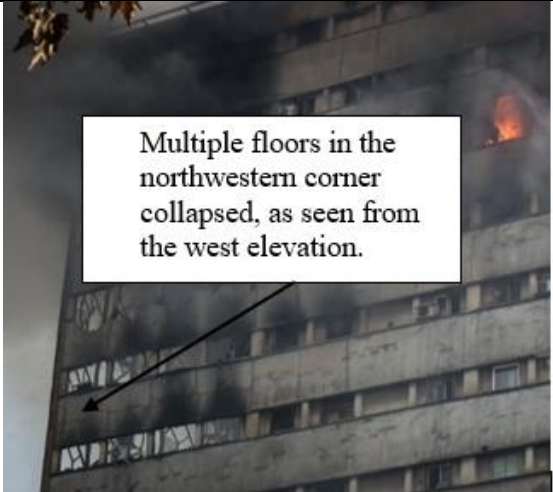
<p>Multiple floors in the northwestern corner collapsed, as seen from the west elevation.</p>
11:33 AM – 10:35 AM	Event 10 (Global collapse)	<p>Intense heat was produced at the southeast corner of the building, where the onset of the global collapse originated.</p>

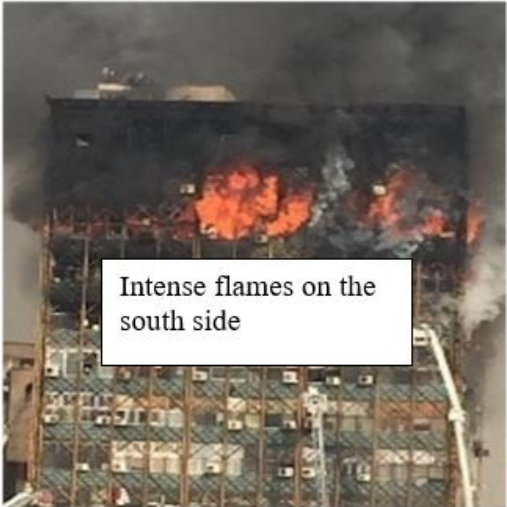
<p>Intense flames on the south side</p>

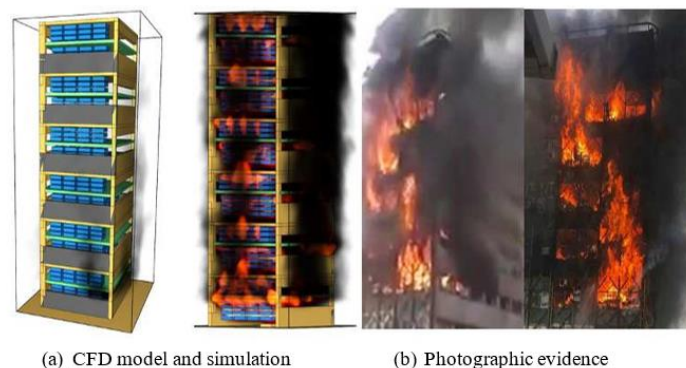
Figure 4.6 CFD model simulating vertical fire travel in the northwestern corner of the tower.

A CFD simulation was conducted to confirm the fire propagation through openings to the upper levels. Specifically, the simulation focused on the northwest corner of the Plasco Building from the 10th to the 15th floors, a scenario that aligns with photographic evidence of the fire accident in the building (refer to Figure 4.6). This simulation was designed to simulate

As shown in the Figure 4.6, following the ignition on the 10th floor, the fire reached the upper levels during the initial phases. The false ceiling allowed for open airflow, and the window coverings consisted only of basic wire mesh on the north and south sides of the building. The availability of ample air supply facilitated a rapid escalation of the fire, leading to the substantial release of heat and high temperatures (see Figure 4.7), thereby aiding its progression to the upper stories.

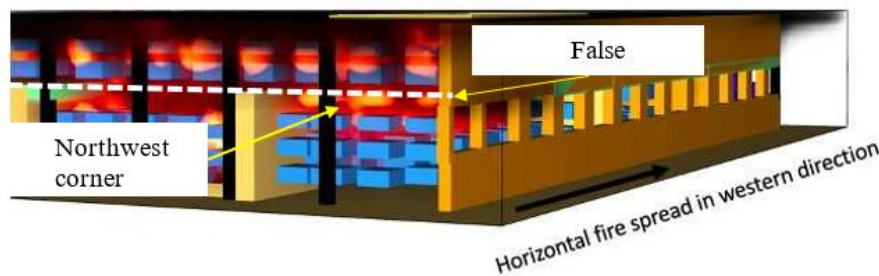
Figure 4.8 CFD simulation showing the horizontal fire spread (Khan (2022a)).

Subsequently, the fire breached into the adjacent compartment located at the north-western corner once the false ceiling was removed, hence failure of the false ceiling is pertinent to the horizontal fire spread, see Figure 4.8. Upon reaching the neighbouring compartment, the fire progressed along the western side of the structure, intensifying in size. Notably, firefighting

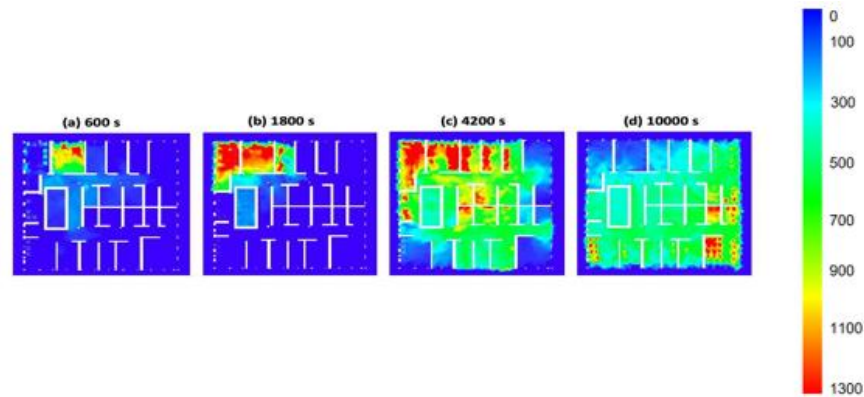
Figure 4.9 Temperature contours of the simulated 13th floor (Khan (2022a)).

During the calibration of the 13th-floor fire scenario, fuel was spread throughout the floor, except in the northeastern region, which showed no fire or smoke. The placement and quantity of fuel in the model were changed to reflect the observed fire spread closely. Images from the simulation and the actual fire incident show that the fire intensified dramatically when it reached the southeastern corner of the 13th floor. The significant heat created was caused by the convergence of fires from the building's eastern and southern sides.

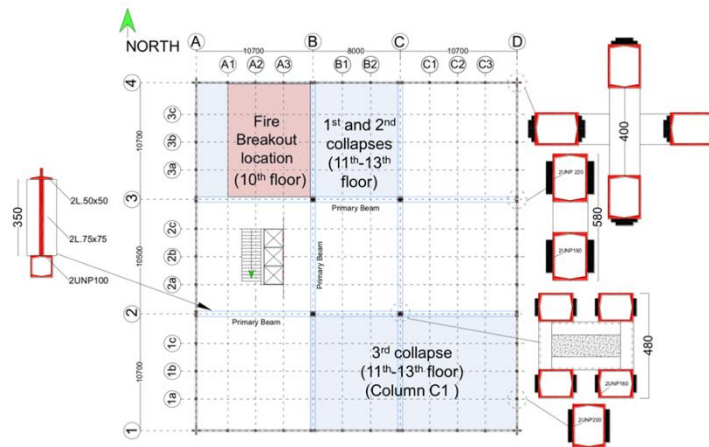
Figure 5.9 The layout of the Plasco tower and areas of collapse (Shakib et al. (2020))

The schematic of the Plasco tower is depicted in Figure 5.9. The structural system consisted of four columns in the core supporting the loads transmitted by the primary beams, supported by built-up box columns along the perimeter. All steel sections were fabricated using standard European channel or angle profiles without any applied fire protection. In the FE model, the beams were modelled using OpenSEES fibre-based sections and displacement-based beam-column elements, while concrete slabs were represented using shell elements. The material properties of the steel were derived from tests conducted on samples obtained from the collapsed structural components (Govt. of Iran (2017) and Shakib et al. (2020)).

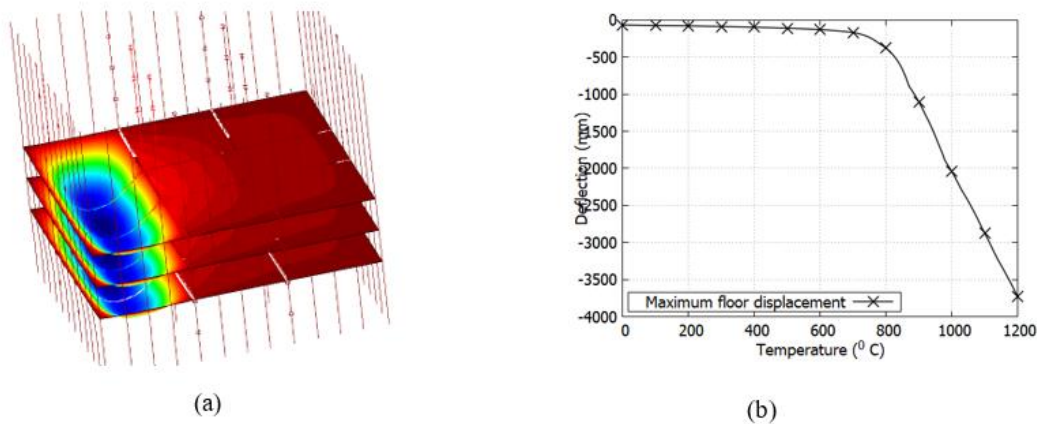
Figure 5.12 (a) Response of the three heated floors; (b) Plot showing maximum floor displacement against steel truss temperature.

The preliminary analysis conducted showed that the corner floor slabs deformed in a partial 2-way bending moment, whereas the edge slab experienced one-way bending action, as seen in Figure 5.12–(a). Large floor displacements of order 350mm are observed; see Figure 5.12 –(b). The deformation rate started increasing after steel temperatures reached 500 °C, and a rapid rate of downward displacements was noticed after 660 °C. The temperatures shown in the plot represent steel truss temperatures. It was observed that the temperature at the bottom face of the concrete is 530 °C when steel truss members are around 660 °C.

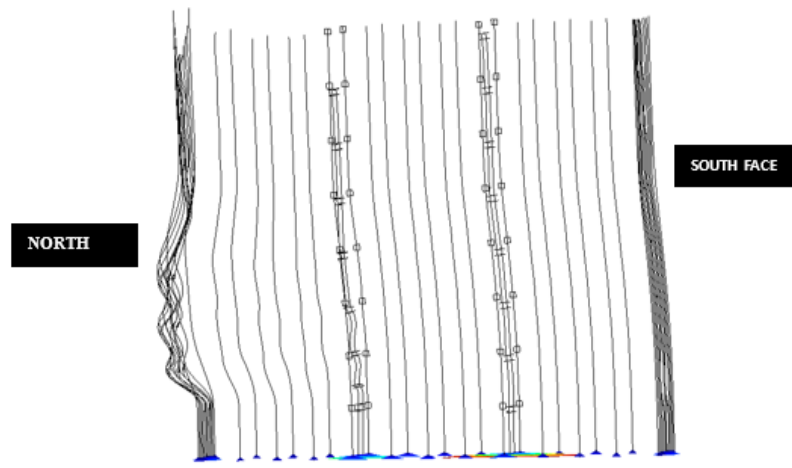
Figure 5.13 Global column response with the North face on the left side and the South face on the right (shown at exaggerated scale for clarity).

The global response of the perimeter columns near the north face at the end of thermo-mechanical analysis can be seen in Figure 5.13, where the floor system is hidden for clarity. The top nodes of the central core columns can be seen at a lower position than the edge and corner columns. This differential vertical column displacement indicates redistribution of the load towards the edge columns. The load carried by the core columns, up to that point, is redistributed to edge columns present on the East and West sides of the tower. This caused a sideways displacement of the building globally.

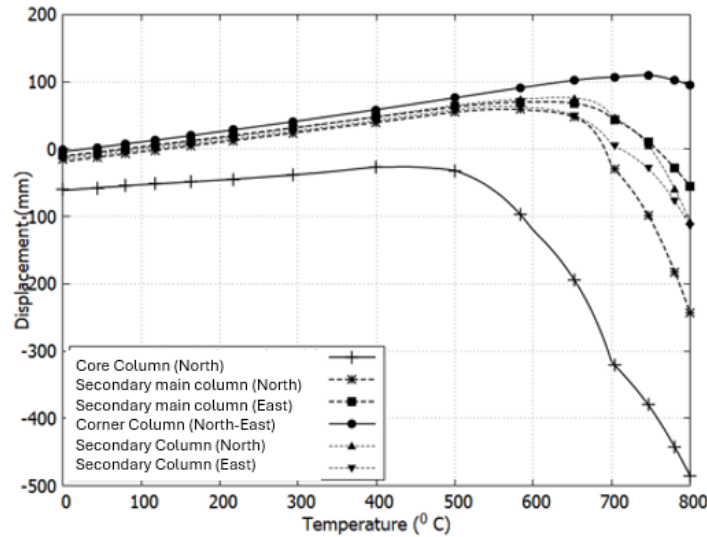
Figure 5.14 The plot shows the vertical displacements in all types of columns.

Figure 5.14 Highlights the vertical displacements of all columns on the northeast corner of the tower that are involved in the fire load. This explains how dependent the global stability of the tower is on the core columns. The likelihood of two core columns reaching critical temperatures cannot be ruled out entirely based on the fire travel pattern observed on the 13th floor. In the coming section, a single-floor model of the structure is subjected to the CFD-based temperature time loading to explore the other possible scenarios that could cause global collapse.

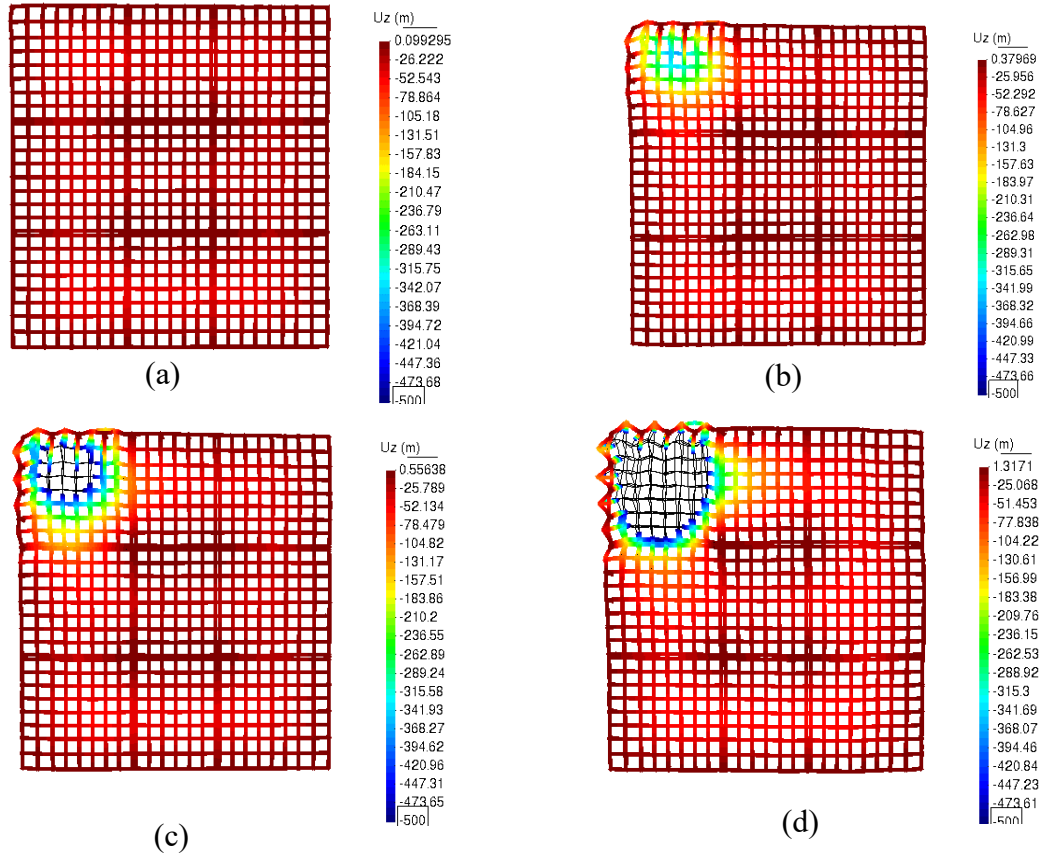
It is known that the fire broke out in the Northwest corner of the Plasco tower on the 10th floor (Ahmadi et al. (2020)). The fire was initially concentrated in the NW corner within the boundaries of two primary beams running in both directions. Still, it had spread rapidly to multiple floors in the vertical direction. By the time the tower collapsed, the fire had engulfed 6 tower floors in the NW corner. The analysis results based on the NW corner of the 13th floor predicted large deformations higher than 500mm over a large section. The following Figure 5.22 This shows the area of deformations greater than 500mm (the region outside the contour limits) at different time steps.

Figure 5.22 The plot shows the areas of large deformations beyond 500 mm at different stages of fire progression in the NW corner in Stage -1 (the areas outside the contour colour limits).
