**MULTIDISCIPLINARY FORENSIC
INVESTIGATION OF BUILDINGS IN FIRE: THE
CASE OF THE PLASCO TOWER**

Multidisciplinary Forensic Investigation of Buildings in Fire: The Case of the Plasco
Tower

A thesis submitted in partial fulfilment of the requirements for the degree of
Doctor of Philosophy
Aug 2024

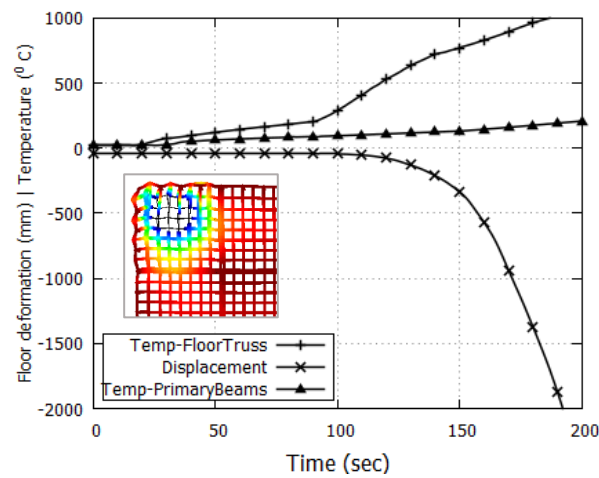
The steel temperatures in the centre of the NW corner remain within 200 °C up to 15 minutes, and after 10 minutes, temperatures rapidly increase to 800 °C, as shown in the Figure 5.23. It should be noted that setting up equipment for external firefighting took nearly 20 minutes after the arrival time. The rapid rise of steel temperatures caused a significant increase in floor deformations in a short time. Floor deformations increased to 360 mm from 50mm within a short duration, see Figure 5.23. Relatively, the temperatures near the Primary beam locations increased slowly. The NW corner is where the first local damage occurred, as firefighters reported. The temperatures in critical members like primary beams were around 150 °C, while temperatures in secondary trusses in the middle of the NW corner crossed 800 °C. This significant temperature difference would have exerted immense force on the floor–beam connections in the area.

Figure 5.23 The plot shows the floor deformations at the centre of the corner and temperatures in an FE element in the floor area, and the midpoint of primary beams. The positive

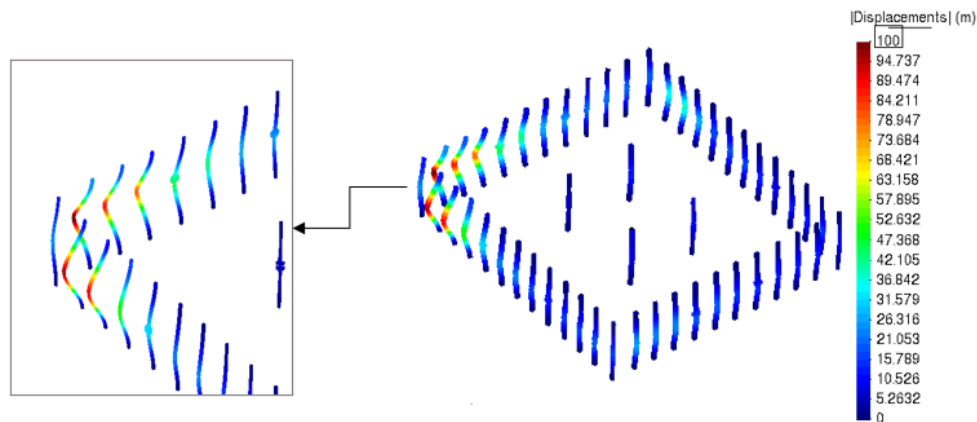
Thermo-mechanical analysis indicated that, under thermal expansion of the floor system, the thinner perimeter columns are pushed farther than the main perimeter columns. Each face of the tower has two main columns supporting the primary beams. Lateral displacement under a thermal expansion of the floor truss beams can be visualised (the deformation scale is increased for clarity), as seen in Figure 5.24.

Figure 5.24 Lateral column displacement in NW corner (Floor system is hidden for clarity).

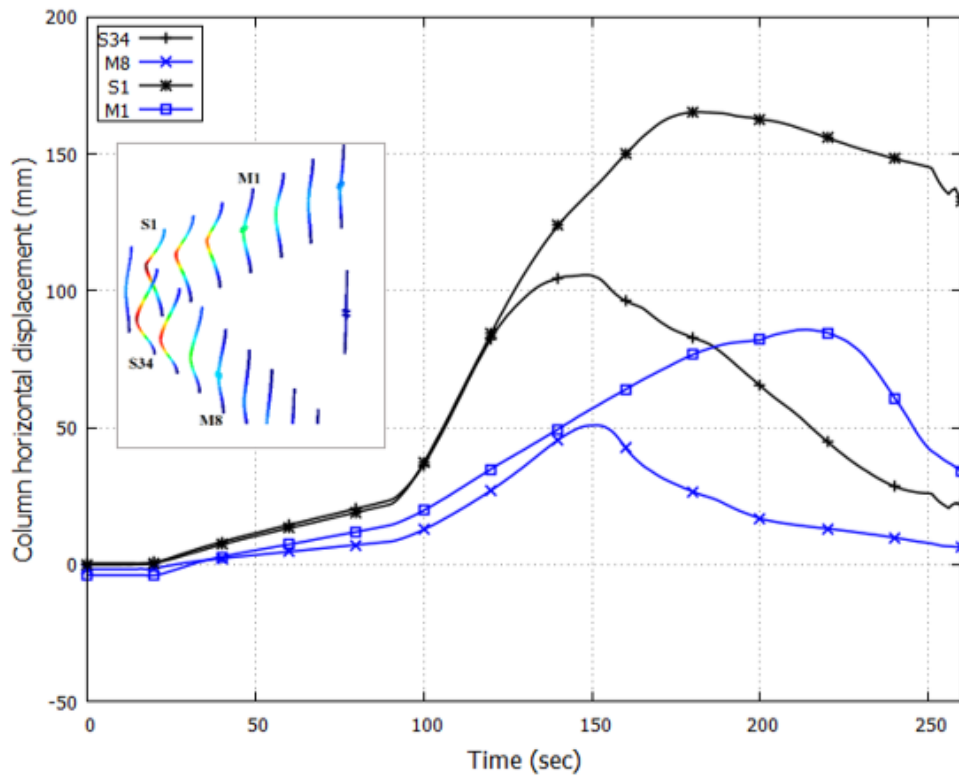
Figure 5.25 Lateral displacement of columns in the corner.

The main perimeter beams are denoted by M1 and M8, whereas secondary perimeter beams are denoted by S1 and S34. M1 and S1 exist on the West side of the corner, whereas M8 and S34 are on the North. The plot in Figure 5.25 shows that the maximum relative lateral displacement between the columns could go as large as 100mm. Other than strength and stiffness reasons, this variation in lateral displacement can be attributed to the variation in floor temperatures and the difference in inner and outer face temperatures of thick and thinner columns. These complex built-in section columns have been idealised using available block element classes in the HT module of the OpenSEES for fire. The temperature differences on both faces can be noticed in the plot of time-temperature histories of a selected FE element; see Figure 5.26. Elements at the top of the column have higher temperatures with higher gradients, whereas elements at lower levels have temperatures of 300-400 °C with lower gradients. As temperature variations along the length and across the depth at multiple levels are considered, it is not possible to show temperature plots at member levels. Hence, the plots below indicate a

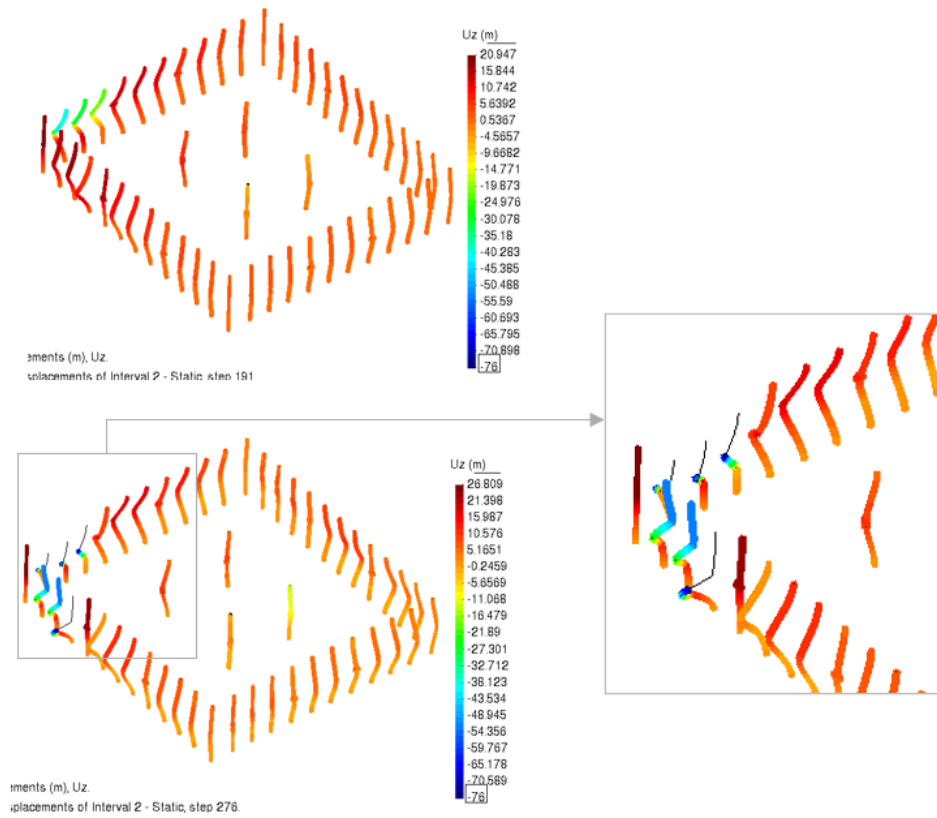
The thinner columns, which were displaced laterally because of the floor, experienced larger lateral deformation under gravity loads; see Figure 5.27. But since each secondary column (S1, S2, S3, S32, S33 and S34) bears around 0.5-1% of the total gravity load, they cannot cause global failure of the structural system even if those columns buckle.

Figure 5.27 Vertical column displacements at different stages.

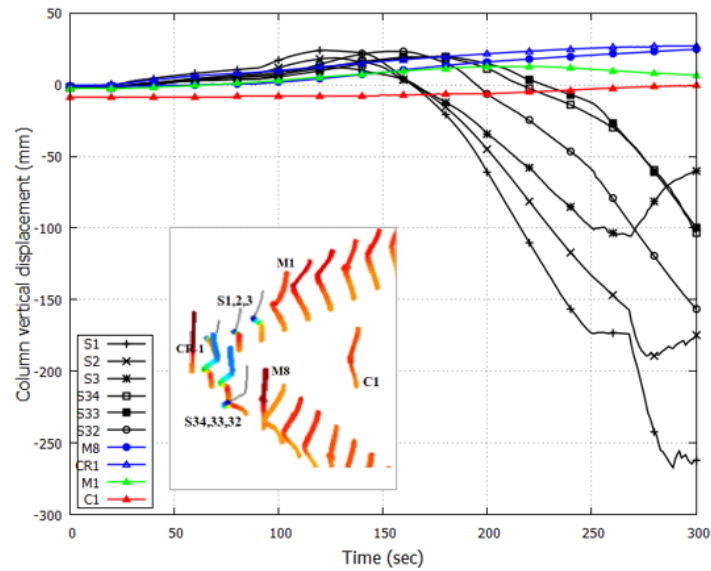
It can be seen from the Figure 5.28 that the stiff corner and core columns underwent maximum vertical elongations of order 25-35mm; in contrast, secondary columns (denoted with the prefix S) underwent a maximum of 20mm axial expansion earlier than the stiffer columns. Still, they experienced a quick reversal as deformations started in the downward direction. Both horizontal displacement and vertical thermal elongations showed a significant variation in the behaviour of secondary perimeter columns with respect to other stiffer columns at four corners (C1, M1, M8 and CR1) of the structure. The loss of strength of secondary columns would eventually not significantly affect the stability of the structure, even locally. However, it is reasonable to believe that significant displacement variations in both horizontal and vertical directions would have weakened the steel connection in the NW corner, thus causing a local structural failure.

Figure 5.28 Vertical column displacements in the NW corner

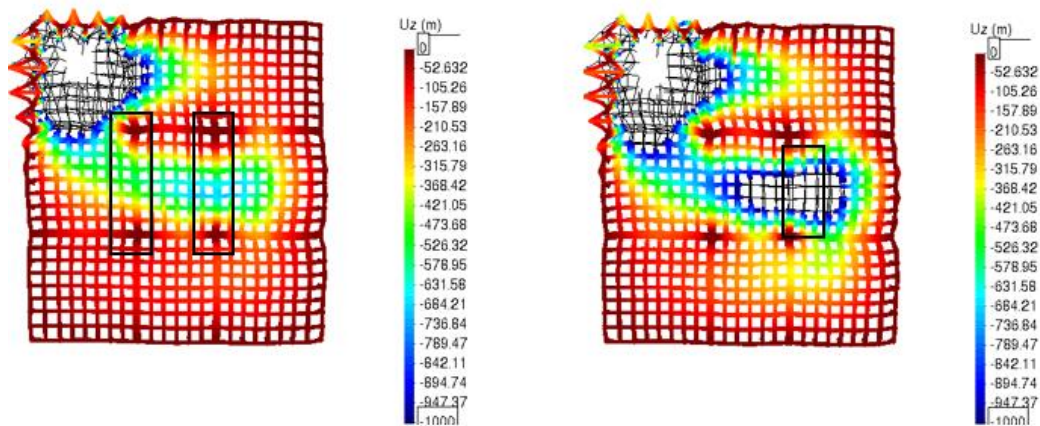
From the NW corner of the building, the fire travelled towards the core and the eastern edge of the floor, as shown in the Figure 5.29. The first leg of the fire travelled progressed towards the East (horizontal direction in the image) and towards the core. According to the floor plans, there was a staircase opening /floor entry point on the western side of the building, which would have allowed the second leg of fire to travel towards the core. They travelled fire subjected both the primary beams running in North-South directions in the core to deform greatly, marked in the Figure 5.29(a). It has been established already that the primary beams of the floor, being a part of the primary load transfer components, are major strength providers. The primary beams are also responsible for holding all load-carrying columns together. Hence, the progression of fire in the core of the building can be seen as a moment after which the global stability of the floor began to be compromised.

The fire intensified near one of the primary beams connecting the core columns towards the Eastern side, as indicated in Figure 5.29 –(b). The core columns and primary beams are critical components of the tower, and their failure ensures the failure of the structure, at least locally. The load redistribution mechanism in the case of critical member failure is not considered at the design stage. Therefore, a potential primary beam failure in the core or core column buckling could potentially lead to the progressive collapse of the structure.

Figure 5.29 The contour plot shows the areas of large deformations beyond 1000 mm at different stages of fire progression in Stage 2.

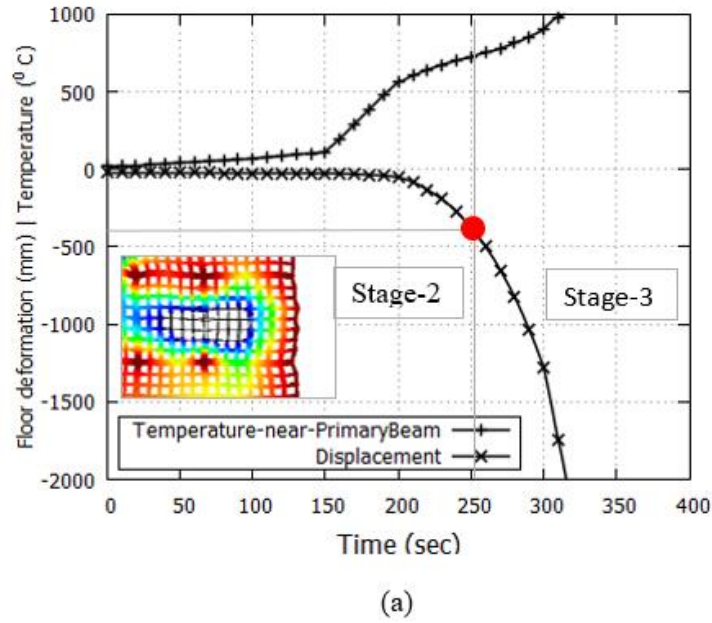
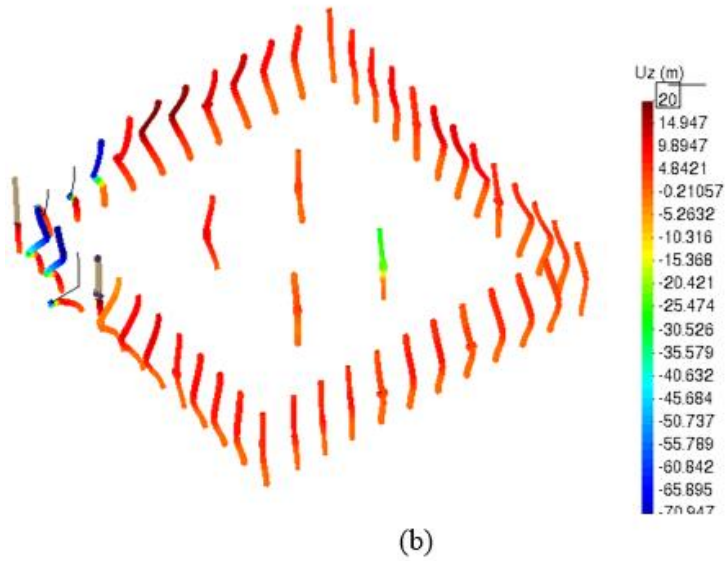
The firefighters extinguished the fire in the NW corner and began re-positioning themselves to fight on the East and South faces. Despite their efforts, the fire inside the eastern part of the building's core started making its way towards the South face. The fire surrounded the regions where the South-East core column was situated. Simulation results showed that deformations up to 500mm in the eastern part of the core and primary beam, see Figure 5.30 – (a).

Figure 5.30 (a) Primary beam deformation vs temperature core area; (b) Vertical column displacement in Stage 2.

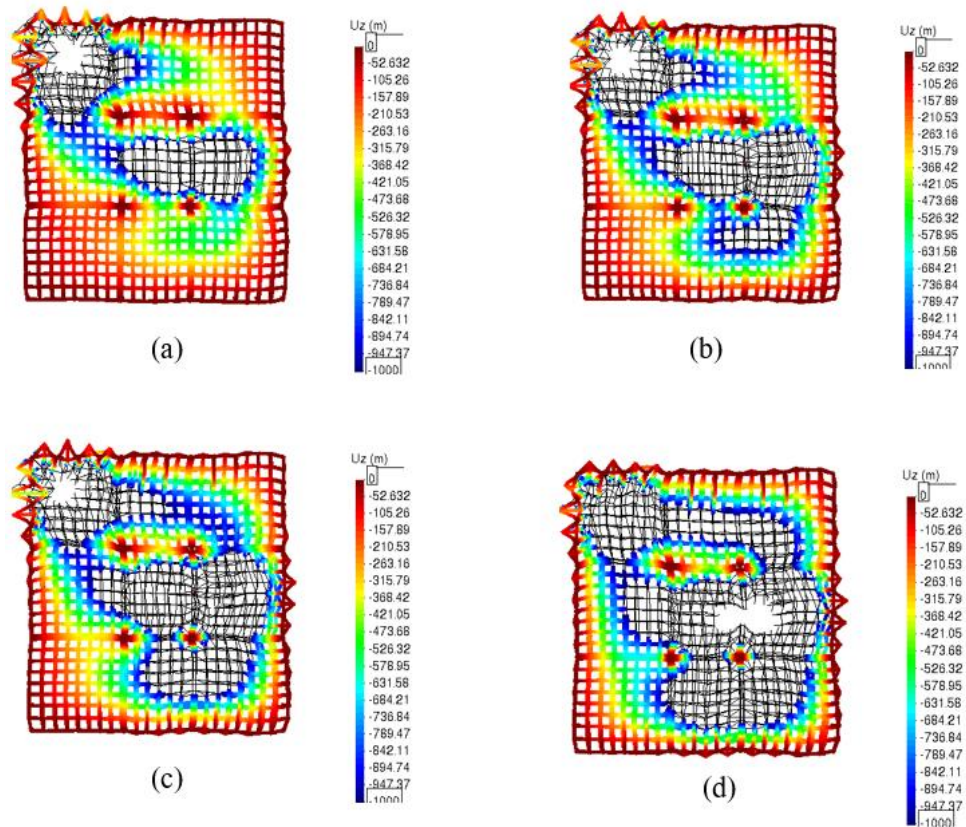
After affecting the core area and the adjoining eastern region, the fire progressed towards the southern part of the floor, as seen in the Figure 5.31. The simulation results showed zones of large deformations beyond 1000mm, as indicated by uncoloured areas. The extent of such high deformation is seen all over the floor model, particularly in the South and surrounding

areas where the Southeast core column was situated. In a real-world scenario, the extent of fire damage could be lesser due to the physical obstructions. It should be noted that the simulation results reflect the response of the tower with the complete failure of the obstruction provided by the false ceiling.

Figure 5.31 The plot shows the areas of large deformations beyond 1000 mm at different stages of fire progression in Stage 3.

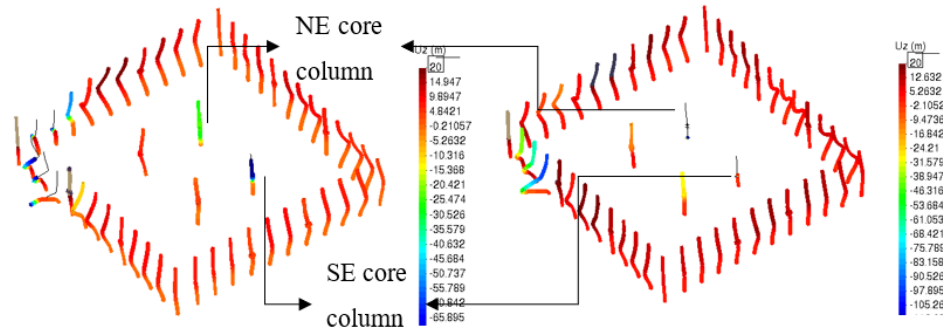
core column had the presence of a colder floor area on the western side, whereas the NE core had none. Hence, even a smaller load redistribution might be detrimental to the safety of the column. It can be seen in Figure 5.32 that the NE core column experienced 25mm downward displacement, while the SE core column experienced 66mm. The failing SE core column and primary beam near it created destabilising effects on the NE core column.

Figure 5.32 Response of SE and NE core columns on the 13th floor before and after SE core column failure.

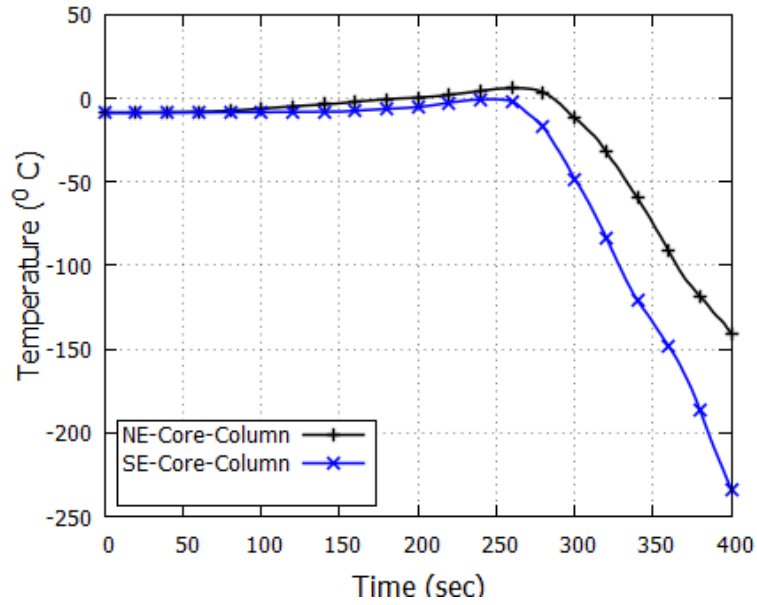
The thermomechanical analysis progressed further, and the simulation showed an equally higher magnitude vertical column displacement in the NE core column, see Figure 5.32 and Figure 5.33. The contour shows that vertical deformations of the columns are more than $0.03H$, whereas $0.01H$ (H is the height of the column) is generally considered as failure compression displacement in the case of fire resistance tests on columns.

Figure 5.33 Vertical displacement of both the core columns

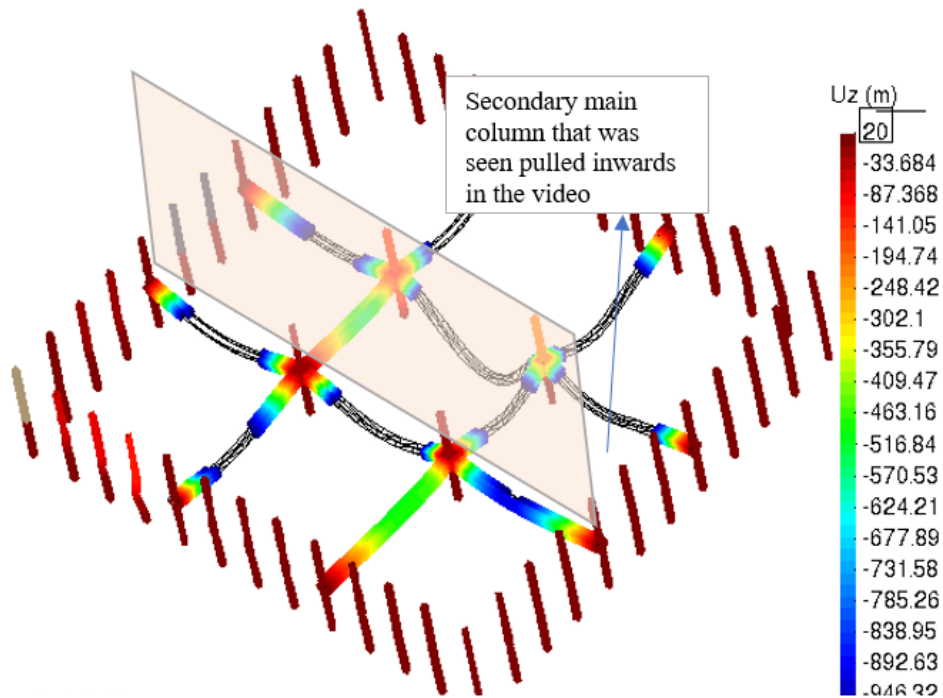
Figure 5.34 Frame of collapse initiation

The analysis concludes that the failure of the core column on the 13th floor could be a potential reason which triggered the collapse of the Plasco tower. Large downward displacements of the SE pulled the primary beam, which in turn exerted pull forces on the external secondary main column. The primary beam running in North-South directions

connecting the SE corner core column is seen undergoing catenary action, see Figure 5.34. This would exert a horizontal pull on the main perimeter column connecting to it, or even an impact force from the partially collapsing debris from the above floor will have a similar effect. Video evidence, as shown in Figure 5.35, captured the initiation of the collapse from this perimeter column, which aligns with the predicted response of the 13th floor of the tower.

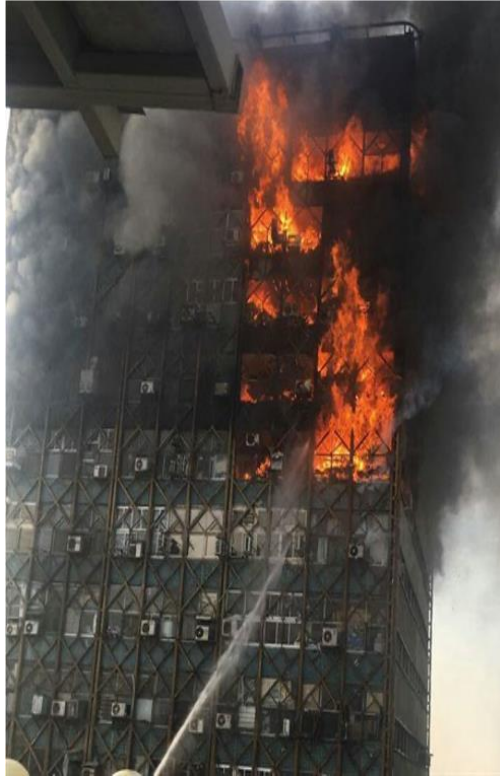
Figure 6.1 Photograph showing the NW corner of the Plasco tower engulfed in flames, spreading across multiple floors.

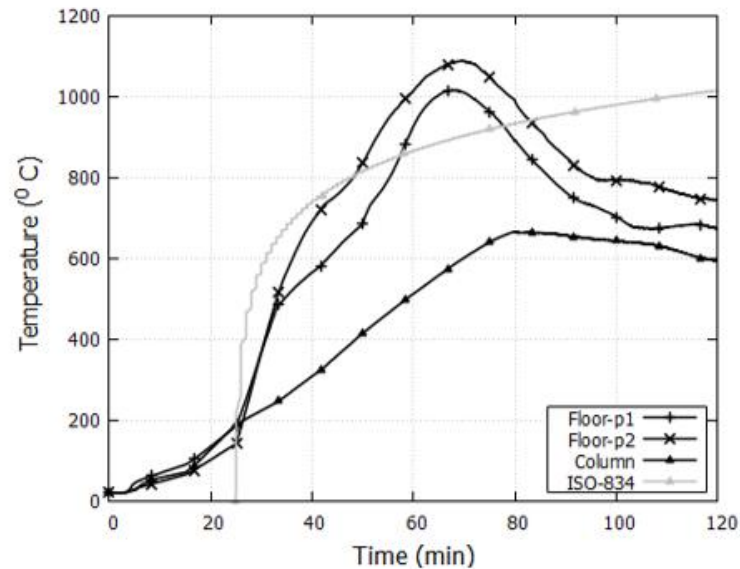
Figure 6.6 Gas temperatures at different locations; p1, p2 correspond to centre and edge locations on the corner area of the 11th floor.

Figure 6.6 shows the plot of the gas temperatures at locations on the 11th floor (ceiling of 10th floor) and the column. The magnitudes of temperatures are around 110 °C for the first 20 minutes of the fire, and after 25 minutes, the fuel burning rate increased enormously, resulting in a sudden increase in temperatures. The temperatures crossed 500 °C after 33 minutes and 1000 °C after 60 minutes of fire. For comparison, the standard ISO 834 curve is plotted (in grey colour) on the same plot with gas temperatures obtained from the CFD analysis. The standard ISO curve is shifted 25 minutes on the time axis for easy understanding. The temperature values on the ISO curve rise rapidly until 600 °C and then gradually until 800 °C, and then a much slower rise beyond that point. This difference in temperature rise shows how differently fires grow in real-life fires. According to the CFD model, peak temperatures are observed about an hour after fire initiation despite the slower rise in the beginning. For comparison, temperatures of 1000 °C or more are seen after 90 minutes in the ISO standard fire.

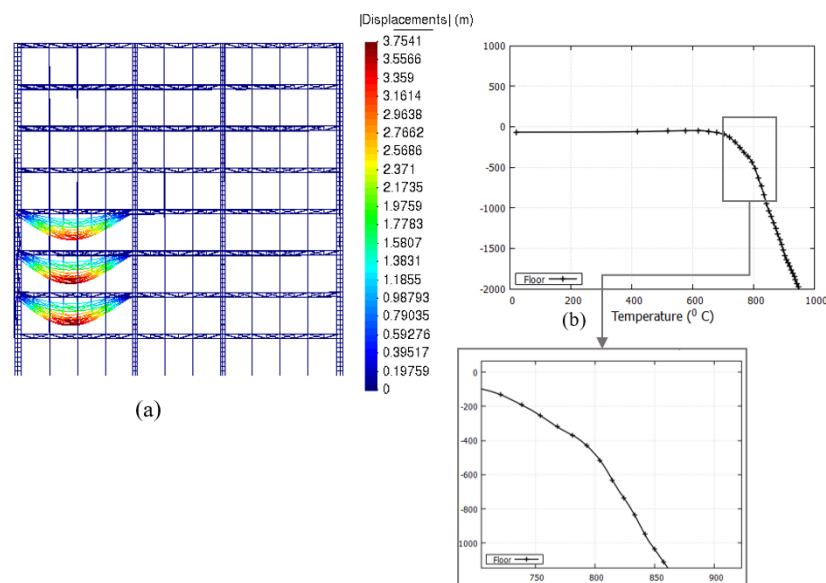
The thermo-mechanical analysis of the model showed (Figure 6.12) large downward sagging deformations higher than 1000mm; see Figure 6.11(b). The floor deformations were only 50mm downwards when the compartment temperatures were around 600 °C. The deformations continued to increase to 400mm as compartment temperatures reached 780 °C. Beyond 800 °C, the floors experienced runaway failure, reaching more than 1000mm by 850 °C.

Figure 6.11 (a) Contour plot showing the maximum floor deformations in the corner; (b) plot showing maximum deformation against the compartment temperature.

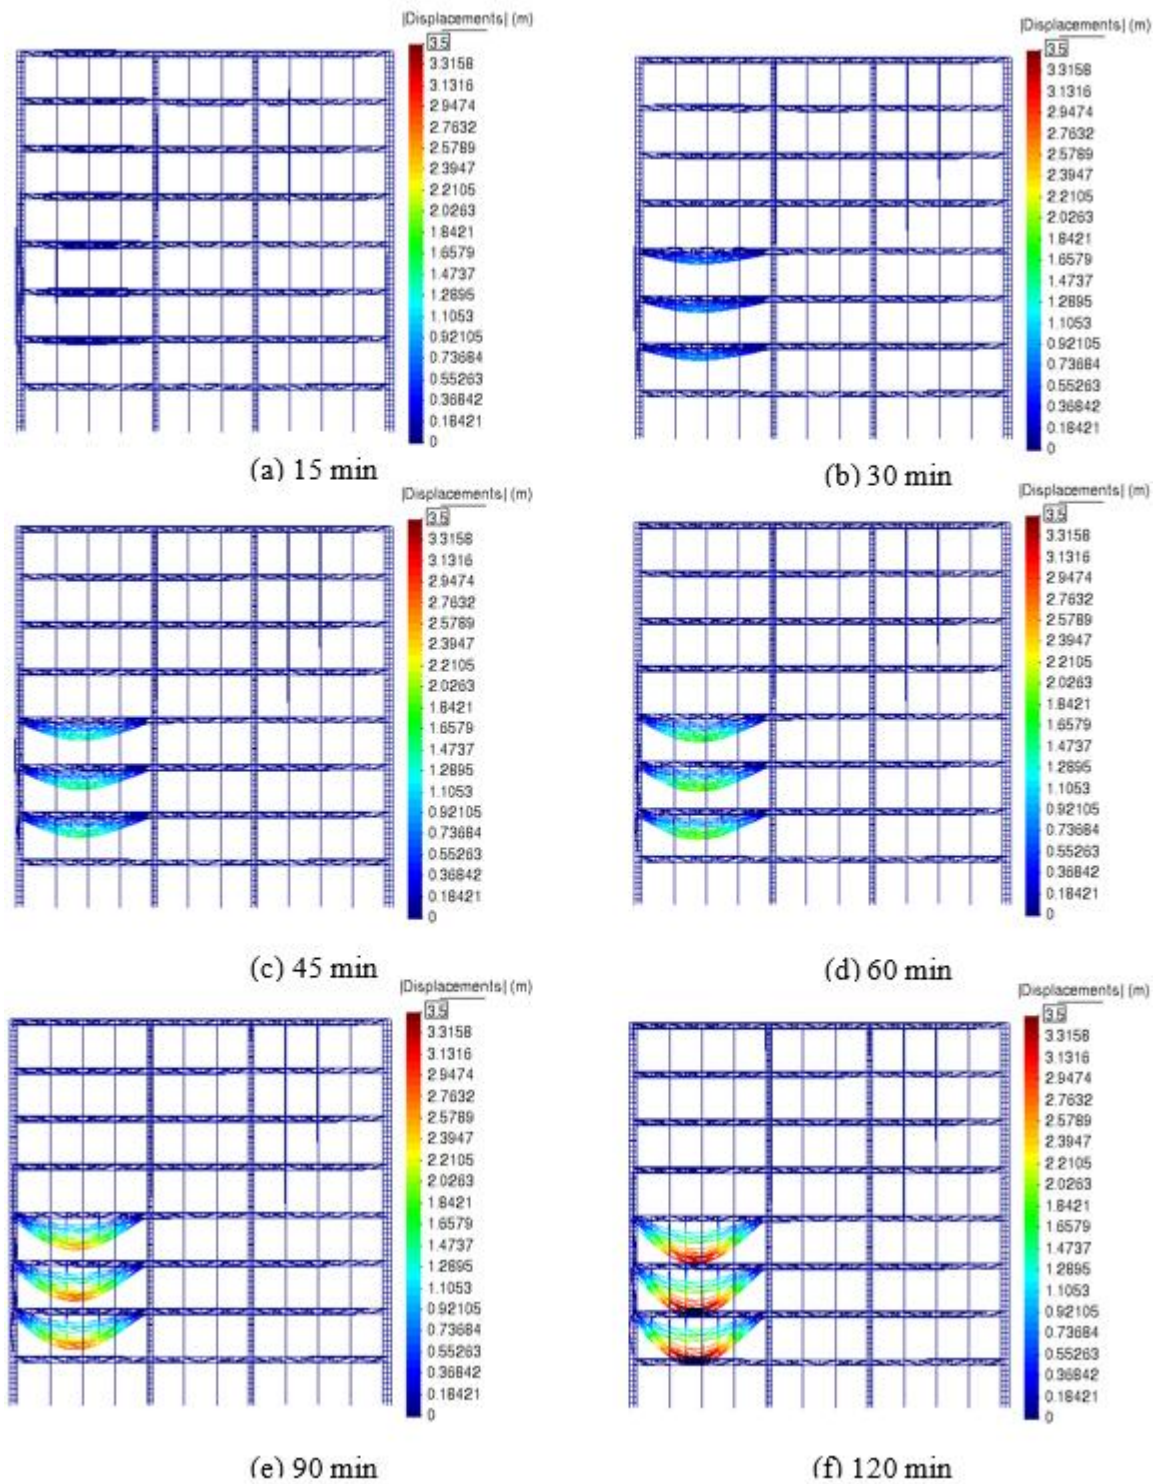
Figure 6.12 Floor deformations in NW corner at different stages of compartment fire; as seen from West to East direction of the building model.

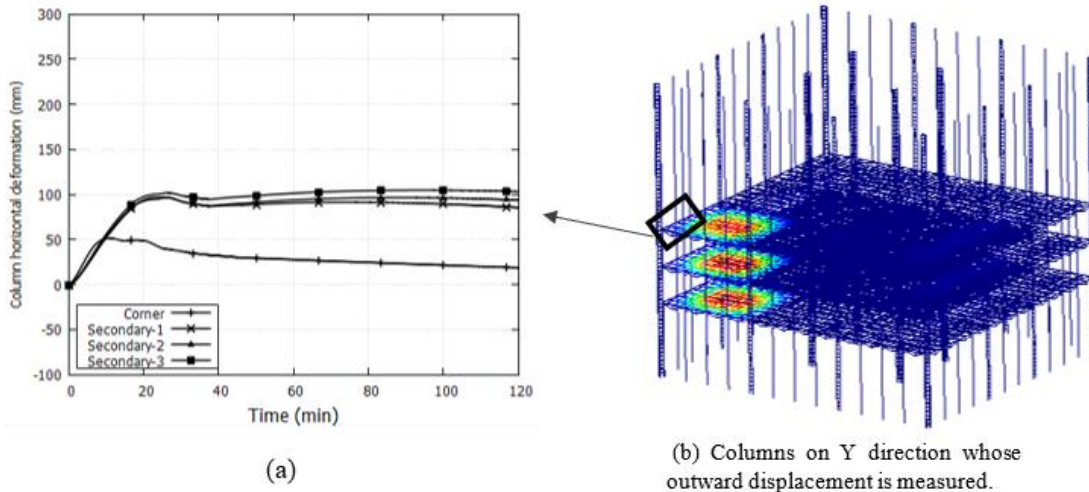
Dead load analysis of the Plasco tower revealed that each core column transfers 11% of the total building weight to the ground, i.e., all the core columns transfer 44% of the total weight. The core and secondary main columns transfer nearly 65% of the weight. Each corner column transfers only 2% of the total load, as they are not designed for gravity load. They are designed to resist global lateral and twisting forces. The NW corner column, stiffer than the other peripheral columns, underwent a lesser lateral (outward) push in both X and Y directions. The NW corner column experienced a maximum lateral displacement of only 50mm at 600 °C, while secondary columns experienced a lateral displacement of around 120mm at temperatures

As observed in the previous chapter, the lateral displacement of secondary columns is higher than that of the secondary main columns. This can be explained by the difference in stiffnesses and primary beams undergoing lesser axial expansion due to their relatively colder temperatures. The floor of the Plasco tower in a North-South direction with Vierendeel beams (Y direction in the model, see Figure 6.9) was longer compared to the East-West direction with truss beams. The thermal expansion of the floor is different in both directions. The outward push and then subsequent inward pull forces on the columns are higher in the Y-direction in comparison to the X-direction.

Figure 6.13 (a) Lateral column displacement of Corner column and Secondary columns on North face, as shown in (b) where non-fire floors are hidden for clarity.

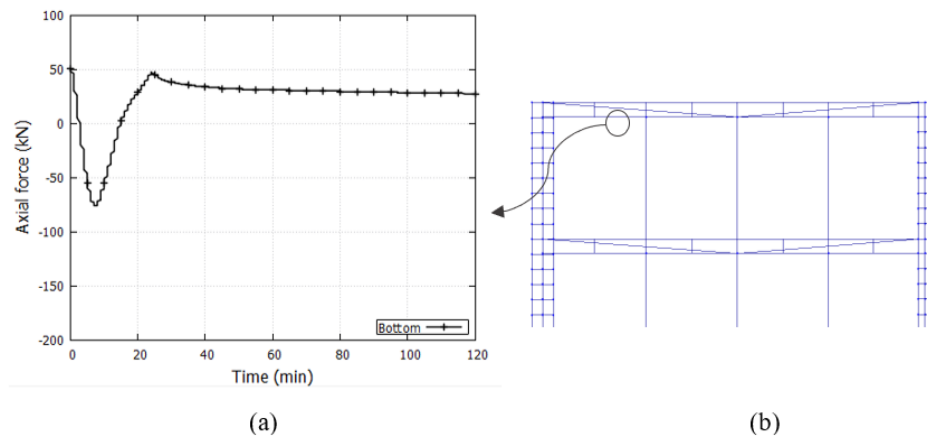
The reversal of lateral column displacements occurred when compartment temperatures were between 670 °C and 750 °C, which is reflected in the changing axial forces of Vierendeel beams. It can be seen in the Figure 6.14(a) which shows that the bottom chord, which was initially under tension, started experiencing compression as the floor expanded. The expanding Vierendeel beams started losing strength around the temperature of 670 °C. As a result, large downward displacements occurred, which explains why the bottom chord reverted to tension.

Figure 6.14 (a) Axial force reversal in the bottom chord of the Vierendeel beam; highlighted in (b) a single 10m span of the beam.

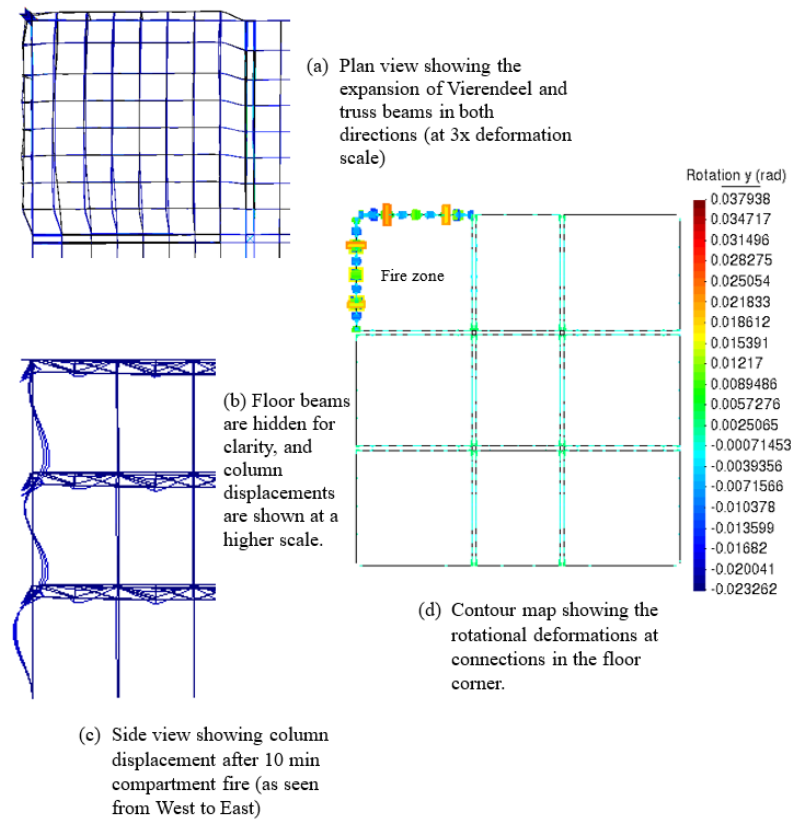
Figure 6.15 Visualisation of expansion of corner beams and rotational deformations at connections.

It is reasonable to believe that large displacement variations in columns, in horizontal and vertical directions, would have damaged the steel connection in the NW corner, thus causing a local structural failure.

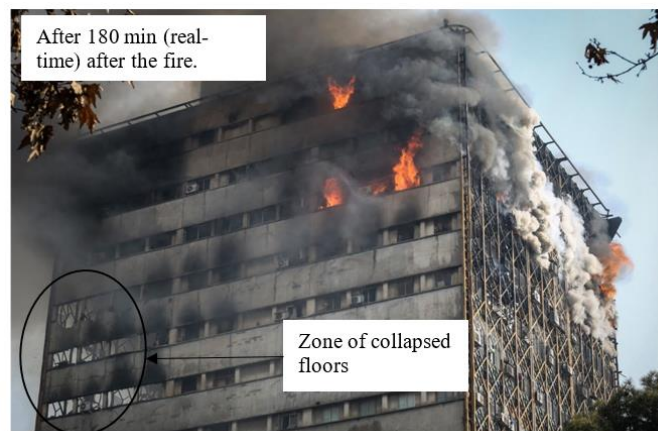
In the partial collapse stage, the fire caused three floors of the tower's Northwest corner to collapse due to the failure of connections between the peripheral columns and secondary beams traversing in both directions. The tower remained stable after this corner failure for over an hour. The total collapse took place only after the fire reached critical core areas. Photographic evidence, seen in Figure 6.16, substantiating that the tower was stable with no corner floors present.

Figure 6.16 The photo shows the loss of fire-affected corner floors while the tower still stood.

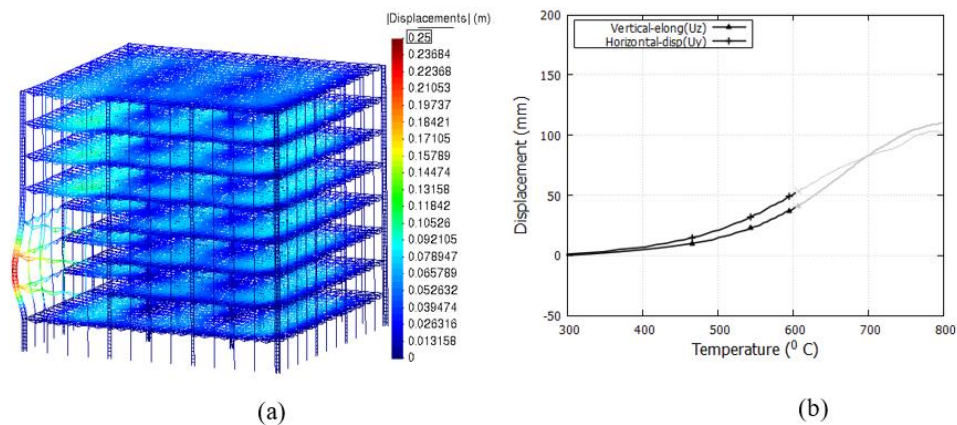
Figure 6.18 (a) Corner column response with collapsed floors; (b) displacement and elongation of the corner column.

The results from the study have shown that the magnitude of deformation experienced by the corner column is around 40-50mm, see Figure 6.18 in both vertical and horizontal directions. From a global stability point of view, these deformations are not critical since the corner columns were not designed to bear gravity loads. As previously discussed, the total gravity load transferred to each corner column is only around 2%. Even if corner columns are exposed to extreme temperatures in local fires, it is not likely that this would cause any instability in the building. Interestingly, the amount of base reaction in the corner column is higher than its service load case reaction. A contour plot showing base reactions of all columns,

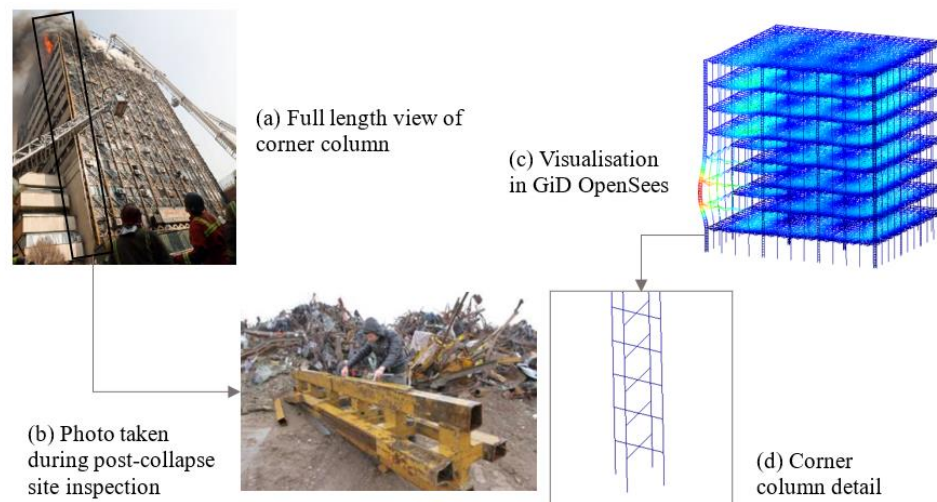
After the partial collapse of the corner floors, the 10.2m long span of the corner column is relatively less restrained laterally. The same can be said about other peripheral secondary columns, but they did not attract larger redistributed loads because of their smaller cross-sectional areas. This increase in effective length should reduce the buckling load-carrying capacity of all the fire-affected columns. In the case of the Plasco building, all columns are designed as built-up box sections joined together with battens, as shown in Figure 6.19(b); the strength quality of welding of these battens (steel members used to hold together individual members) adds to the complexity of assessing their buckling strength, which is not the focus of this study.

Figure 6.19 Post-collapse photo and computational model of the corner column

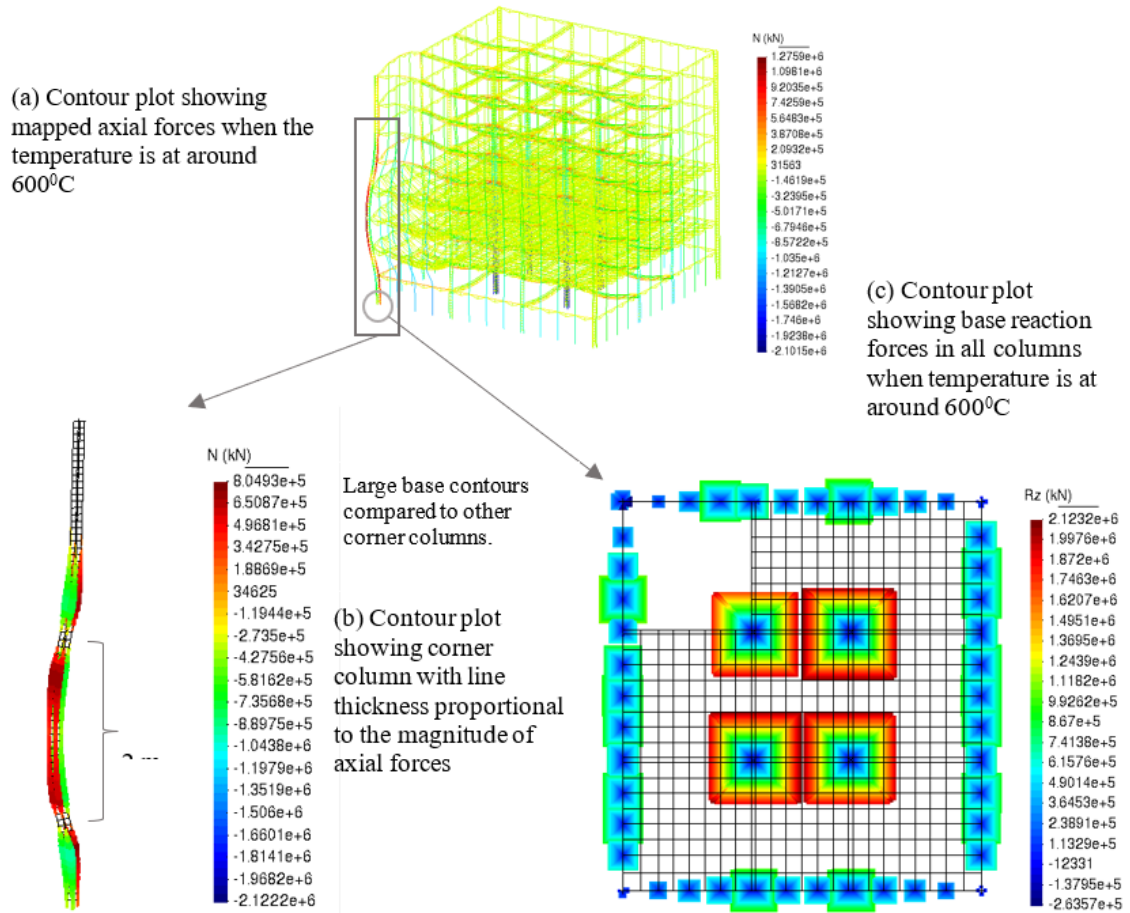
As the temperatures in the column increased to 600 °C, the outer box members are seen experiencing tension forces and the inner box members compression forces over the entire span of 10.2m, as seen in the Figure 6.20(a) and (b). Unlike rolled steel sections acting monolithically as a single member, built-up sections may not behave as a single unit at elevated temperatures.

Figure 6.20 Visualisation of corner column response under fire

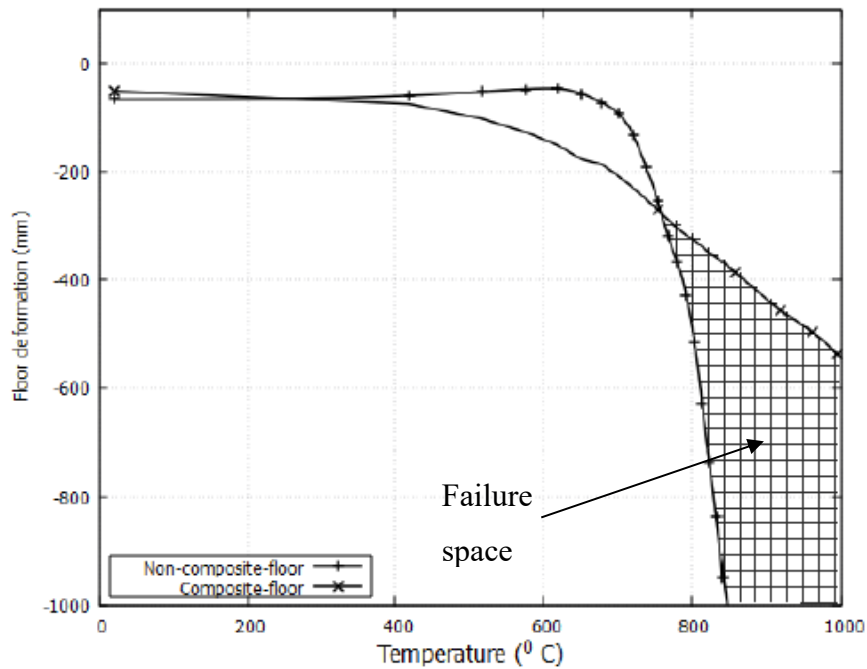
Figure 6.23 Plot showing maximum floor displacement (centre of the floor slab) with and without composite action.

As expected, the analysis showed that the composite action of the slab resulted in lower floor displacements than the non-composite floor model. For comparison, maximum floor displacements of composite and non-composite floors are plotted together, where non-composite floors experienced runaway failure at temperatures of 650 – 700 °C, while

displacements in the composite floor model increased gradually. At 600 °C, the maximum displacement in the non-composite floor is around 40mm, whereas the composite floor experienced nearly three times higher 135mm displacement due to thermal bowing. By the end of the analysis, the maximum displacement observed in the composite model is 640 mm (nearly 10% of the span length), see Figure 6.22 (c) and Figure 6.23. It can be reasoned that a realistic failure space would exist somewhere between the full composite and non-composite response. Based on the studies carried out so far, it is proposed that the local floor failure in the Plasco building started with thermal bowing, which initiated the buckling of truss members, see Figure 6.22(c). This, combined with a partial composite action, would have caused significant downward displacement, exerting critical rotational strains on the connections between trusses and Vierendeel beams with peripheral columns, leading to local failure.

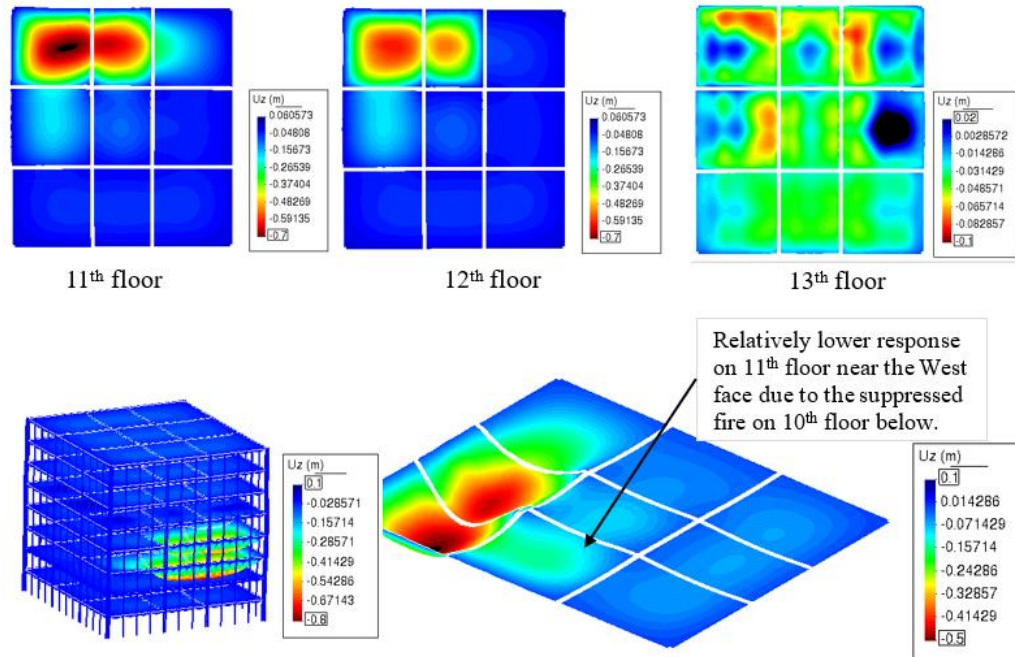
Figure 6.24 Deformation contour maps of the 11th, 12th and 13th floors.

The thermomechanical response predicted the failure of nearly 67% of the NW floor area on the 11th and 12th floors of the building, see Figure 6.24. The deformations observed in the region on the 11th and 12th floors of the structure are more than 600mm. Deformations of 205mm and 110mm are noticed on the West and interior regions of the 11th floor, respectively. This is because the fire that started on the 10th floor NW corner moved westwards and was quickly suppressed due to easy reachability (externally) for firefighting. The North face of the tower was not easily reachable; hence, the region saw quick fire growth and spread.

The failure of the 11th floor marks Event 8, as shown in the established fire timeline used for this study. Events 9 and 10 occur after the failure of the 11th floor (Event 8), and both involve significant damage on the 13th floor. In this exercise, the deformation contours showed only the arrival and fire spread on the 13th floor, but did not show deformations of comparable

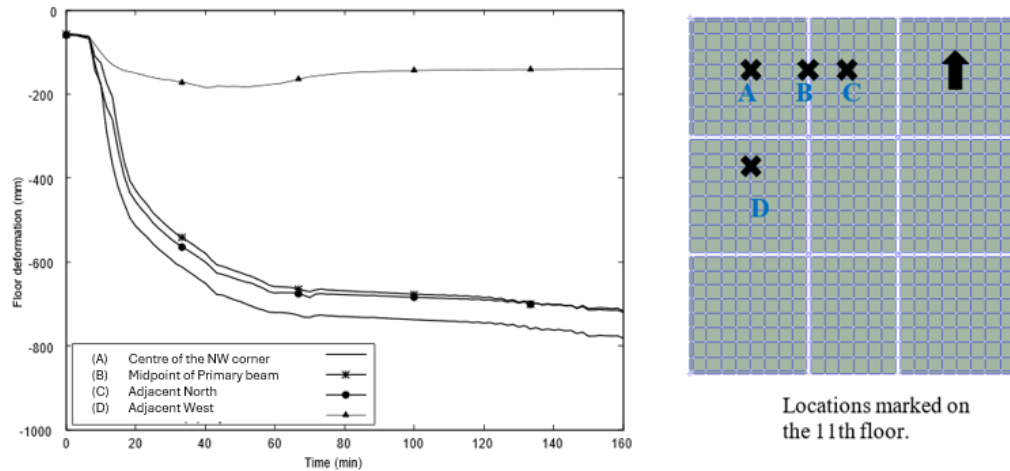
Figure 6.25 Plot showing deformations at different locations on the 11th floor.

The deformations on the 11th floor at different locations, see Figure 6.25, show the failure of the NW corner and the adjacent area on the North side. The adjacent side on the West shows relatively lower deformations (200mm). The thermomechanical response indicating the failure of 2/3rd of the North side of the 11th floor agrees well with the visual evidence, thus proving the accuracy of the fire modelling. The fire load on the 13th and remaining floors (14-16) should be calibrated before analysing Event 9 and Event 10.

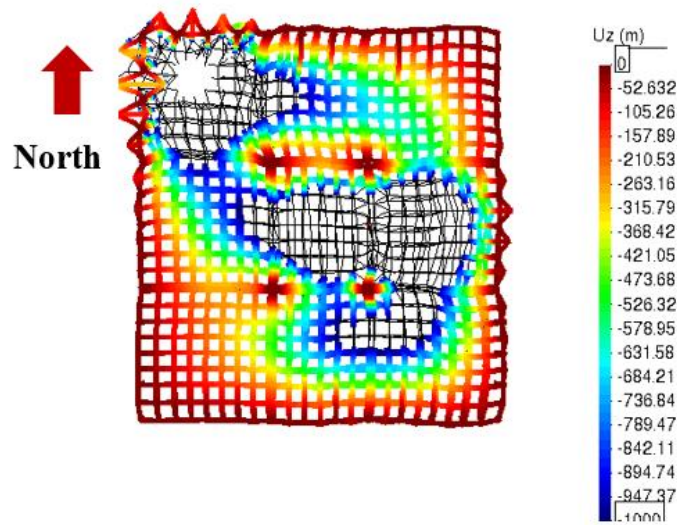
Figure 6.26 Structural damage on the 13th floor

As observed by Khan (2022a), the fire intensity on the 13th floor of the Plasco tower surpassed that of all other fires recorded in the building. Conversely, the fire on the western side was brief due to the effective firefighting carried out by the firefighters. Therefore, in the CFD simulations, the modelling of fire intensity and spread considered the limited duration of the fire in the western area. The fire spread varied across different floors of the building. The fire mainly affected the northwest corner and partially extended to the adjacent sections on the 11th and 12th floors. On the 14th floor, the fire spread resembled that of the 11th and 12th floors, but with elevated temperatures in the core region. Similarly, the extent of fire spread on the 13th, 15th, and 16th floors was comparable, with the 13th floor experiencing higher fire intensity.

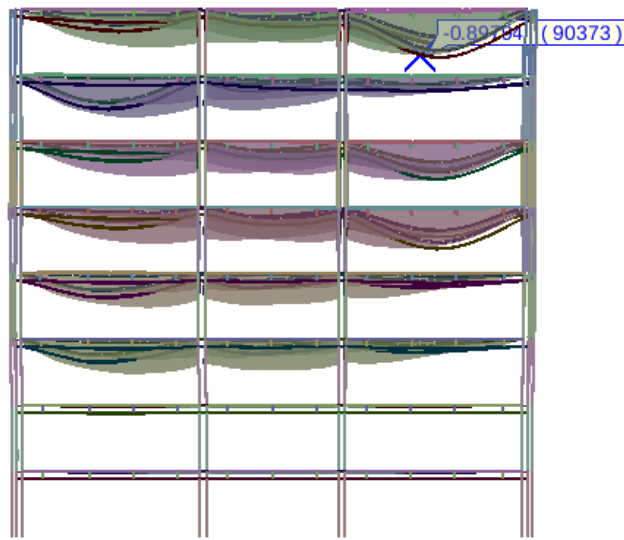
The simulation results demonstrated significant downward displacements on all six floors affected by the fire. The most substantial floor displacement observed in the simulation occurred on the roof or ceiling of the 15th floor (sometimes referred to as the 16th floor for convenience). This was attributed to the columns supporting the roof being less laterally restrained compared to columns on other floor levels, see Figure 7.2.

Figure 7.2 Deformation showing the location of maximum floor displacement (South elevation) by the end of the analysis

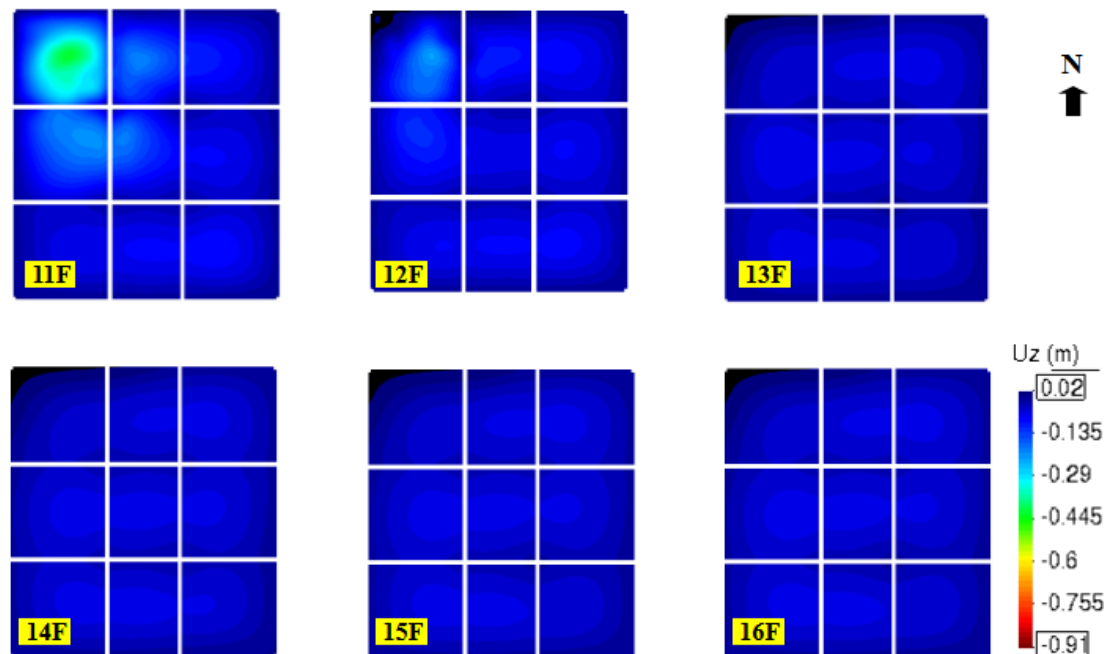
At 1000 seconds into the fire, roughly 17 minutes after the fire initiation, the maximum displacement of nearly 420 mm was observed on the 11th floor (or the ceiling of the 10th floor), as shown in Figure 7.3. By this time, the fire had spread to the 11th floor, resulting in approximately 220 mm displacement on the 12th floor, as depicted in the contour of the 12th floor. The other four floors above remained unaffected at this point in time.

Figure 7.3 Vertical floor displacements at $t=1000$ sec (17 min)

During the initial 15 minutes, the impact of the fire was localised to the northwest corner of the tower, affecting the 11th and 12th floors primarily, as depicted in Figure 7.3. However, by the 33-minute mark, significant displacements ranging from 100-400mm were observed in the floor sections adjacent to the northwest corner, as shown in Figure 7.4. Similar displacements were also noted on the eastern side of the tower, specifically on the 13th and 14th floors, posing a greater threat to overall stability compared to the corner fire. It was discussed in the robustness study in Chapter 3, which highlighted the critical nature of fires affecting the edge floor segments involving two primary beams.
