**MULTIDISCIPLINARY FORENSIC
INVESTIGATION OF BUILDINGS IN FIRE: THE
CASE OF THE PLASCO TOWER**

Multidisciplinary Forensic Investigation of Buildings in Fire: The Case of the Plasco
Tower

A thesis submitted in partial fulfilment of the requirements for the degree of
Doctor of Philosophy
Aug 2024

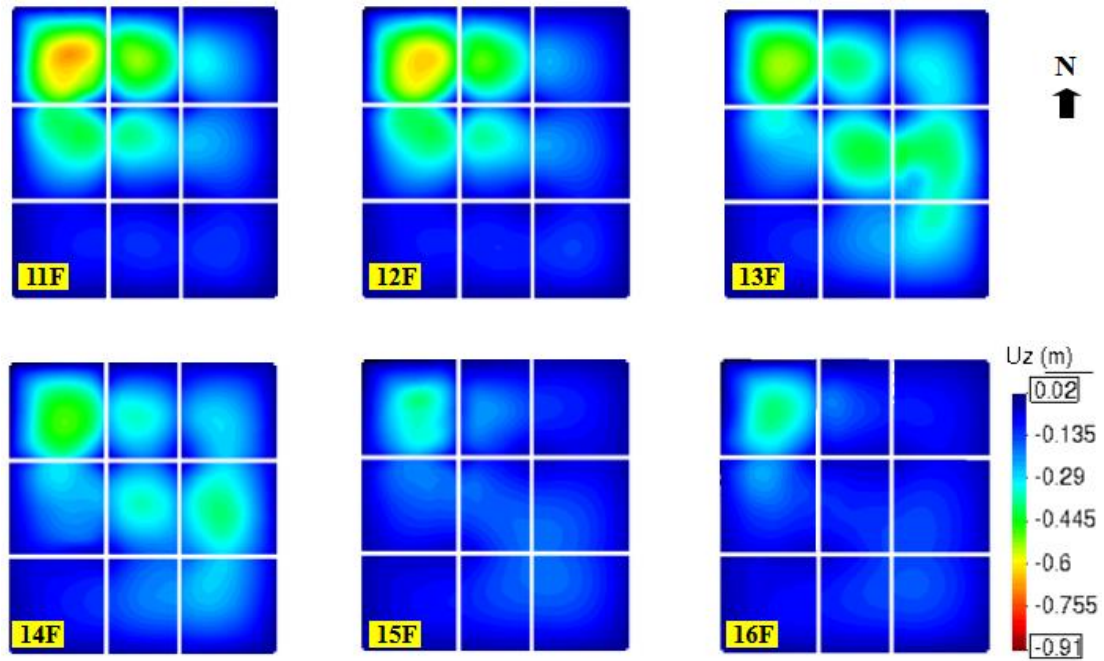
Figure 7.4 Vertical floor displacements at $t=2000$ sec (33 min)

The results depicted in Figure 7.4 showcase the floor displacements approximately 5 minutes after firefighting commenced. Notably, the maximum vertical displacement of 590 mm was observed in the northwest corner of the 11th floor, with similar locations on the 12th, 13th, and 14th floors exhibiting displacements of 520 mm, 280 mm, and 130 mm, respectively. These substantial displacements underscore the severity of the fire in the NW corner. The deformation on 15F is relatively less due to the lower intensity of the fire.

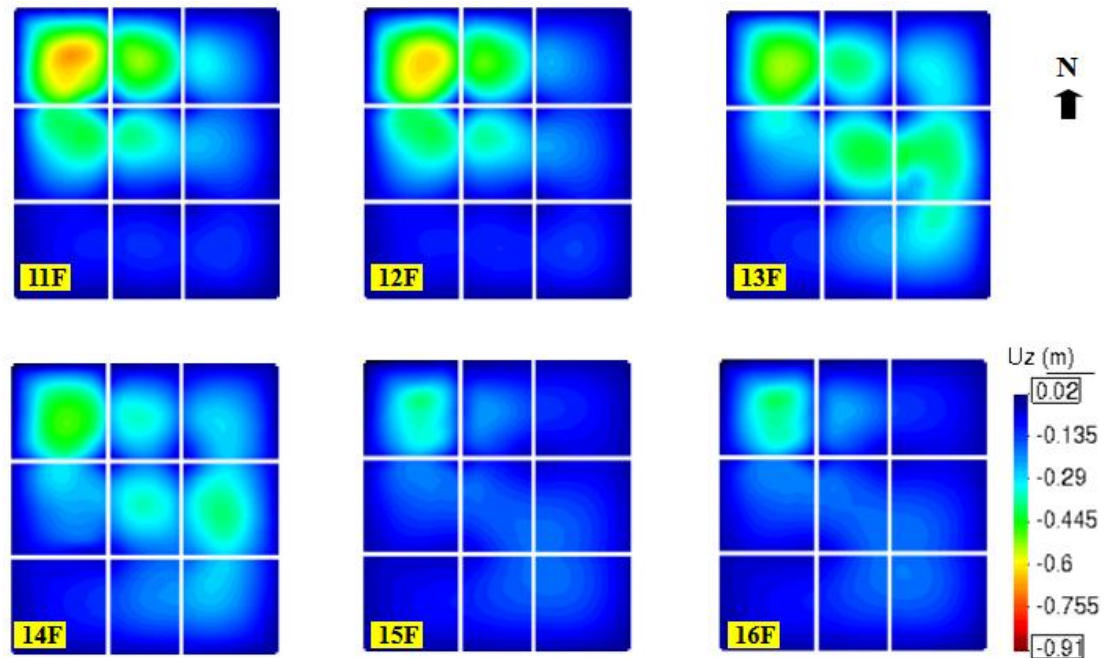
Figure 7.5 Vertical floor displacements at $t=3000$ sec (50 min)

Firefighting efforts were primarily focused on the northwest (NW) corner of the tower, only in the latter 30 minutes of the 50-minute duration of the fire. By this time, the fire had spread significantly across the 13th and 14th floors. The displacement contours depicted in Figure 7.5 show substantial vertical displacements of approximately 670 mm and 620 mm in the NW corner of the 11th and 12th floors. Visible damage can be observed on the adjacent and interior floor segments on these levels.

On the 13th, 14th, and 15th floors, displacements ranging from 200 mm to 500 mm are evident across extensive areas in the NW, SE, E (east), and core regions. Notably, on the 15th floor, displacements in the NW corner reach around 300 mm specifically. Consequently, the fire in the NW corner resulted in significant displacements across all six floors above the 10th floor, underscoring the extensive structural impacts caused by the fire in this region.

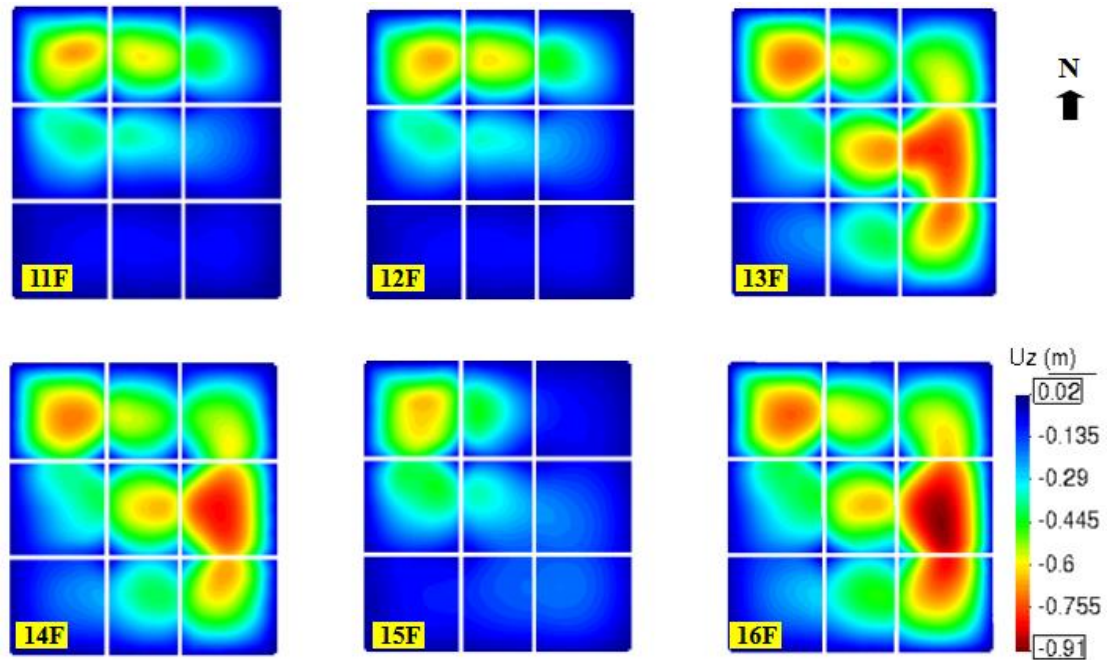
Figure 7.6 Vertical floor displacements at $t=6000$ sec (1 hour and 40 min)

Up to this point in time, firefighting efforts were going on the 10th and 11th floors. The contours in Figure 7.6 represents the moment that marks the beginning of Event 6 (temporary fire suppression in the NW area) based on the established fire timeline discussed in Chapter 4. It is crucial to note that the fire on the 10th and 11th floors led to displacements on the 11th and 12th floors. Temporary success was achieved in controlling the fire on these two floors, which prevented its spread towards the western direction.

As a result, the contours in Figure 7.6, illustrating the displacement of the 11th and 12th floors, show relatively lesser floor displacement in western areas. Conversely, displacements exceeding 800 mm are observed on the 13th, 14th, and 16th floors. Throughout this period, indications of the fire were noticeable near the edges of both the western and eastern sides of the building on the 12th floor and above.

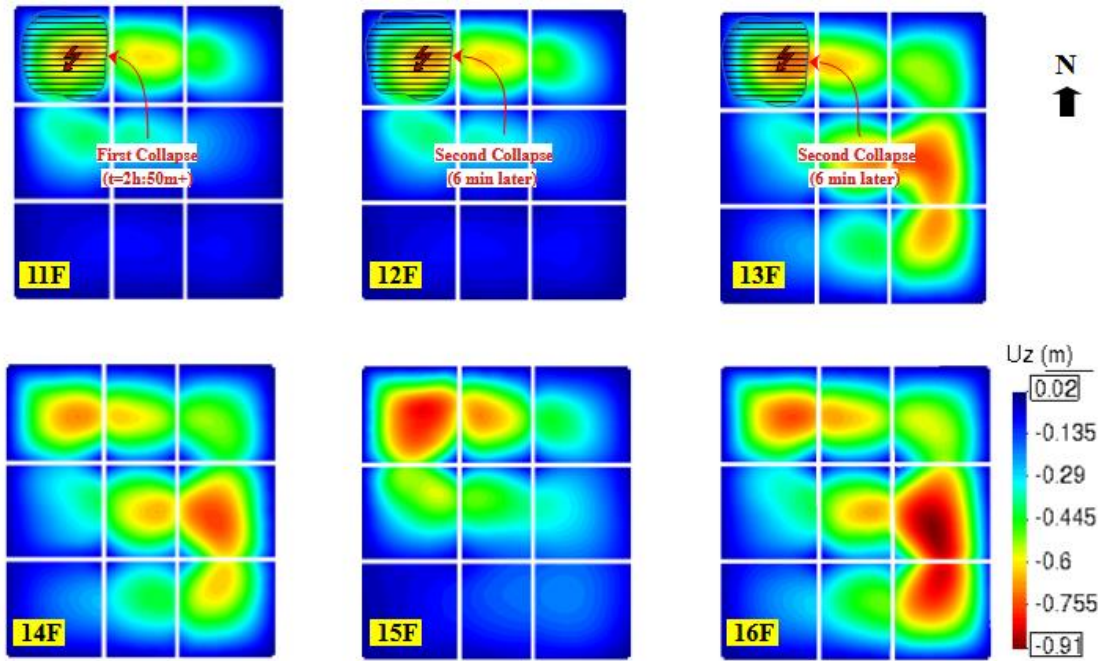
Figure 7.7 Vertical floor displacements at $t=102000$ sec (2 hours and 50 min)

The fire started at 7:56 AM in the morning, and after 2 hours and 50 minutes, approximately at 10:50 AM, the first partial collapse of the 11th floor over the 10th floor was observed. The displacement contours in the simulation predicted the large displacements on all floors at this specific moment. About 6 minutes later, the floors of the 12th and 13th floors also collapsed onto the 10th floor. The impact of these collapsed floors, marked in Figure 7.7, led to the subsequent failure of the 10th floor and multiple floors below it.

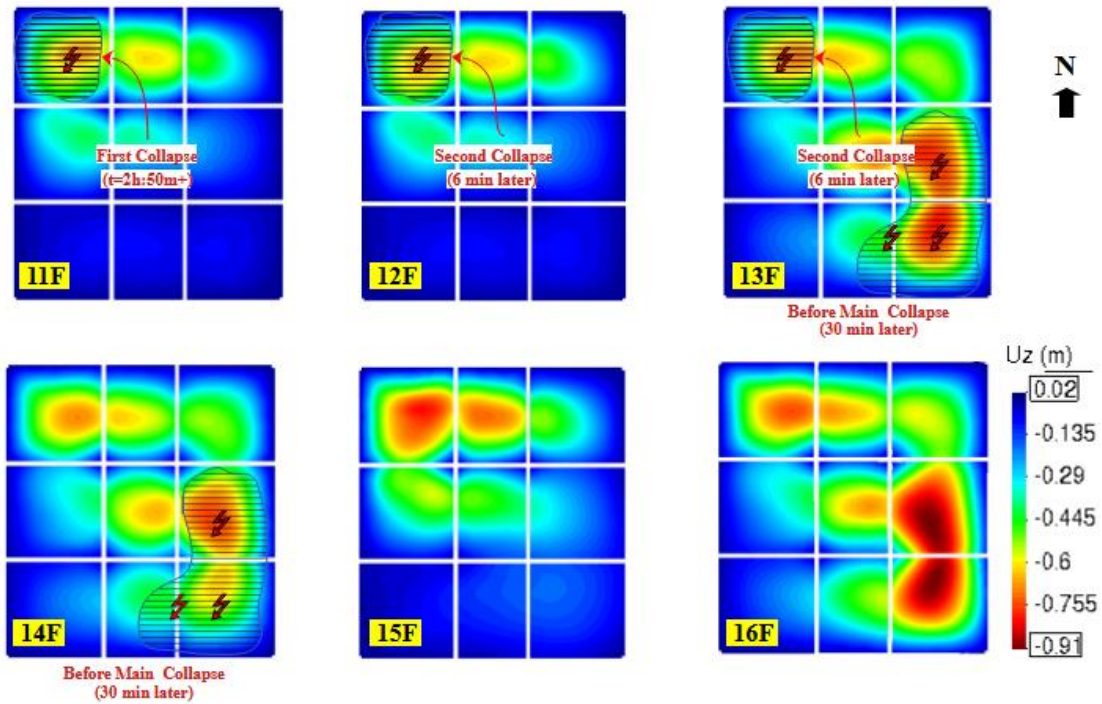
Figure 7.8 Vertical floor displacements moments before the global collapse, i.e., at $t=126000$ sec (3 hours and 20 min)

Around this time, the fire intensified, with heat rapidly emanating from the southeastern edge of the building. Video evidence indicated the collapse of floor segments in the southeast (SE) regions, as marked in Figure 7.8. It is reasonable to infer that the SE floor section of the 13th or 14th floor collapsed over the floor below. This collapse propagated to multiple floors below, resulting in the loss of lateral bracing support for the perimeter columns.

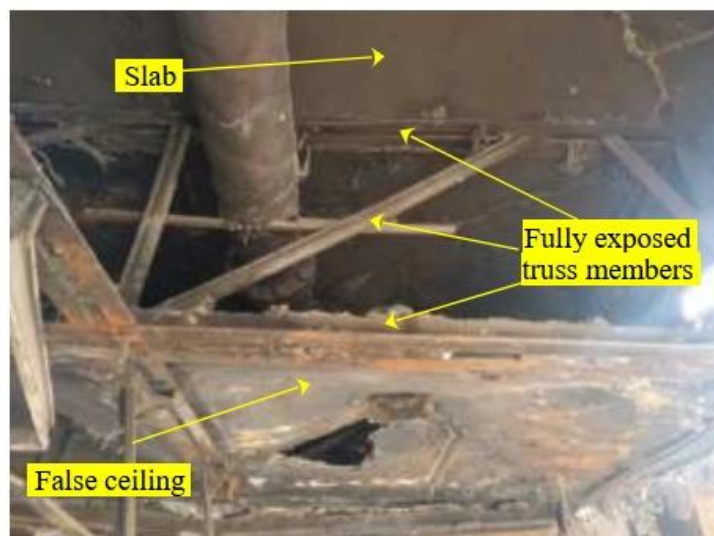
Figure 7.9 Photo showing the fully exposed steel members (Shakib et al. (2020))

Based on the observed floor response, the corner floor segments exhibited downward displacement within 7 minutes after the fire initiation. This rapid response of the floors can be attributed to the high-temperature gradients within the floor system. As discussed in Chapters 1 and 4, it was noted that the steel members in the tower are fully exposed to the fire, as shown in Figure 7.9.

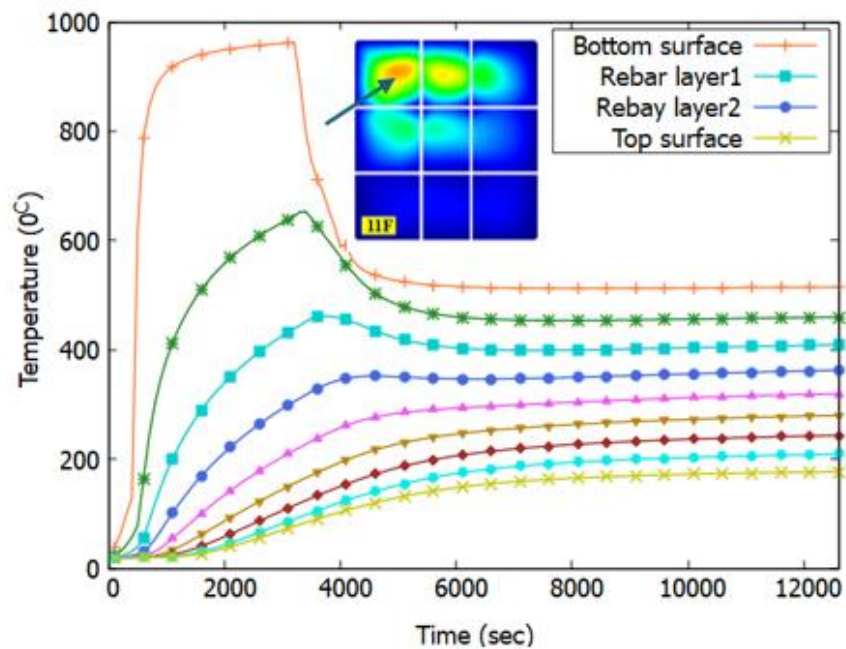
Figure 7.10 Temperature profile across the concrete slab section near the centre of the NW floor segment.

The heat transfer analysis of the shell element selected in the centre of the corner floor segment reveals that the temperatures at the top surface of the concrete stabilised around 523°C, while at the bottom surface, the temperature stabilised at 179°C, as depicted in Figure 7.10.

In the transverse and longitudinal reinforcement, temperatures are approximately 410°C and 360°C, respectively. It is crucial to note that the strength degradation of steel typically begins after 400°C, indicating that the rebars in the structure retain nearly full strength.

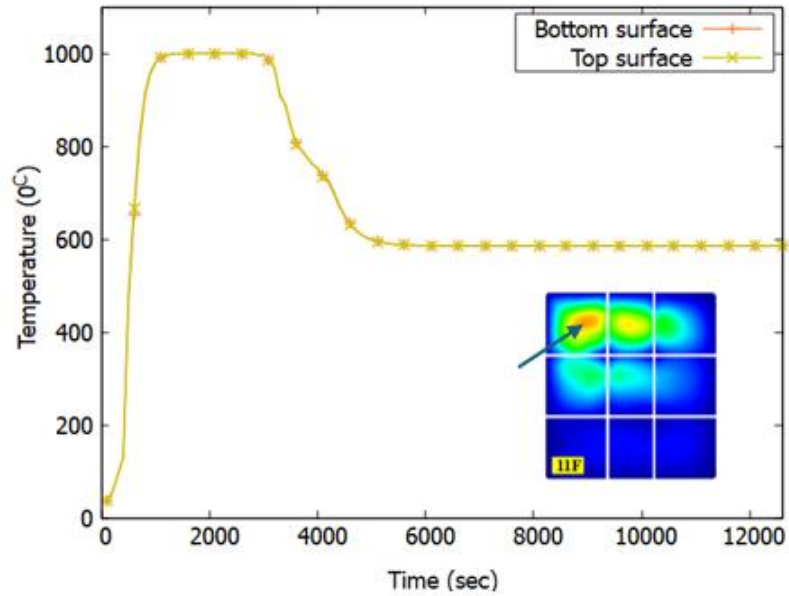
Figure 7.11 Temperatures in the steel section of the NW floor segment.

Figure 7.11 illustrates the temperatures in the bottom chord steel section at the bottom and top surfaces. The temperatures at both surfaces remain similar at all times, given that the section was fully exposed to the fires (refer to Figure 7.9). The bottom chord steel section is a UNP 100 channel section with a web thickness of 6mm. Due to the thinness in majority of trusses, significant temperature variation across the steel temperatures was not observed following the heat transfer calculations especially in areas where fire was intense.

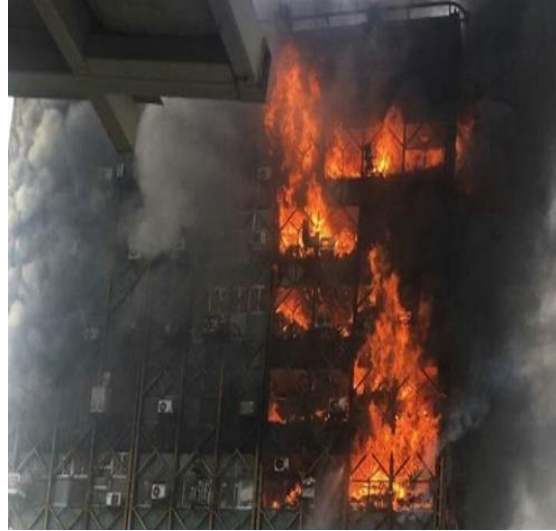
Figure 7.12 The NW corner of the tower is engulfed in fire.

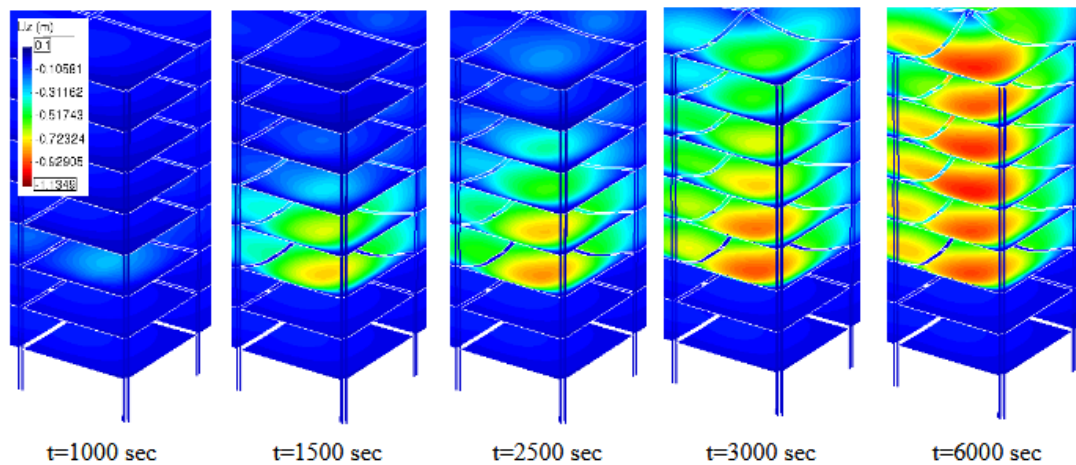
Figure 7.13 Displacement contours at different times in the NW corner zone

Figure 7.13 displays the floor displacements in the northwest (NW) corner at various time points, providing a visual representation of how the displacements progressed over time leading up to the collapse event.

Figure 7.6 and Figure 7.13. This difference in displacement can be attributed to the variation in the extent of fire spread between the upper and lower floors. In areas adjacent to the northwest corner on the 10th and 11th floors, where the fire spread was contained, the primary beams remained unaffected, resulting in lesser floor displacements in these regions (Figure 7.15). The maximum displacements on the 11th and 12th floors were approximately 70-80mm lower than those observed on the 13th and 15th floors and 180mm lower than on the 16th floor.

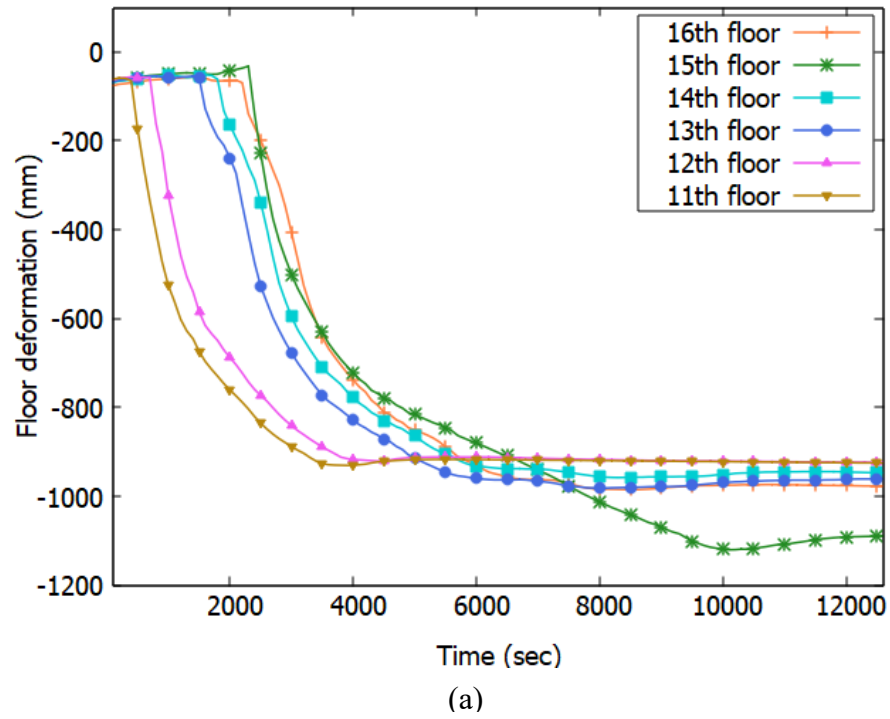
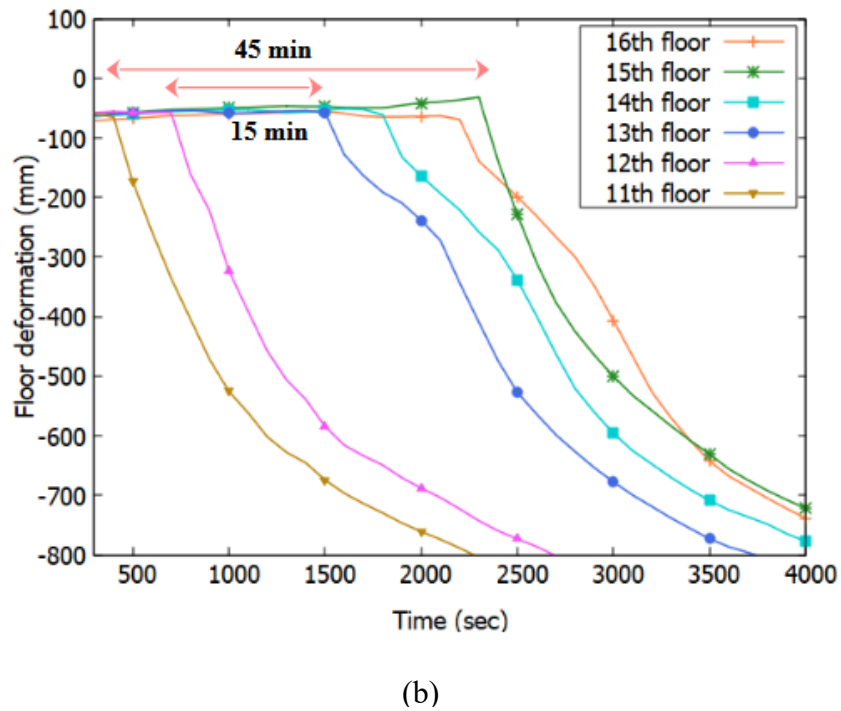
Figure 7.14 (a) Maximum floor displacements near the NW corner of all six floors; (b) closer view

Upon heating, the 11th floor (or the ceiling of the 10th floor) experienced thermal bowing displacement at approximately 6.67 minutes, as illustrated in Figure 7.14(b). Subsequently, 6 minutes later, the 12th floor exhibited thermal bowing behaviour. There was a gap of 15 minutes before the 13th floor responded similarly. The remaining three floors responded similarly following the thermal bowing observed on the 13th floor.

In all the floors, displacements up to 800mm were noticed due to rapidly increasing temperatures. However, beyond the 800mm mark, the displacements increased more gradually before eventually stabilising.

This observed behaviour is due to the reduction in thermal gradient (after 4000 sec) and the stabilisation of temperatures within the concrete slab, as depicted in Figure 7.14(a). The gradual increase in displacements in the later stage before reaching a stable state highlights the complex interplay between temperature changes, material properties, and structural responses in the context of fire-induced displacements in building floors.

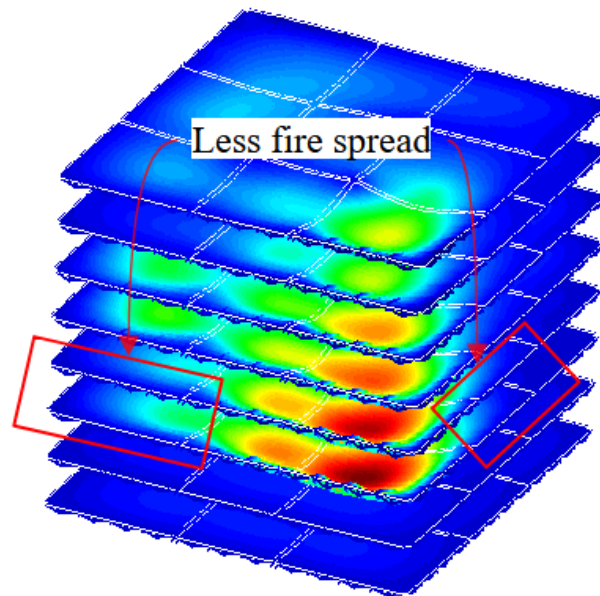
Figure 7.15 Marked areas on the 11th and 12th floors where the fire-induced displacements are lower ($t=3000$ sec).

The vertical displacements observed in the upper floors, specifically from the 13th to the 16th floors, are notably higher compared to what was observed on the 11th and 12th floors, see

- b. **Thermal Restraint:** The adjacent floor segments of the 11th and 12th floors were relatively at colder temperatures; see Figure 7.15. This temperature differential can create higher thermal restraint, resulting in increased rotations at the connections (Figure 7.17(a)). The higher rotations at the connections can induce additional stresses in the structural elements, potentially leading to failure despite lower overall displacements.

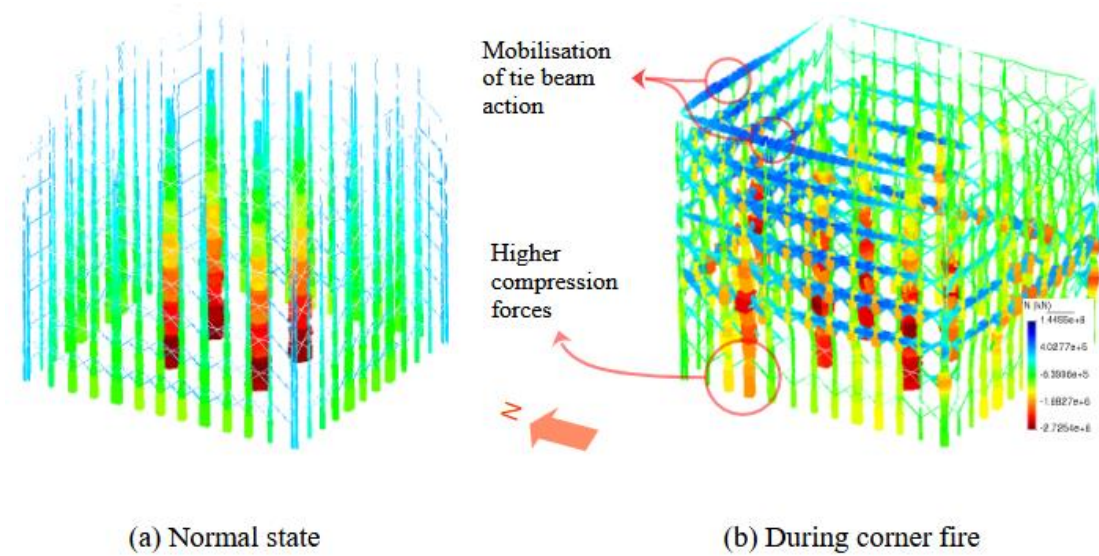
Figure 7.16 Line thickness contours showing the axial force evolution

In the corner, the columns were constrained from freely displacing due to the presence of steel bracings and edge beams, especially in the early stages of the fire or as long as they were not directly exposed to the fire. The force contours (thickness contours) extracted from the simulation indicate that as the floor trusses expand outwards, tie beam action is activated in the bracing and edge beams, as the increased tension forces are observed, see Figure 7.16.

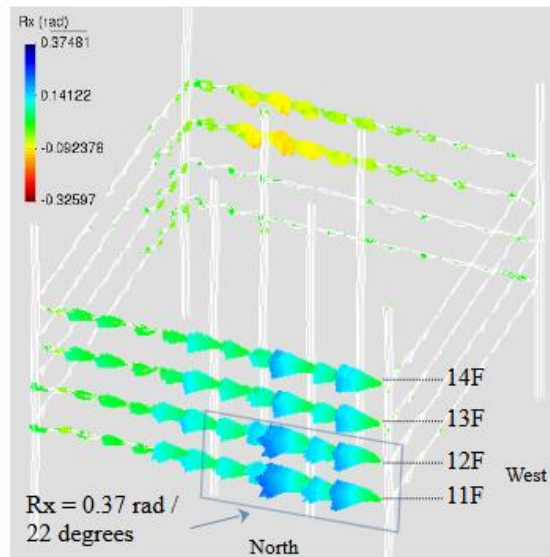
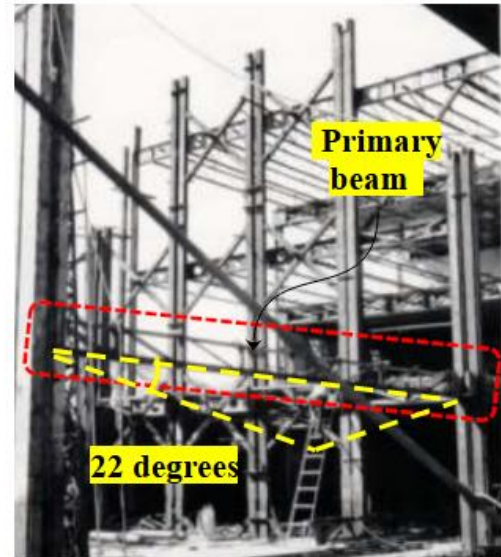
Figure 7.17 (a) Nodal rotations about the X axis (R_x) in the NW corner; (b) construction stage photo showing primary beam.

Given that the first collapse took place approximately 2 hours and 50 minutes after the initiation of the fire, the conditions existing at the floor truss and column connections during the instance of failure can be examined. At the moment of the first collapse, the magnitude of rotations at the beam-column connections was extracted. The contours depicted in Figure 7.17(a) revealed a maximum connection rotation of 0.37 radians, equivalent to 22 degrees about the east-west direction, or X-axis in the model. A similar magnitude of rotation was observed near the west side of the corner, which is not displayed in the figure.

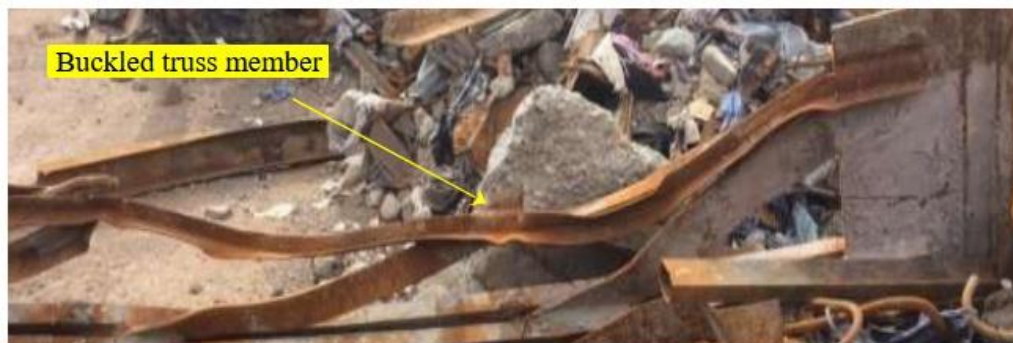
Figure 7.18 Buckled truss beam found in debris

Given that all beams in the floor system are designed as trusses with a depth of 400, the bottom chord members are susceptible to buckling under significant vertical displacements induced by thermal bowing. Photographic evidence (Figure 7.18) collected from the debris substantiates the occurrence of buckling failures in the truss chords observed in thermal response.

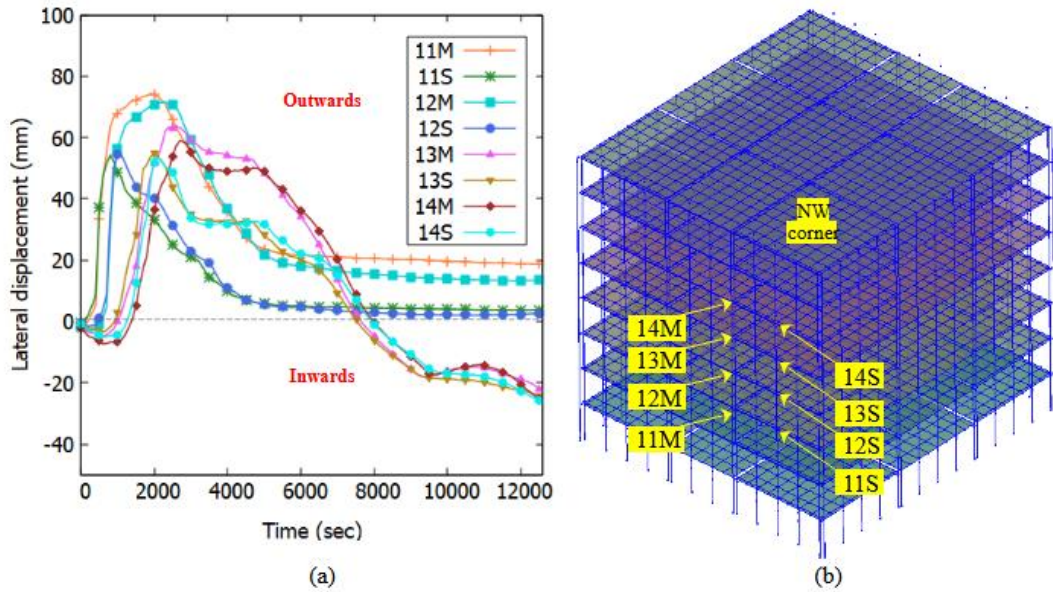
Figure 7.19 (a) Plot showing the lateral column displacement at (b) locations near the NW corner as indicated.

As a result of thermal bowing in the floor system and the expansion of truss beams, the columns near the perimeter underwent a maximum outward displacement of 75mm, as depicted in Figure 7.19(a). The outer columns, comprising secondary main columns and secondary columns (marked as 'M' and 'S' in Figure 19 (b)), experienced sideways displacement due to the thermal expansion of truss beams. Despite being stiffer, the lateral displacement of the secondary main columns exceeded that of the secondary columns, as shown in Figure 19(a). This could be attributed to the lesser thermal bowing effect near the primary beam when compared to the centre of the NW area.

In Figure 19(a), the column at position 11M shifted outward by 74mm and 11S by 53mm, while 13M and 13S moved 63mm and 54mm. The discrepancies in displacement are linked to the extensive fire spread on the 13th floor, unlike the 11th and 12th floors. The effect of fire on the northern side of the 13th floor created significant thermal gradients in the concrete floor segments on either side of the primary beam at 13M, explaining the varying displacements observed.

Columns on each floor exhibited varying times to reach their maximum lateral displacement. Additionally, out-of-phase lateral displacement is also observed among columns on the same floor due to differing lateral stiffness and the impact of fire, as previously discussed. This can lead to significant stresses on beam-column connections when a vertical fire spread occurs. In

Figure 7.19(a), the secondary main columns at 11M and 12M peak at 2000 seconds, while peaks at 13M and 14M occur at 2500 seconds. While a reversal in column lateral displacement is seen on the 13th and 14th floors, this is not observed on the 11th and 12th floors. This is attributed to the presence colder structure adjacent to the northwest corner on the lower floors, whereas fire spread on the upper floors results in higher inward pull forces. Figure 7.19(a) illustrates a maximum inward pull of 25mm observed by the end of the analysis.

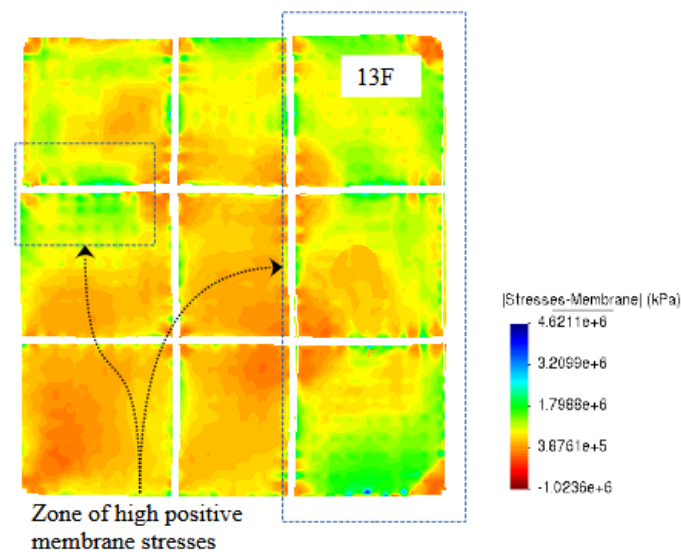
Figure 7.20 Contour map showing the membrane stresses on the 13th floor (t=10200 sec)

Figure 7.20 shows the zones of positive (tensile) membrane stress contours on the 13th floor at 10200 seconds, where NW floor segments experienced partial collapses. Moreover, since there was a notable absence of column inward pulling during different phases of the fire (except on NW and SE of the 13th floor), it is improbable that tensile membrane action across large floor areas was initiated. The floors in the core, west and southern regions primarily experienced membrane compression, mainly due to edge restraint. It should be noted that the study assumes a full composite interaction between the concrete slab and steel truss system, overlooking any potential slippage between these components. The method of connecting the shell and beam elements in the analysis assumes a rigid coupling of nodes. In reality, the connection between the concrete floor and truss beams is semi-composite and relies on insufficient shear keys, as noted by Shakib et al. (2020) and Behnam (2019). In Chapter 6, to assess the difference in behaviour between fully composite and non-composite, a study was conducted; refer to Figure 23 (in Chapter

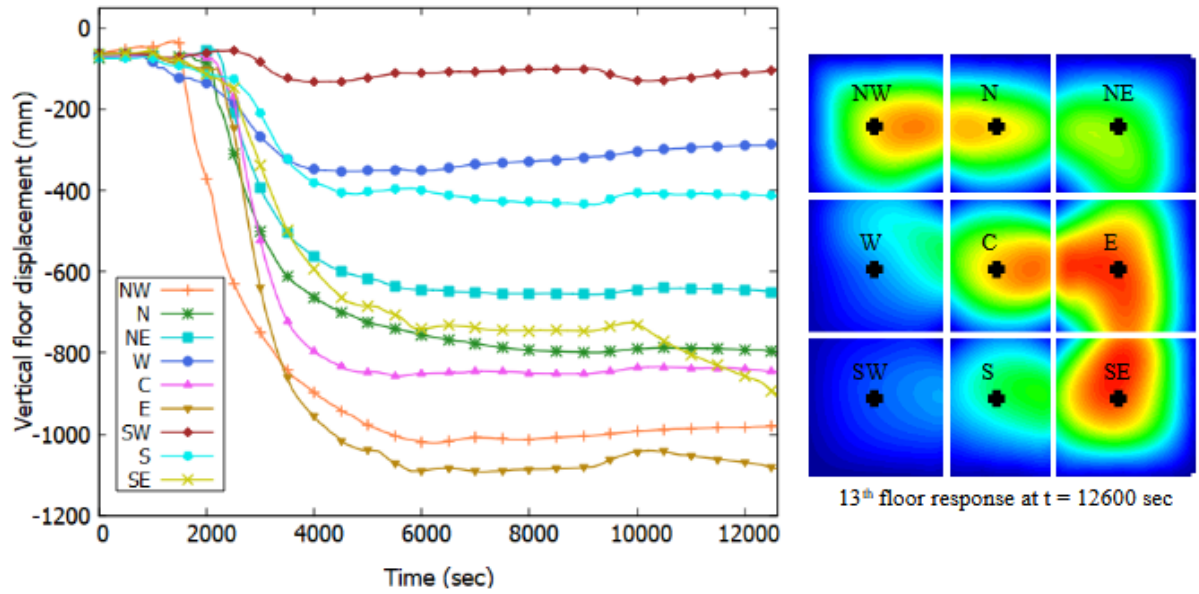
Figure 7.21 Response of the 13th-floor segments at different locations are marked.

For instance, the scenario involving the fire on the 13th floor is illustrated through Figure 7.21 and Figure 22. These plots depict the vertical displacements at the centre of each floor segment plotted against time. Each data point is labelled according to its location on the floor plan. In Figure 7.21, the displacements at W, SW, and S remain under 400mm. The results predict the most significant downward displacements at the NW and E floor sections, surpassing 1000mm after 6000 seconds. After 10000 seconds, an increase in displacement is also observed at the SE

floor segment. According to the visual representations and established event timeline in Chapter 4, the collapse of the NW floor segment occurred at 102000 seconds, followed closely by the E and SE segments just before the overall structural failure. Figure 7.22 is plotted for a better illustration of the onset of vertical deflections of the floor segments.

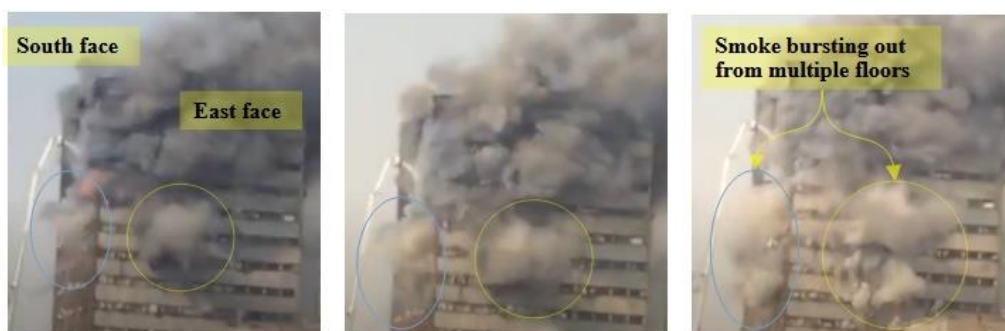
Figure 7.23 Photo of the east and south faces showing the bursting-out smoke

At this juncture, the tower had already suffered the collapse of several floors adjacent to the northwest corner, extending below the 13th floor. Meanwhile, a significant fire had intensified in the southeast corner of the tower, particularly affecting the 13th and 14th floors. As with the northwest corner, the abundance of air and ventilation in the area had facilitated high temperatures. The final moments were marked by numerous smoke eruptions, signalling the failure of floor segments in the southeast sector. This progression can be observed in Figure 7.23, where an increase in the number of floors emitting smoke is evident as one moves from left to right.

In the photo on the left, smoke emerged due to the collapse of either the 11th or 12th floors, whereas in the photo on the extreme right, it was evident that several floors, possibly those below the 12th floor, failed in succession. This stage of multiple local collapses lasted for 10 seconds.

The collapse sequence, lasting 4-5 seconds, is illustrated in Figure 7.31. Owing to dynamic forces at play, the damage propagated vertically downward, reaching as far as the 8th floor. This progression is supported by observable evidence, such as smoke (dust) bursts on both the south and east faces of the tower, as depicted in Figure 7.23.

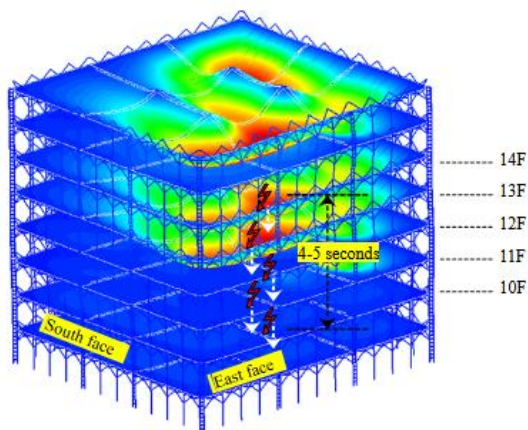
Figure 7.24 Displacement contours of all floors in 3D perspective, moments before the collapse

The response of the floors, primarily influenced by thermal bowing, resulted in significant displacements in the SE corner and the floor sections to the east, as depicted in Figure 7.24. In contrast to the fire incident in the NW corner, the fire on the eastern side impacted both primary beams, leading to large displacements evident throughout the eastern edge (as shown in Figure 7.24). This side of the building was challenging to reach with external firefighting equipment, increasing the fire duration in this area. The fire intensity was particularly heightened in the SE corner of the 13th floor due to the ample availability of unrestricted airflow.

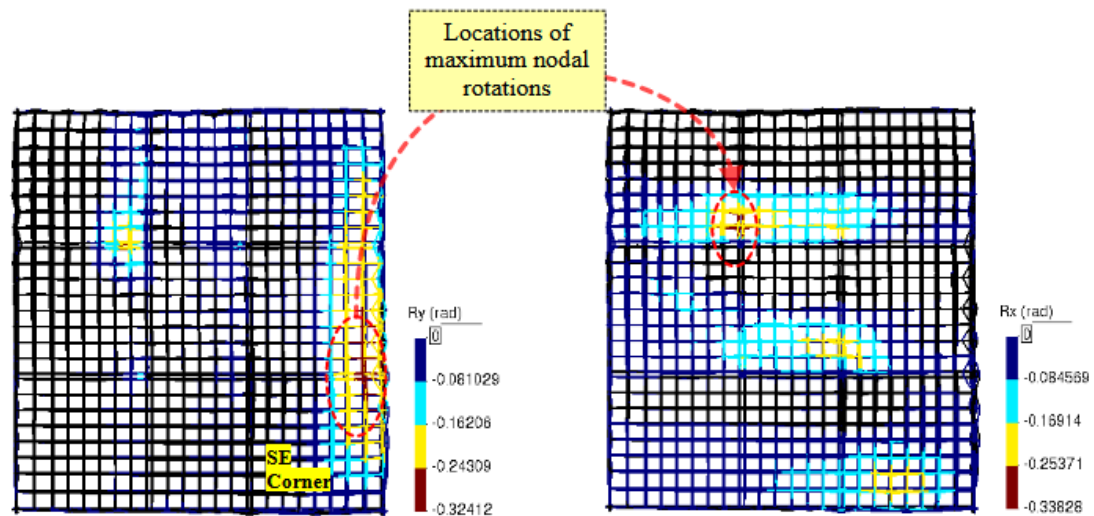
Figure 7.25 Contour map showing maximum nodal rotations- R_x and R_y , on the 13th floor.

The simulation results predicted the highest rotational displacement at the primary connection near the eastern side of the 13th floor, as illustrated in Figure 7.25. The left contour image denotes the nodal rotations in the north-south direction (R_y), while the right contour image (R_x) represents the nodal rotations in the east-west direction. The analysis reveals that the primary and adjacent secondary beams underwent rotations approaching 0.33 radians or approximately 19 degrees at the connections. But in reality, the edge beams on the eastern side exhibit greater resistance to twisting forces and increased connection stresses compared to the southern edge beams because of the presence of masonry walls, as depicted in Figure 7.23. The visual evidence of the vertical damage propagation in Figure 7.23 agrees well with the anticipated failure location as predicted by the thermo-mechanical model shown in Figure 25.

Before the overall collapse of the tower, it is probable that the primary beams close to the southeast (SE) corner of the 14th floor experienced failure at the location highlighted in Figure 7.25. Consequently, a significant portion of the 13th floor collapsed, impacting two primary beams that supported the floor segment of the SE corner.

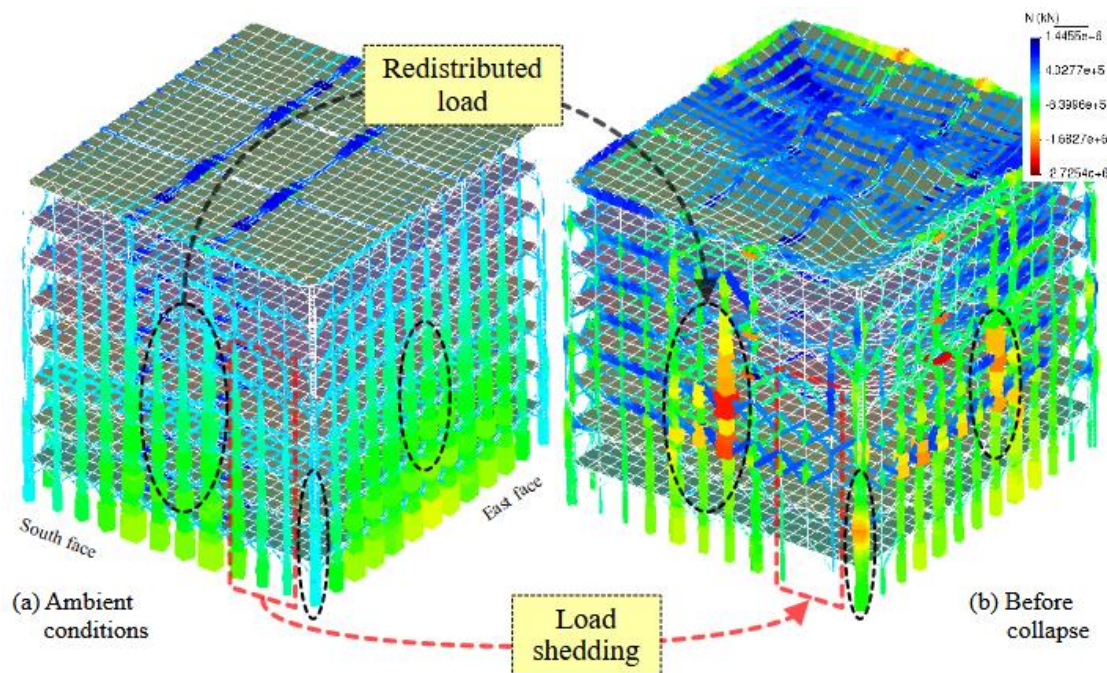
Figure 7.28 Line thickness contours showing the column axial forces at (a) ambient conditions and before collapse.

The findings and visual cues suggest that the adjacent columns successfully withstood the additional compressive loads resulting from the load transfer from the heated columns. Notably, the adjacent columns remained stable without buckling, likely due to the presence of cooler

structural elements in the western and southwestern (SW) regions of the building, as depicted in Figure 7.21. Load redistribution before the global collapse was successful because of the intact peripheral beam. Stability mechanism during this phase is akin to what was described in section 3.5.3, refer to Figure 3.19.

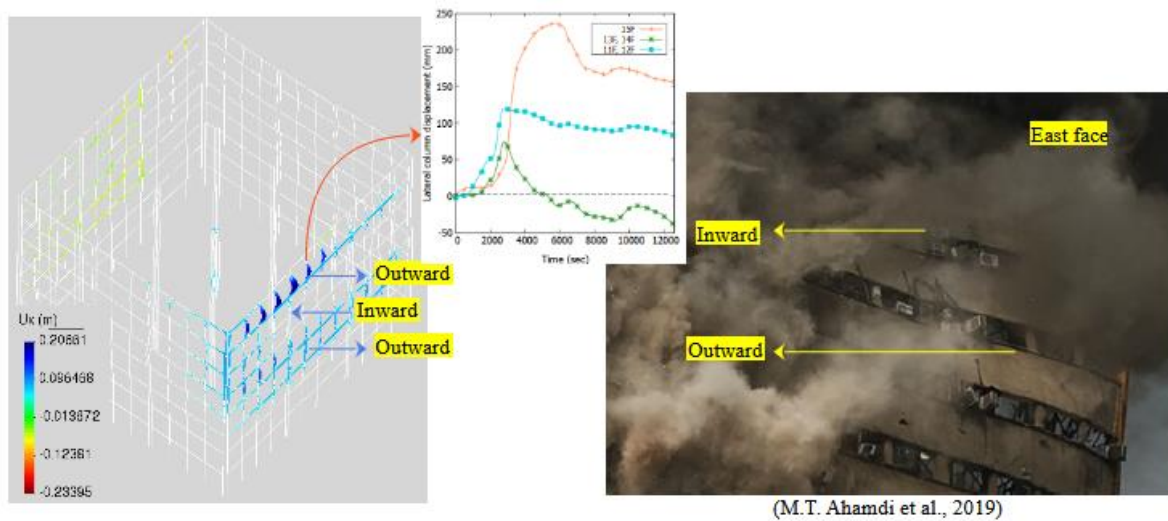
Figure 7.29 Outward displacement of columns on the east face

The simulation results reveal a distinct pattern of column displacements within the tower. Initially, columns on the eastern face exhibit outward displacement during the initial hour of the fire. Subsequently, columns on the 13th and 14th floors shift inward, while columns on the remaining floors maintain their previous trend, as illustrated in Figure 7.29. The maximum outward displacement of a column on the eastern face observed between the 15th floor and the roof amounts to 240mm, as depicted in the plot in Figure 7.29. Simultaneously, an inward displacement of approximately 13mm (negative) is noted on the 14th floor, resulting in a net column eccentricity of 253mm.

Furthermore, the highest inward displacement of a column on the eastern face, around 40mm (negative), is observed on the 14th floor, with a corresponding outward displacement of roughly 160mm, resulting in a column eccentricity value of 200mm. Throughout most of the fire duration, the columns on the east side experienced eccentricities ranging from 200mm to 250mm, primarily due to the fire affecting the eastern face of the 13th and 14th floors.

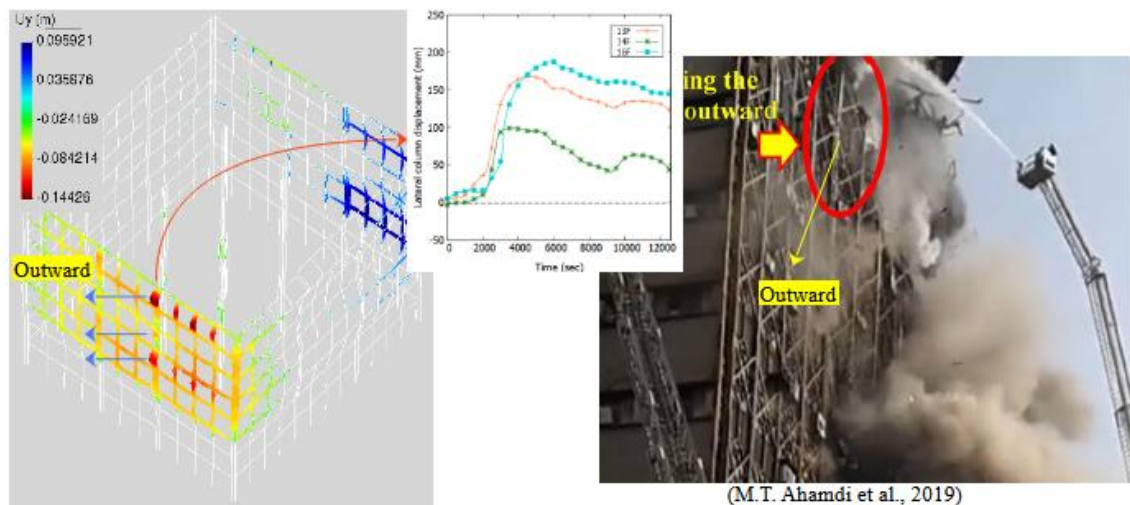
Figure 7.30 Outward displacement of columns on the south face

On the southern face, the lateral displacements of the columns peaked at 163mm and 188mm on the 13th and 16th floors, respectively, while reaching 96mm on the 14th floor. The maximum net eccentricity observed was 100mm throughout the analysis. Due to the extensive spread of the fire, the column eccentricities on the eastern face exceeded those on the southern face, with values reaching 253mm. Both external columns on the eastern and southern sides exhibited a reversal in lateral displacement after 4000 seconds (1 hour and 6 minutes) of the fire duration. This suggests that even if connections manage to withstand the damage, there are hypothetical fire conditions that could potentially trigger global collapses. In the context of the Plasco tower, it is plausible to suggest that connection failures led to premature and abrupt collapse, thereby limiting the opportunity to witness the collapse induced through altering structural geometry.

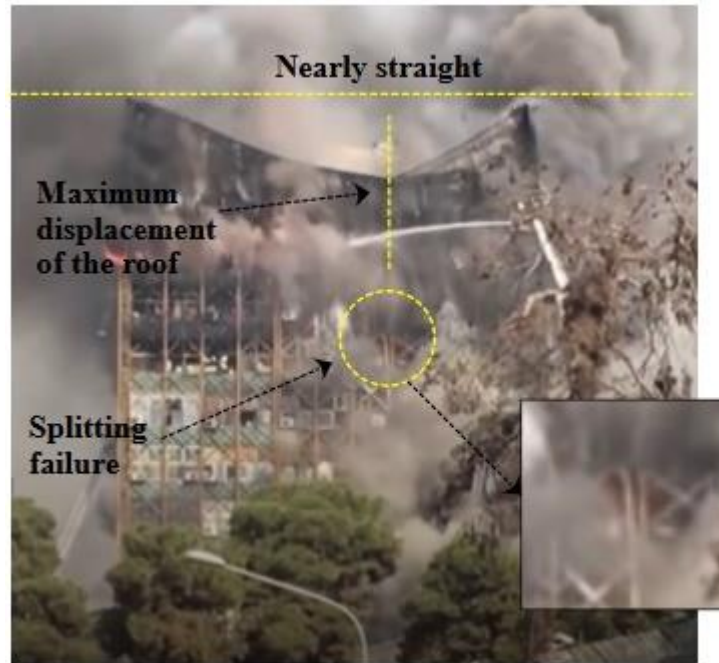
Figure 7.32 A significant moment during the global collapse

Video recordings demonstrate that the complete collapse occurred as the external columns near the southern facade started to displace inwards during the final stages. Figure 7.32 illustrates that the roof encountered its most significant displacement precisely over the external primary column, visibly buckling inwards. This column, which was built using two box sections (each box section again was built up using 2 UNP channels), was seen undergoing a splitting failure.

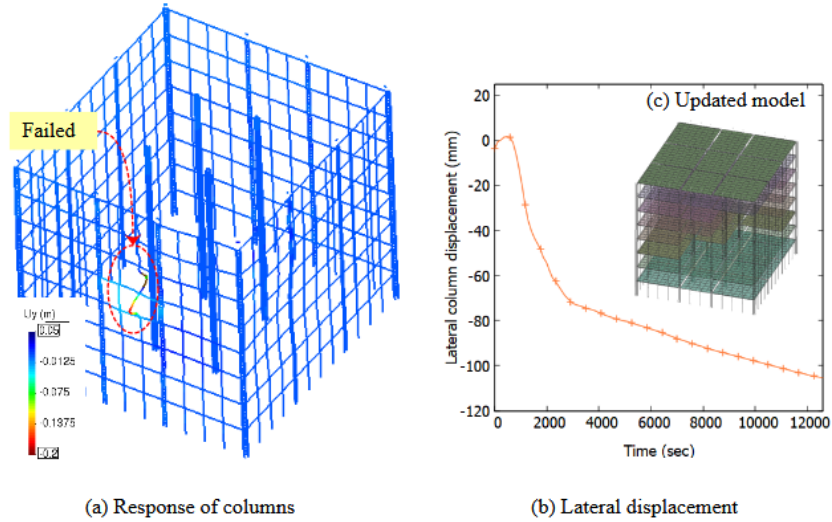
Figure 7.33 Response of columns based on the revised model

Multiple floors near the southeast (SE) corner were removed, and thermal loading was exclusively applied to the external columns. The simulation predicted the failure of the column adjacent to the secondary primary column, as depicted in Figure 7.33(a). This column deforms in an 'S' shape, exhibiting a maximum lateral displacement of around 100mm inward and 100mm outward. Figure 7.33(b) illustrates the lateral displacement of the column. Since this analysis is based on static loading, the reliability of the response is limited to the point of failure initiation. Therefore, once the collapse commences, the displacements escalate swiftly within a short timeframe. In the present model, only the outcomes corresponding to 4-5 seconds before the collapse are considered worthy of discussion.

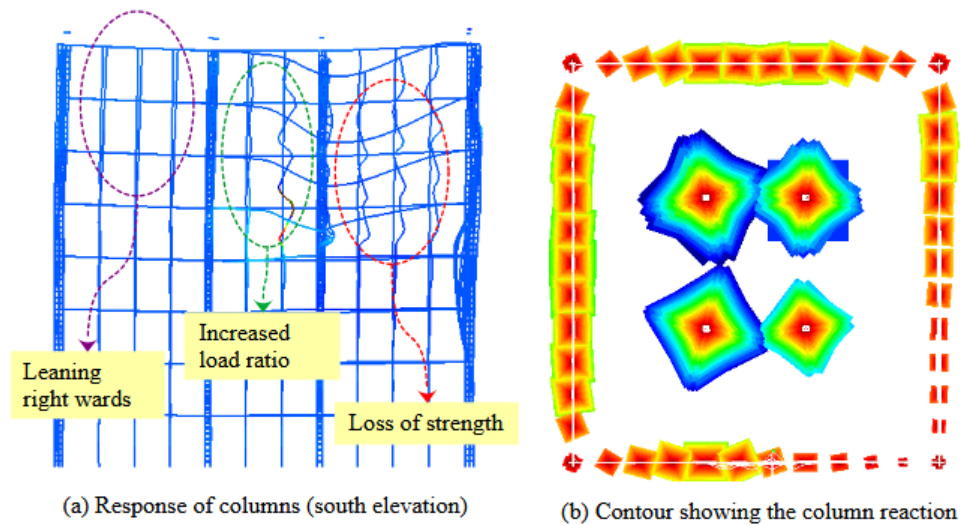
Figure 7.34 South elevation view of the model showing vertical displacements and column base reactions

The depiction in Figure 7.34(a) illustrates the response of columns on the southern facade of the model. The columns near the southeast (SE) corner failed because of fire, leading to load shedding and subsequently transferring the load to adjacent columns. Figure 7.34(b) demonstrates the increased base reaction of the columns situated in the middle of the edge frame. Due to the removal of floor segments near the corner region, the corner column did not exhibit increased base reactions. Columns positioned in the centre of the frame display 'S' shaped displacements, signalling the failure initiation. Consequently, the columns on the far left are observed leaning inwards. In the upcoming sections, the global response simulated using the updated model will be compared with available video evidence.
