**MULTIDISCIPLINARY FORENSIC
INVESTIGATION OF BUILDINGS IN FIRE: THE
CASE OF THE PLASCO TOWER**

Multidisciplinary Forensic Investigation of Buildings in Fire: The Case of the Plasco
Tower

A thesis submitted in partial fulfilment of the requirements for the degree of
Doctor of Philosophy
Aug 2024

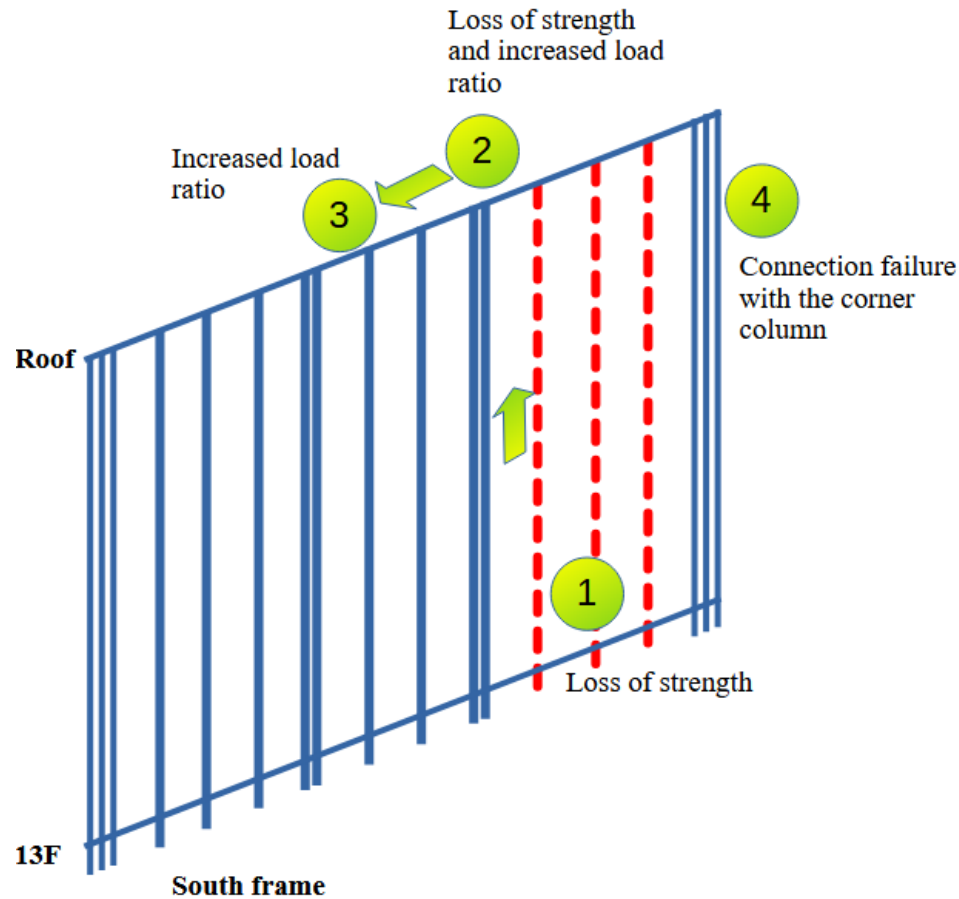
Figure 7.38 Summary of the video evidence & simulation: In-plane propagation of external column failures

The final collapse was primarily triggered by the in-plane propagation of external column failures. The simulation agreed with the video evidence by accurately depicting how these failures spread horizontally, leading to a cascading effect that ultimately resulted in the complete collapse of the structure.

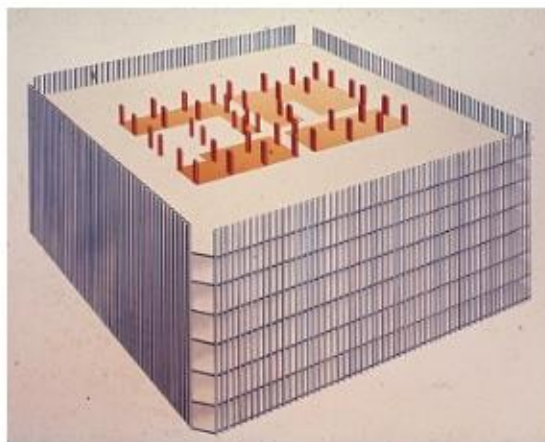
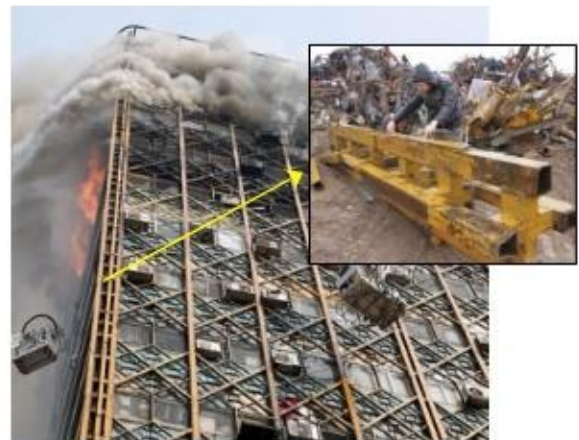
Figure 7.39 External framing in the WTC towers and Plasco tower

In the WTC towers, lateral forces were primarily resisted by thin external columns distributed along the perimeter, as depicted in Figure 7.39(a) (Archives of Michigan (n.d.)). However, in the Plasco Tower, the corner columns are designed to resist lateral loads, reducing the demand on the perimeter columns. This design approach can be risky in situations where external columns are subjected to overloading. The structural design of the Plasco Tower appears to be vulnerable to challenges related to load redistribution efficiency during extreme events, highlighting potential flaws in the design to withstand and respond to significant structural stresses and disturbances.

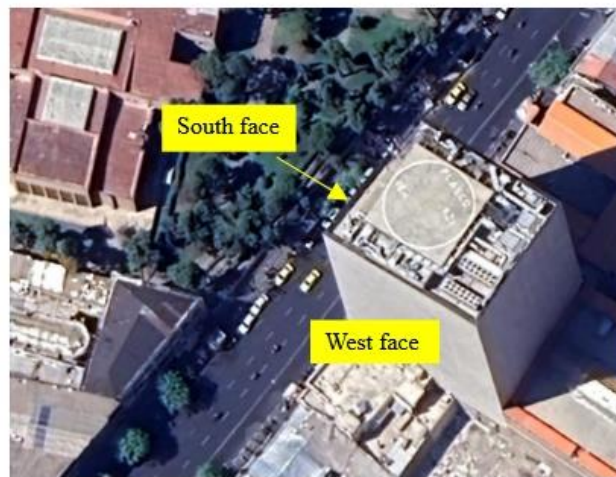
Figure 7.41 Satellite view of the tower showing directions

The primary firefighting operations focused initially near the northwest corner, effectively containing the spread of the fire towards the west. However, as the fire advanced to the eastern section during later stages, firefighting efforts were hindered by limited accessibility on the eastern side, as depicted in Figure 7.41. Furthermore, the presence of masonry walls on the western facade,
